LEIDOS FIELD AT RIPKEN STADIUM

Assessment Report | July 8, 2022

EXECUTIVE SUMMARY

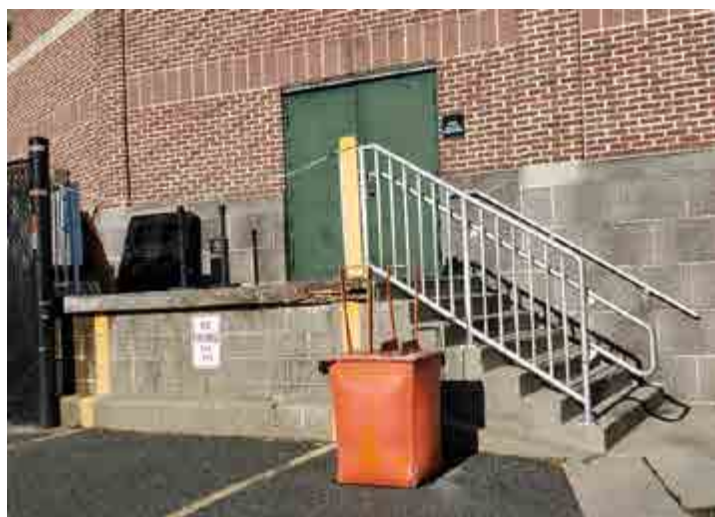
AM-3 *Loading Dock Bumper*

3. Loading Dock Bumper: Wood bumper is deteriorating. **AM-3** Replace timber bumper bolted to front of loading dock.

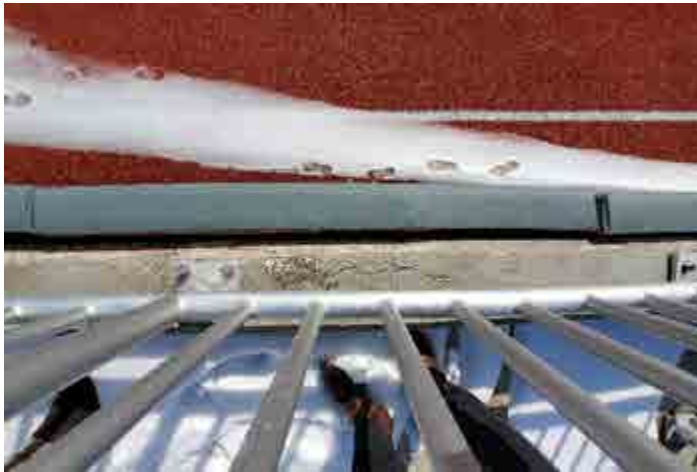
ASB-8 Cracking at sloped retaining wall

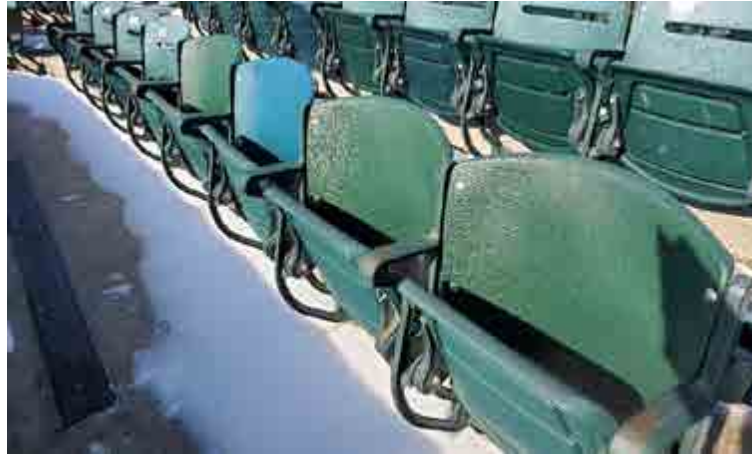
- b. Seat Numbers: Many locations of missing seat numbers observed. **ASB-11**
Replace missing seat numbers.

ASB-11 *Seat Numbers*

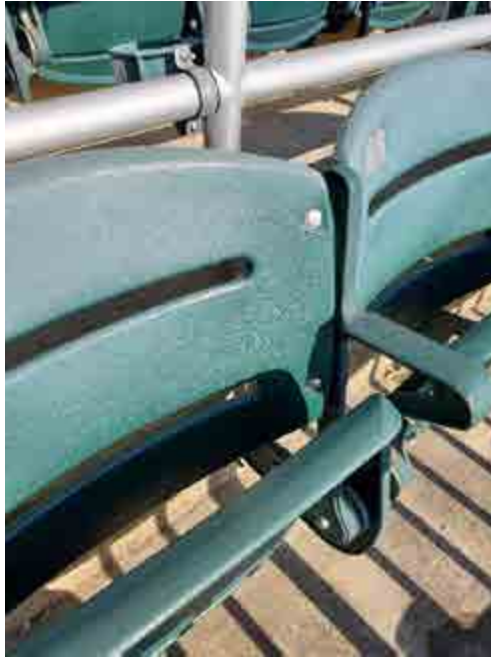
ASB-12 Cracked seat backs

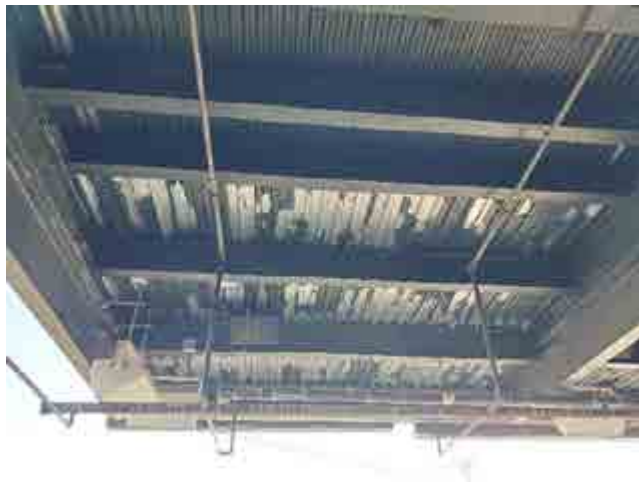
1. Steel Structure: Paint is failing on underside of metal decking and structure.
ASE-1 Clean/repaint all exposed steel structure including exposed metal deck on underside of the Suite/Club Level, structure supporting the videoboard and marquee sign and partially enclosed exit stairs.

ASE-1 Steel Structure

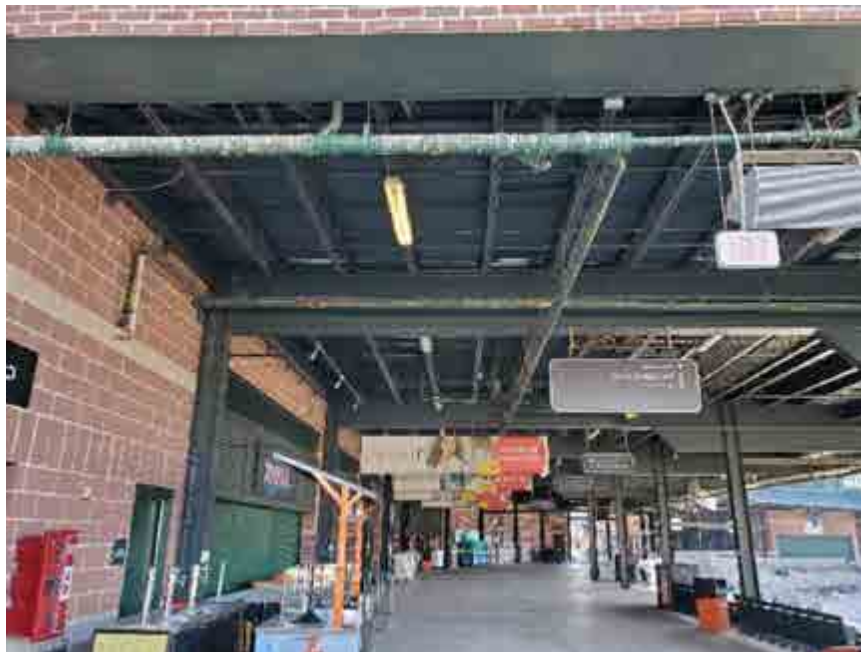
3. Bird Control Netting: Widespread evidence of bird roosting above the Concourse and Suite Corridor was observed. **ASE-3** Add bird netting throughout covered exterior areas of concourse. Recommend engaging a subcontractor that specializes in bird control measures to evaluate and recommend an appropriate solution.

ASE-3 Bird Control Netting

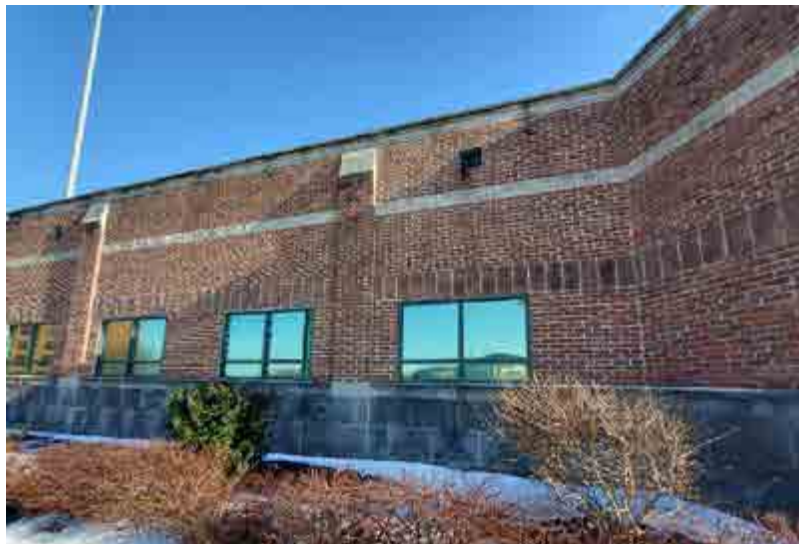
ASE-5 *Masonry Walls*

4. Heated Soffit: Facilities team noted issues in winter with exposed piping overhead in concourse. They currently a combination of winterizing and adding temporary heaters to prevent freezing. **ASE-1** Construct heated soffit under the Kitchen to protect pipes from freezing.
5. Masonry Walls: Moisture and water infiltration issues were observed in a number of interior locations. **ASE-5a-c** In lieu of rebuilding walls to industry standard cavity wall construction to prevent moisture migration, clean and seal all brick and CMU masonry walls with a vapor permeable sealer - i.e. siloxan. Reseal every 5 years.

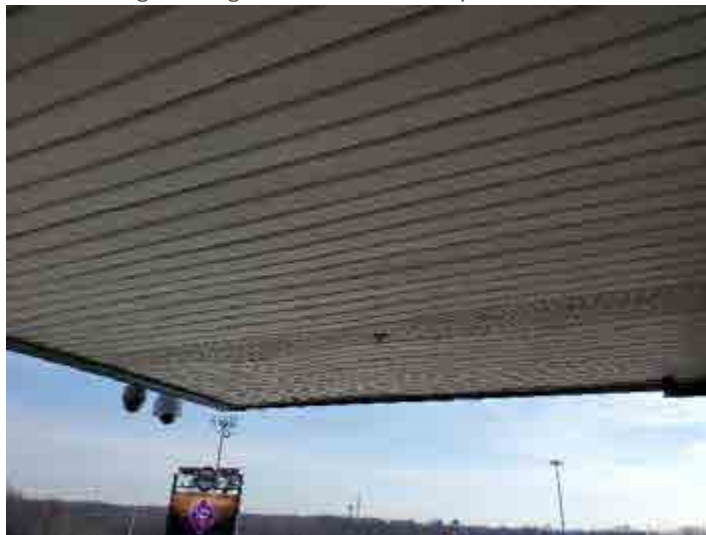
- d. Corrugated Metal Roof Soffit: **ASR-4** Replace warped/damaged/missing corrugated metal soffit panels over Suite/Club seating areas.

ASR-4 Corrugated Metal Roof Soffit

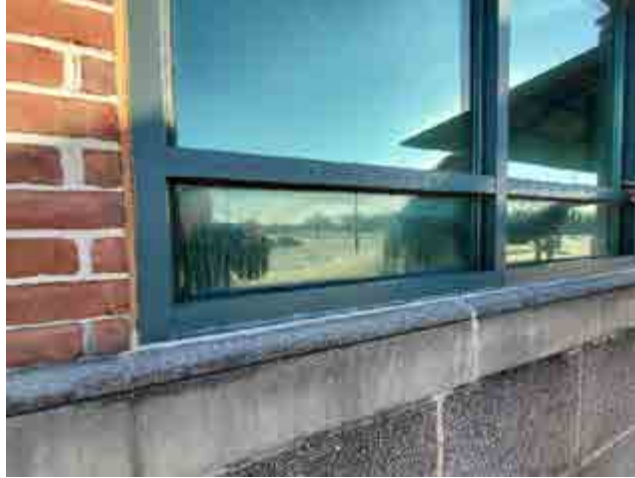
- e. Glass Window Panels: **ASCE-5** Replace failed insulated glass windowpanes on parking lot side of Admin. Offices.

ASCE-5 Glass Window Panels

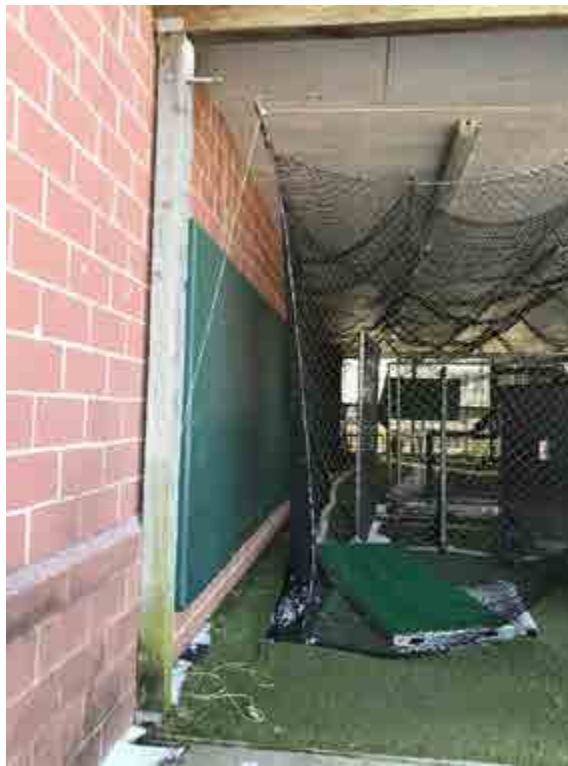
- a. Plywood Ceiling: Plywood ceiling shows signs of deterioration. **AHCE-9** Remove plywood ceiling and replace with suitable exterior grade ceiling material.

AHCE-9 Plywood Ceiling

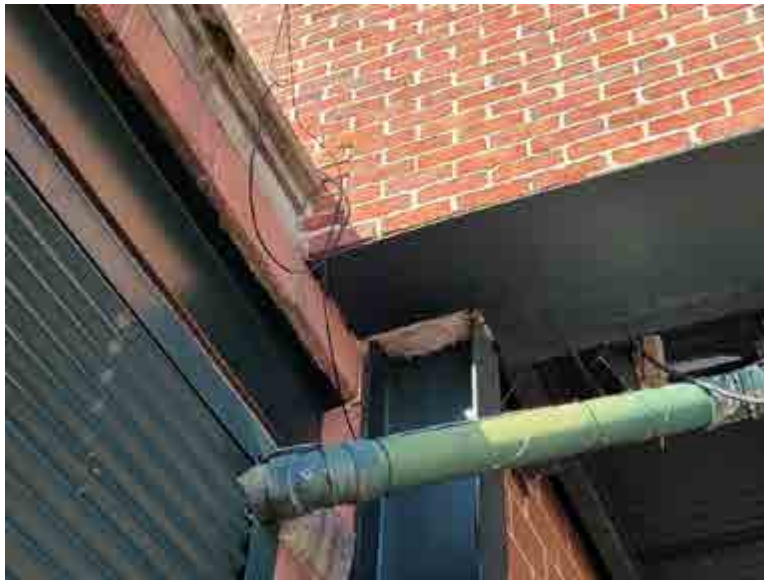
- S-1 At column A/4 and GG/4 at the Suite Level, there is a 3/8" plate acting as the brick shelf at the bottom of the spandrel from grid 4-5. The plate is coped at the column and is deflecting where it ties to the concession building parapet. It is recommended that steel support brackets be welded onto the column flanges to support the plate and prevent further deflection. Once field welding of the brackets is completed all welds should be painted with a zinc rich paint and then finish painted to match adjacent steel. The existing cracks in the brick joints should be repointed and any damaged bricks should be replaced.

Deflected Brick Shelf and Cracking in Brick Veneer.

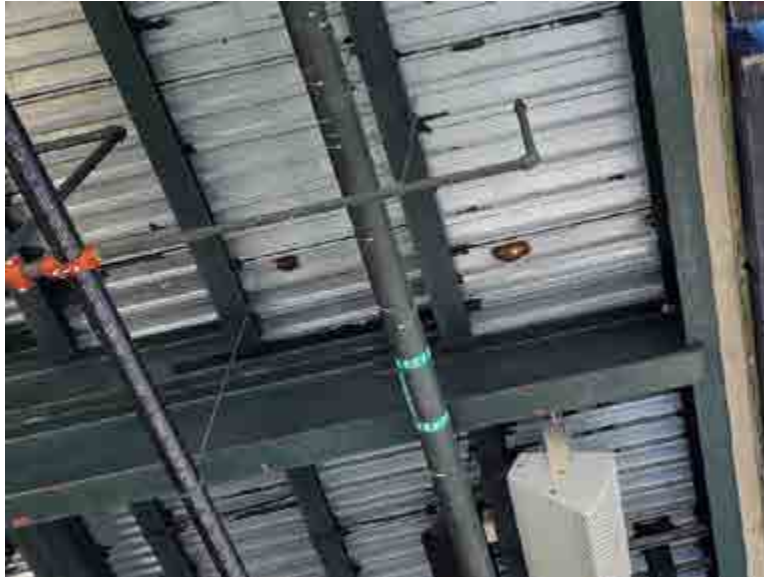
Corroded decking below suite level seating.

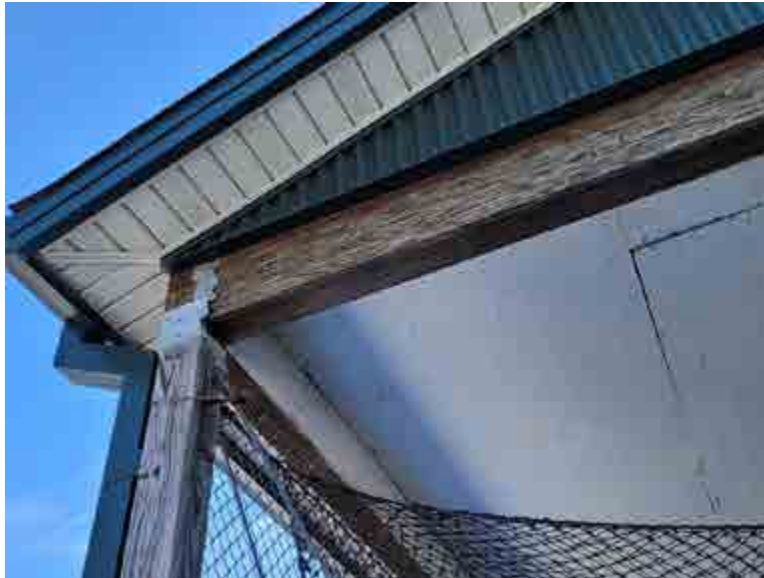
Weathered exposed wood framing at clubhouses.

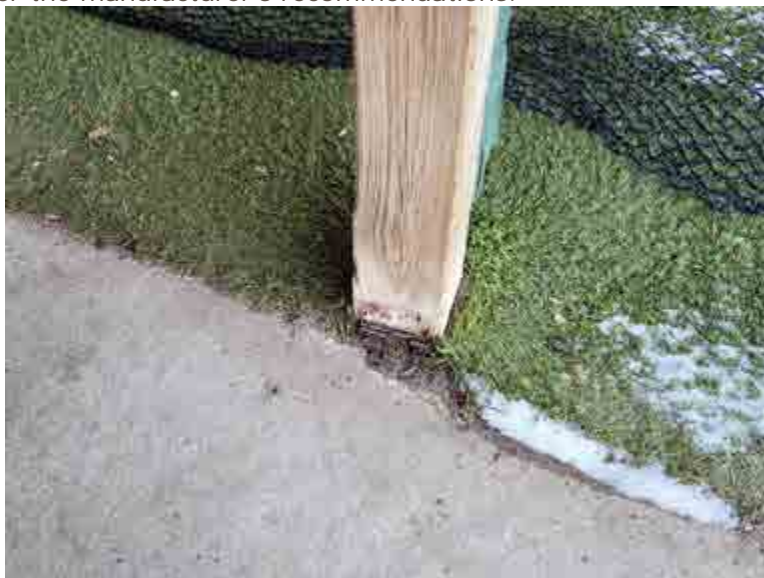
- S-4 The metal post bases at the bottom of the exposed wood 6x6 posts at both clubhouses were in various states of deterioration. All bases show signs of corrosion and should be repaired. Temporary support of the roof structure adjacent to post will be required to remove the deteriorated post base and install a new corrosion resistant base. New retrofit post bases should be installed with stainless steel fasteners to the post and into the concrete per the manufacturer's recommendations.

Corroded post bases at exterior 6x6 posts of clubhouses.

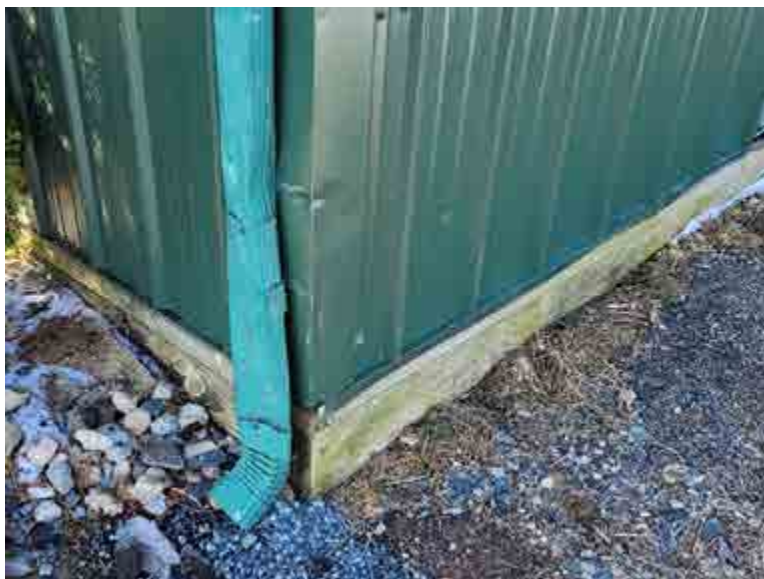
Deterioration of dimensional lumber curbs at storage buildings.

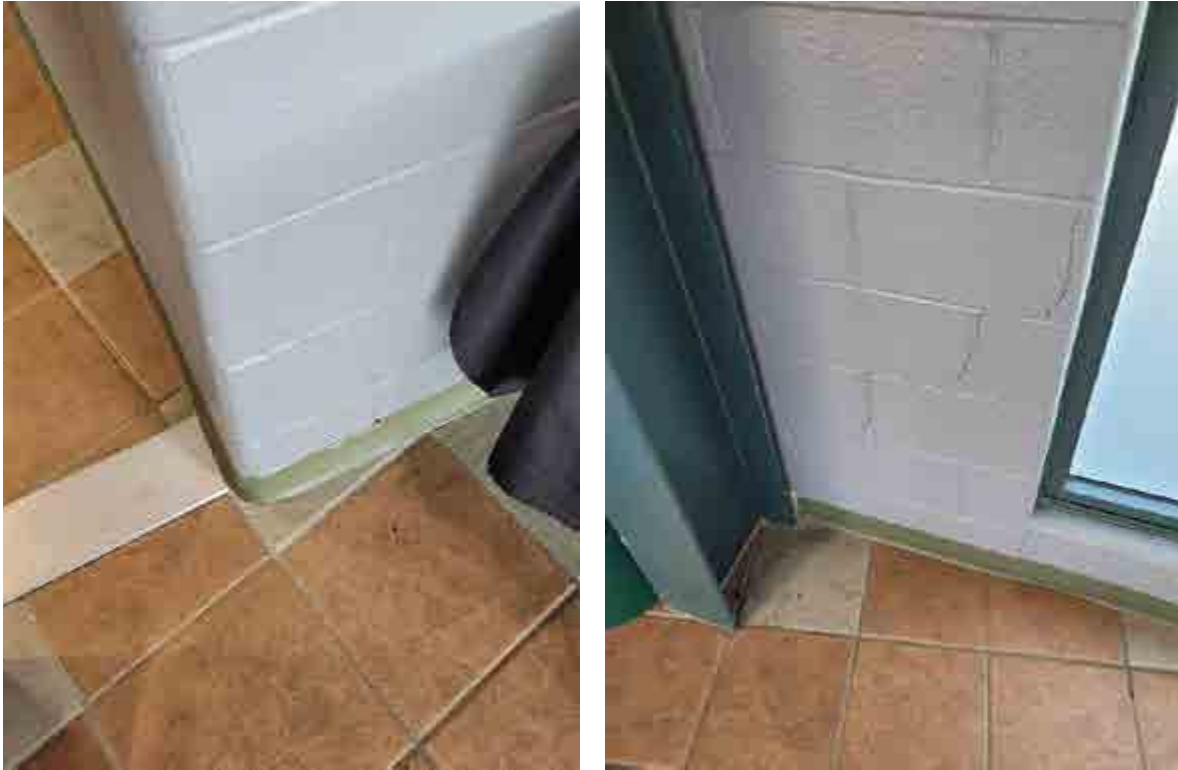
Cracking in CMU walls at Suite Level.

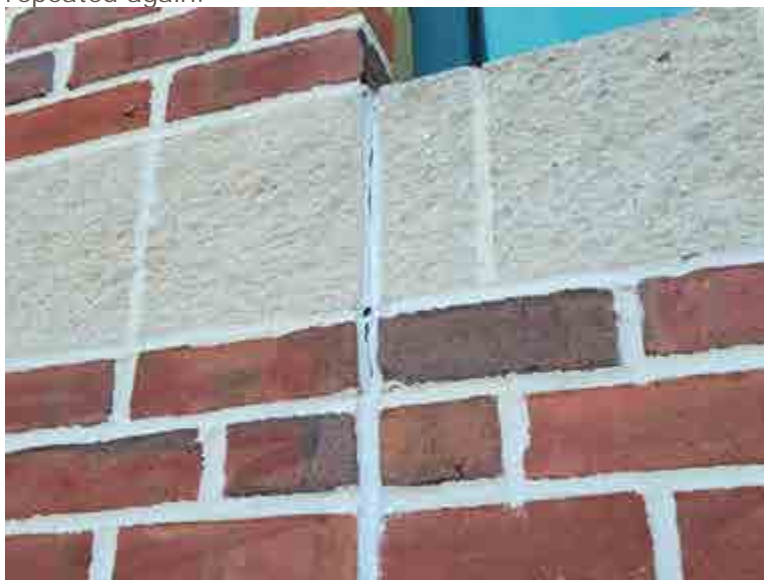
S-7/7a Contraction / control joints in the building's masonry facades were observed to have failed in many locations. Existing sealant joint materials should be completely removed, and new sealant/joint material should be installed. The lifespan of these types of sealant materials is generally less than 20 years so it should be anticipated that this work will need to be repeated again.

Failed contraction/control joint in brick veneer.

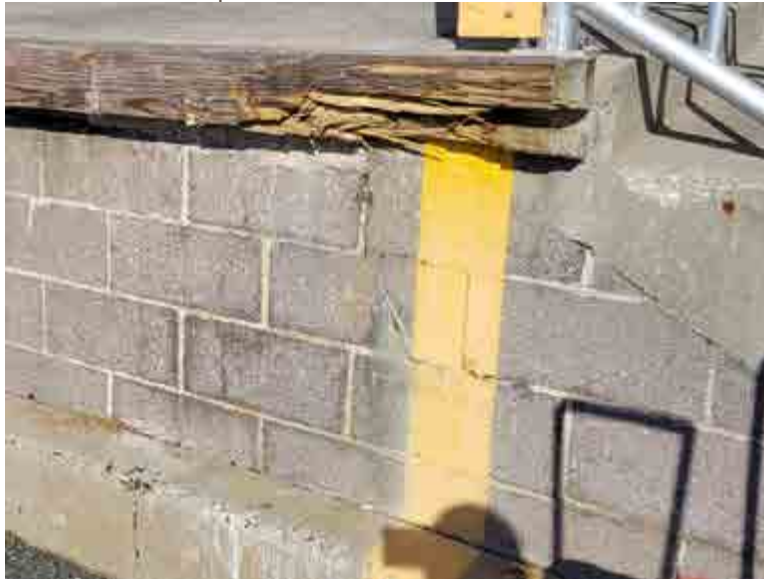
- S-8 CMU walls at the loading dock appeared to have been damaged from impact by vehicles. These damaged blocks should be replaced with new CMUs and cracked or displaced joints should be routed out and repointed.

Damaged CMU wall at loading dock.

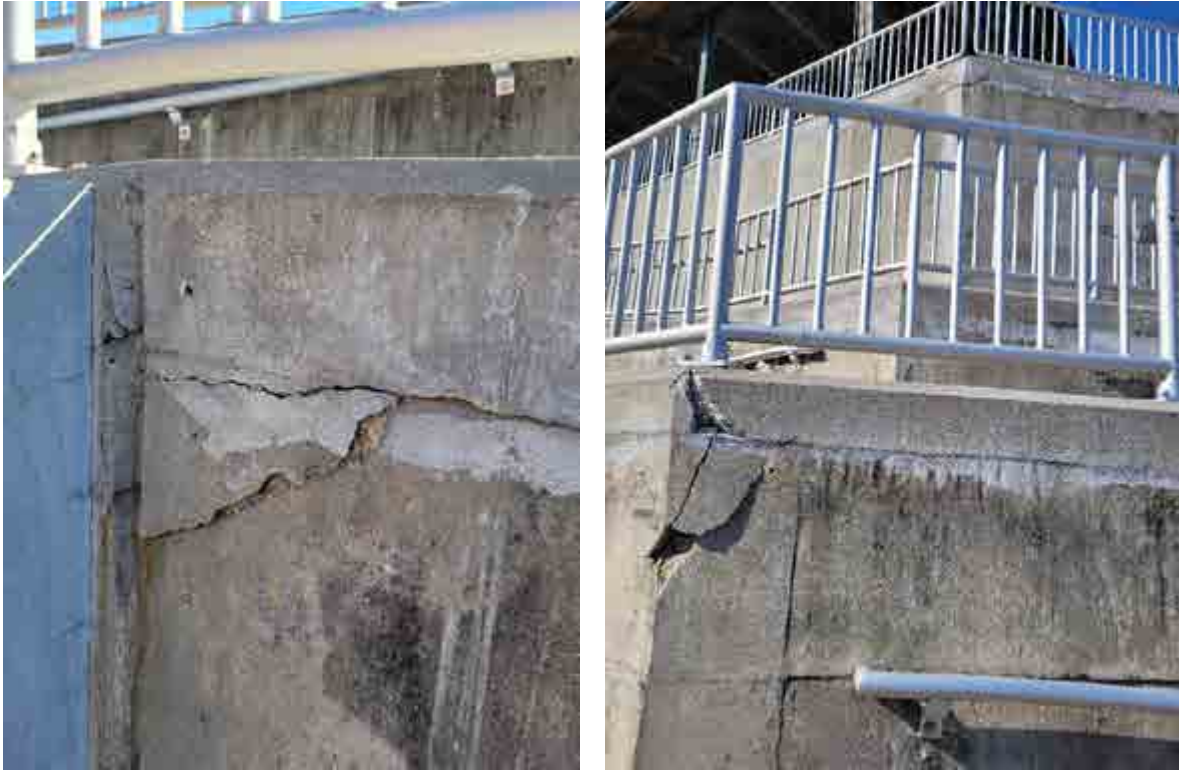
Spalls and cracking in CIP concrete walls at ramps.

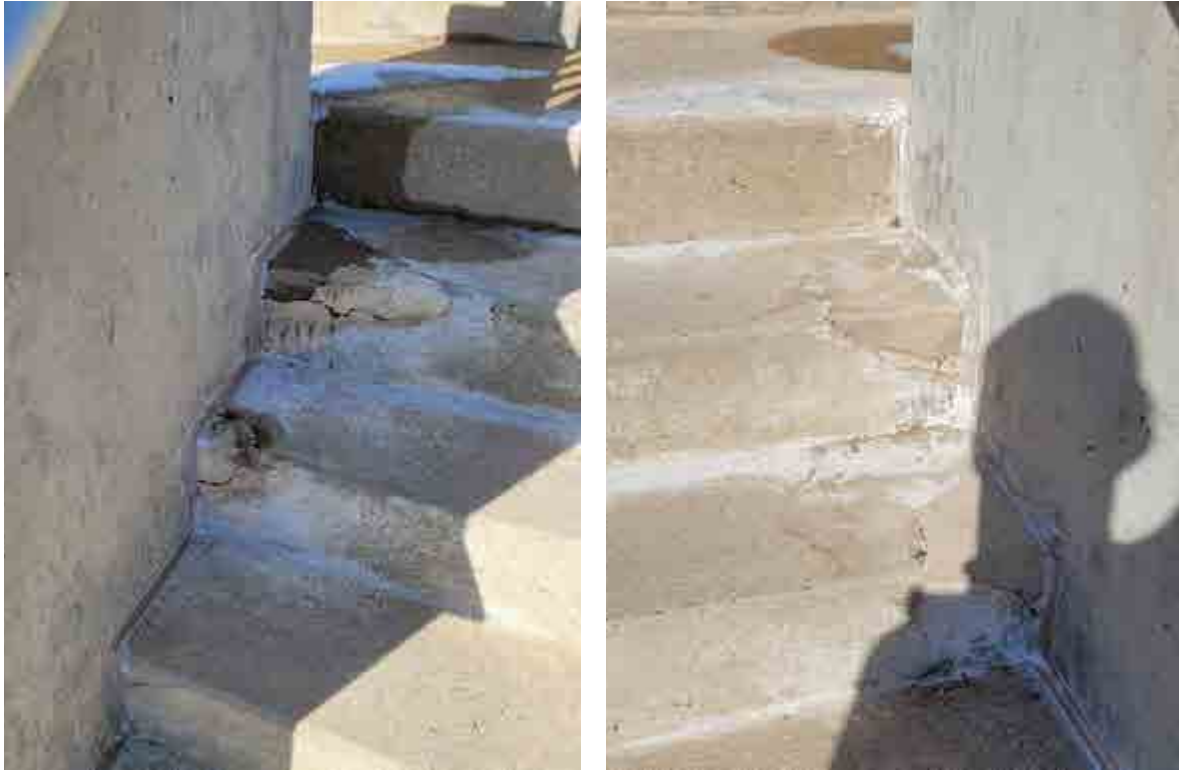
Spalls and cracking in CIP concrete cross aisle stairs.

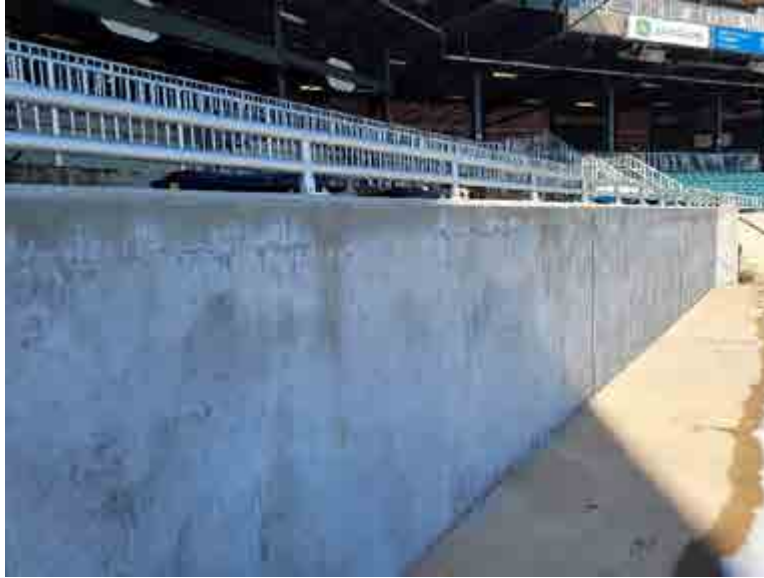
Cracking in existing parge coating on cross aisle wall.

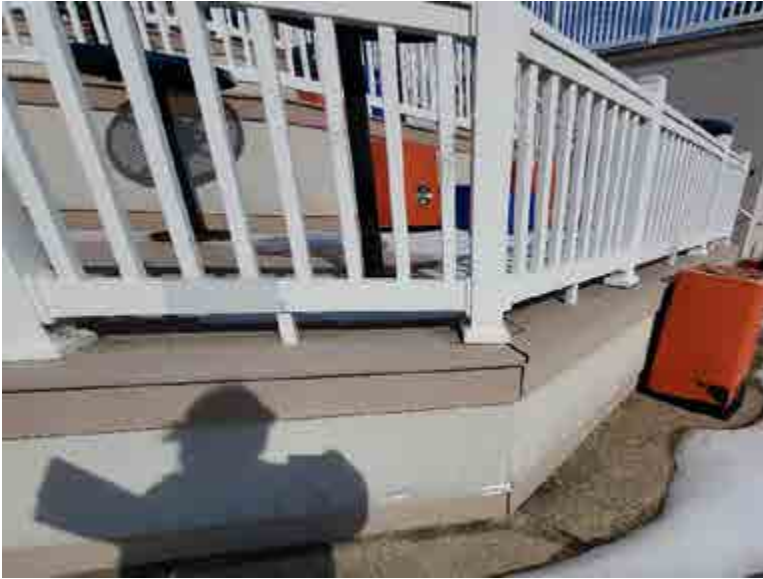
Damaged PVC railings at left field deck.

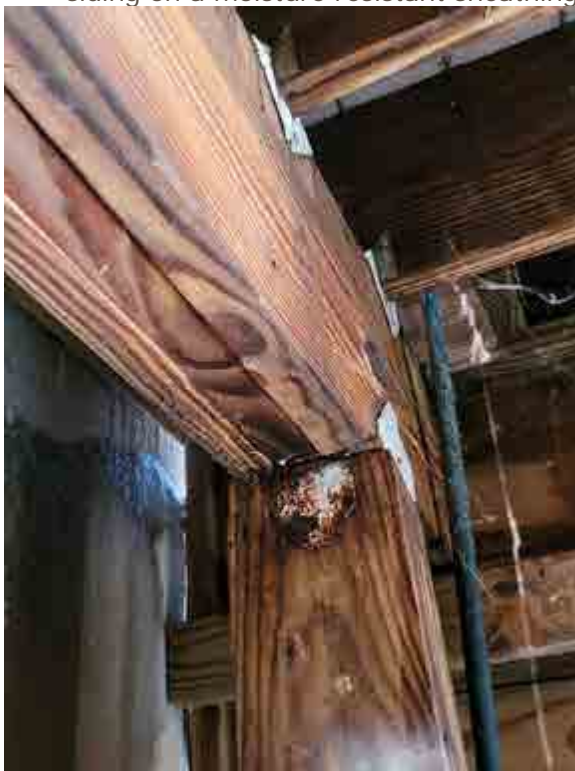
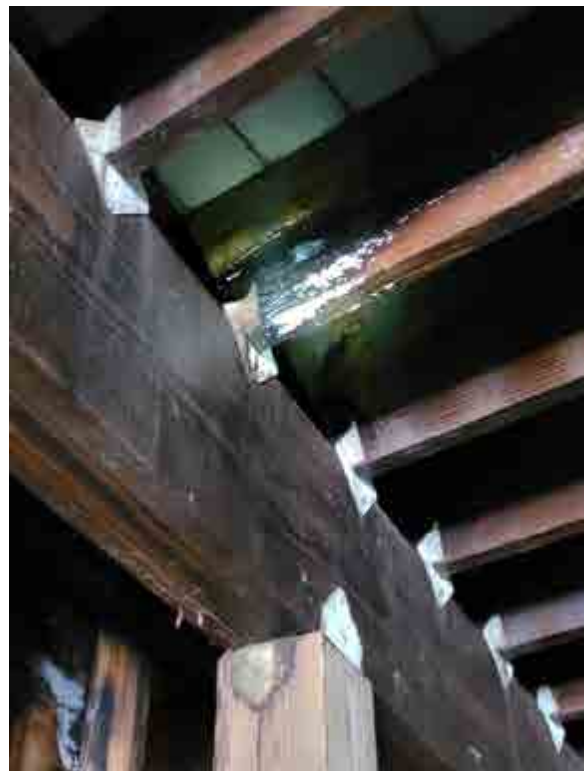
- S-14 The wood structure under the left field deck is showing signs of deterioration particularly at the joints between members and the fasteners and connection plates. The wood structure should be replaced with pressure treated dimensional lumber and stainless steel fasteners. When the structure is being rebuilt, we would recommend replacing the vertical EIFS walls with a more robust material such as painted Hardie board or metal siding on a moisture resistant sheathing.

Deterioration of left field deck wood structure and connections.

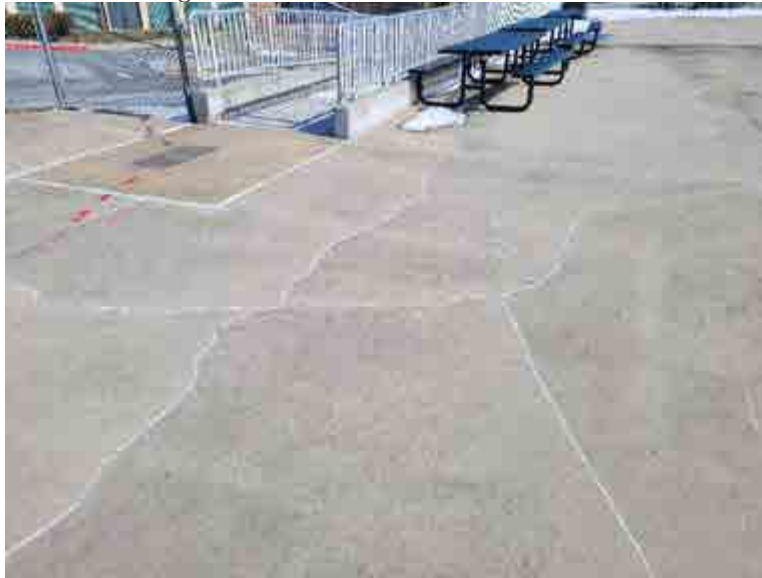
S-15 The concourse concrete slab on grade adjacent to the left field deck appears to be settling unevenly and excessively in some locations resulting in cracking and potential tripping hazards. We recommend saw cutting around the affected area and demoing the existing slab. Compact the subgrade and fill any low spot with engineered fill, then repour the slab to match existing.

Cracked and settled left field concrete slab on grade.

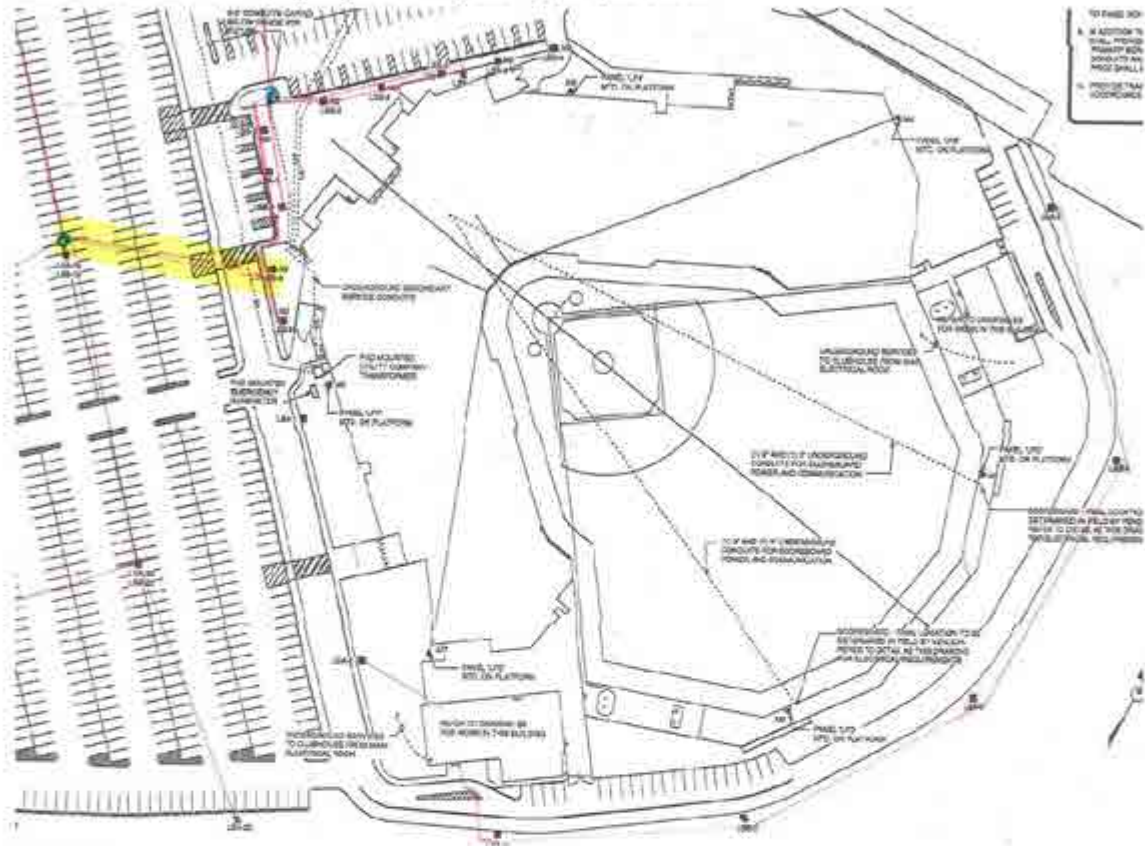
- EP-3 Underground Site Lighting Conduit:** It was reported that there have been at least 2 branch circuit failures. It is recommended to provide new conduit and branch circuit conductors to the first hand hole outside of the building. The conduit run is estimated to be 200 feet and would require 2#6 & #6G in 1 1/4" C. Refer to the image below for the exact conduit run (highlighted in yellow) in question.

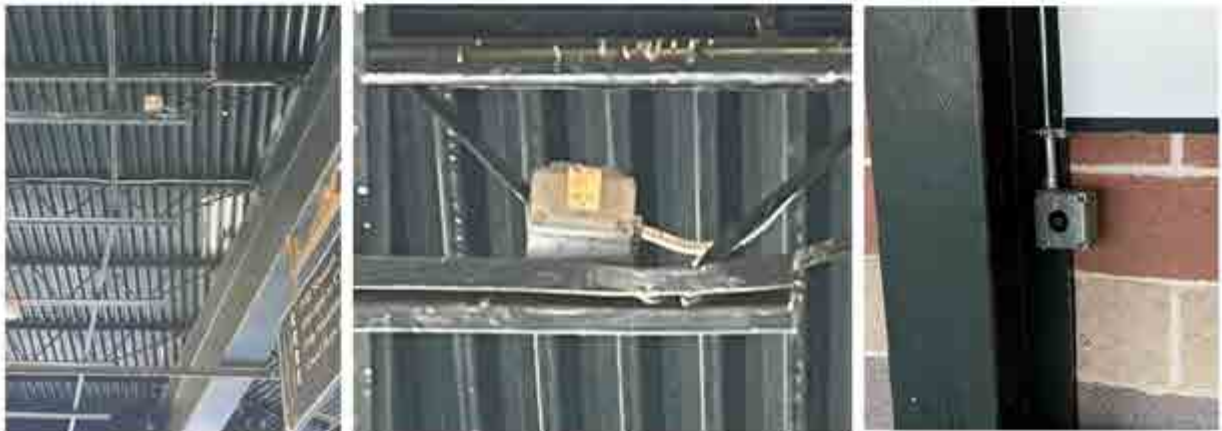
- EP-4 Exterior Receptacle Coverings:** It was observed that there are several outdoor receptacles that do not have a covering. Provide receptacle cover for all exterior installed receptacles.

Exterior receptacles without coverings

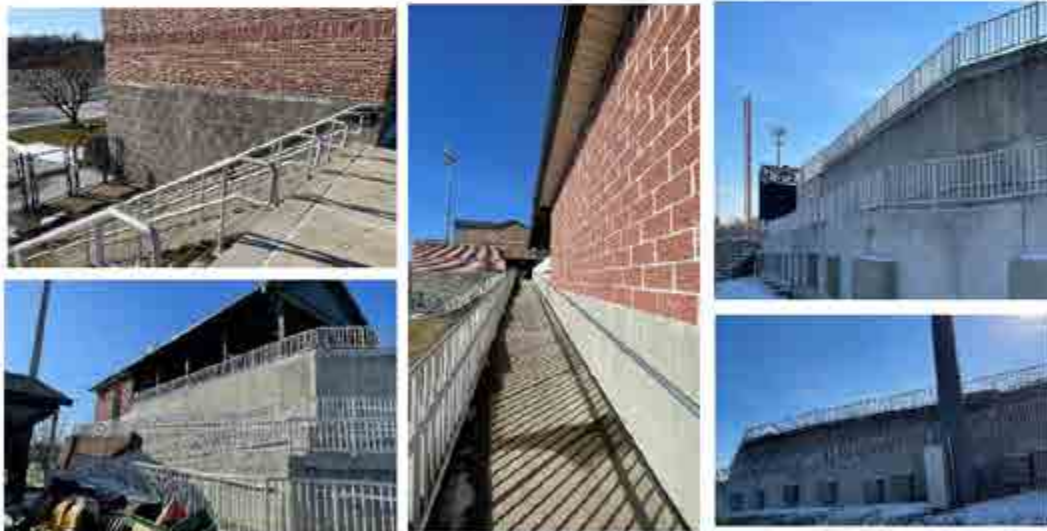
EL-1 Emergency Egress Lighting: It was observed that there is insufficient lighting for egress purposes in areas such as ramps, stairs, and patio areas. This presents a safety hazard at these locations when sports lighting is not turn on and these areas are occupied. It is recommended to replace the existing lighting in these areas with LEDs and add additional LED fixtures in order to meet emergency egress lighting levels. Additionally, the lighting controls shall be replaced and programmed with the overall building lighting control system as part of this upgrade.

Egress pathways without lighting

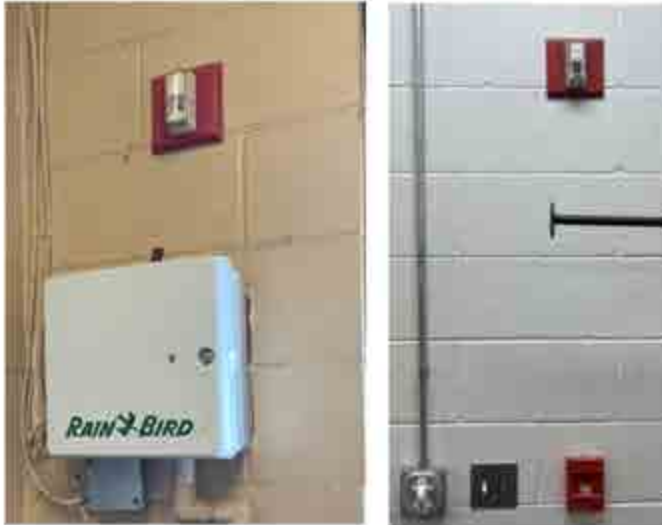
- FA-3 Fire Alarm Indoor Strobes/Speakers: The fire alarm indoor strobes/speakers throughout the ballpark are in need of replacement. We recommend replacing all indoor strobes/speakers for the fire alarm system.

Outdated indoor fire alarm strobes/speakers

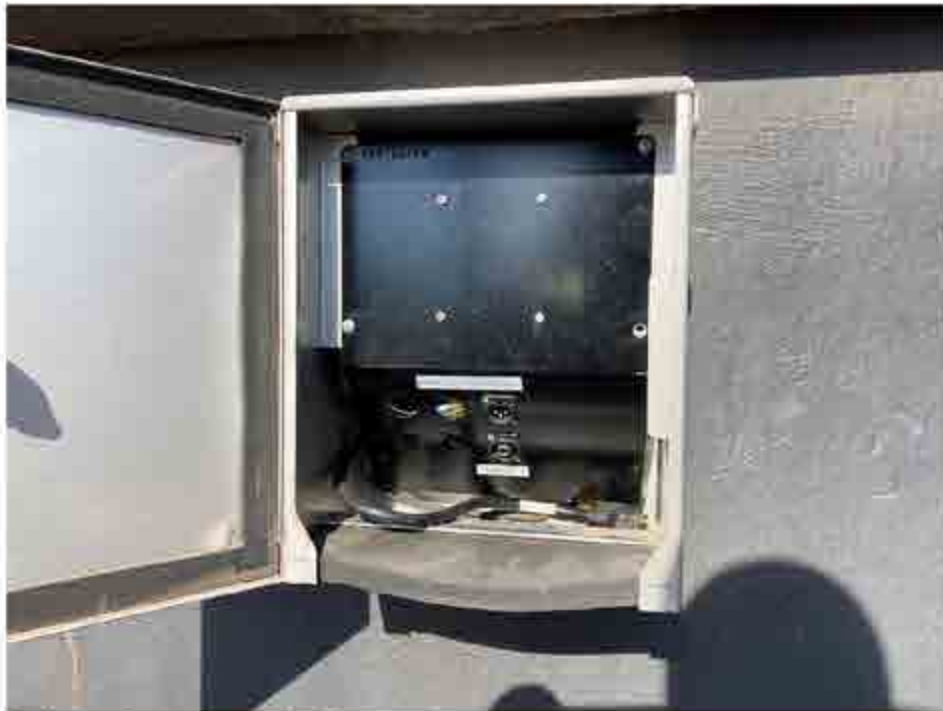
- Cabling and connections for cameras is very worn and corroded.

Production Camera Connection Box

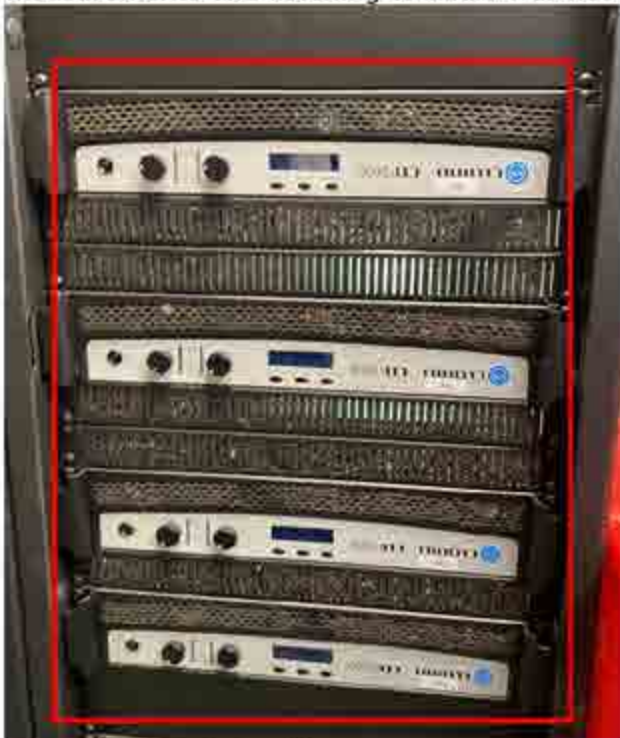
Deficient Bowl Speaker Amplifiers

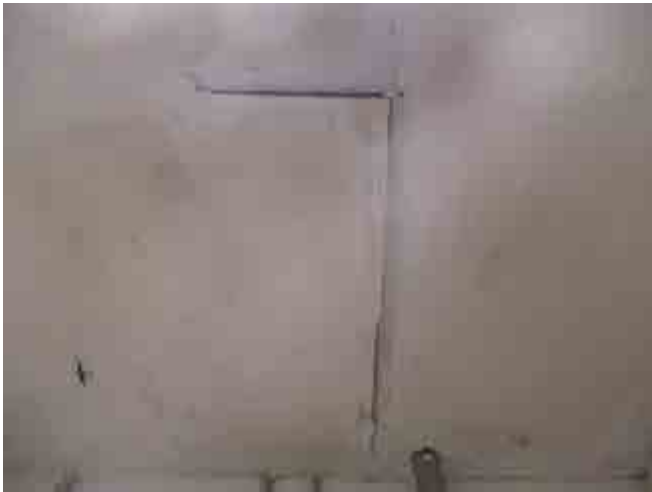
1. Repair ceiling in machine rooms

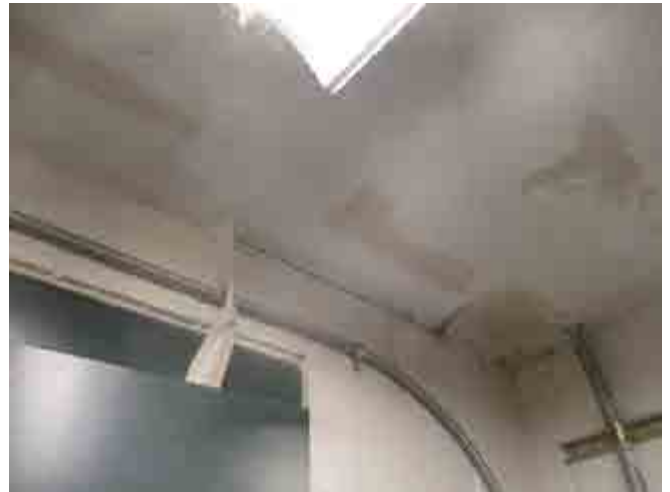
2. Repair ceiling in machine rooms

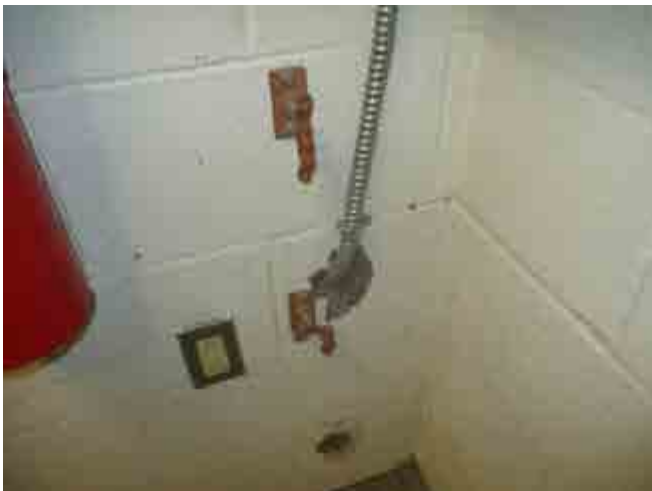
3. Relocate flexible conduit entering elevator #2 machine room

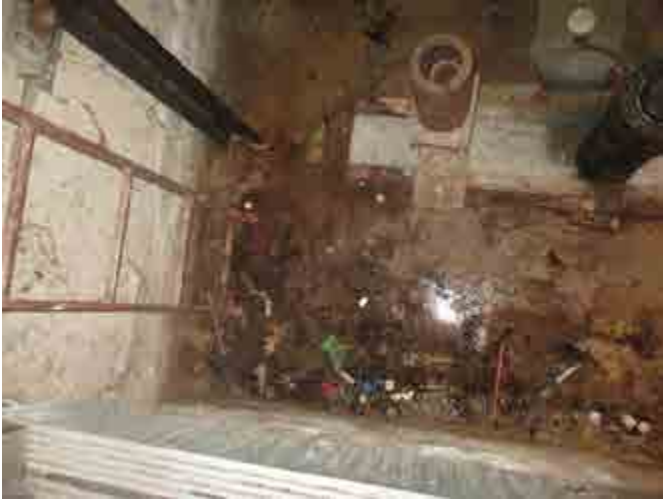
5. Locate water leak in elevator #1 pit and seal it

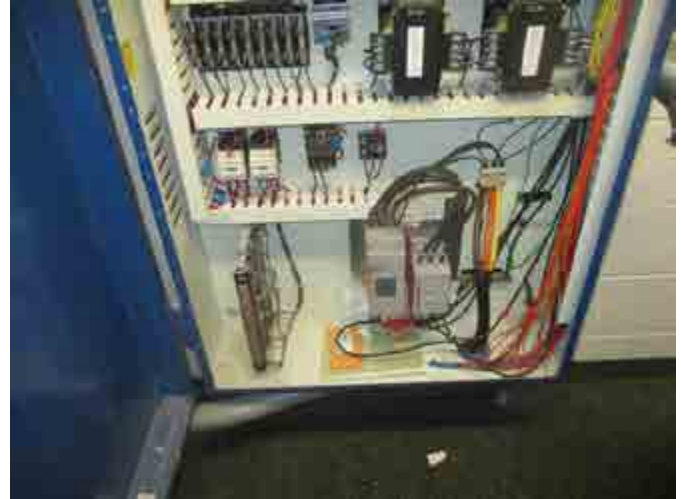
6. Clean out inside of controllers

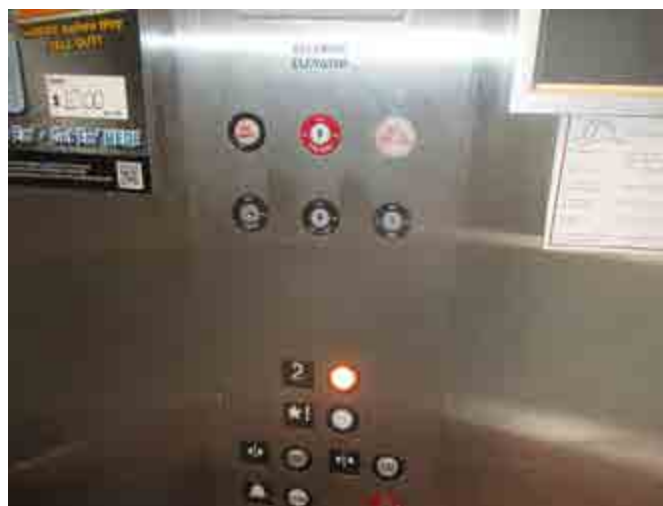
11. Replace missing screw in Elevator #1 car operating panel

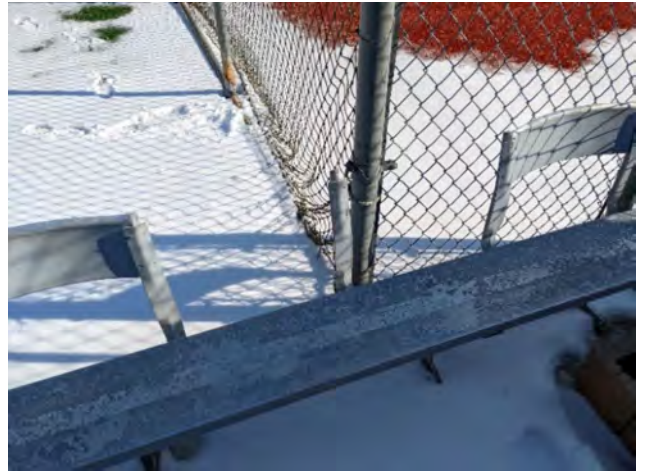
LEFT FIELD BULLPEN – REPLACE BROKEN SEATBACKS.

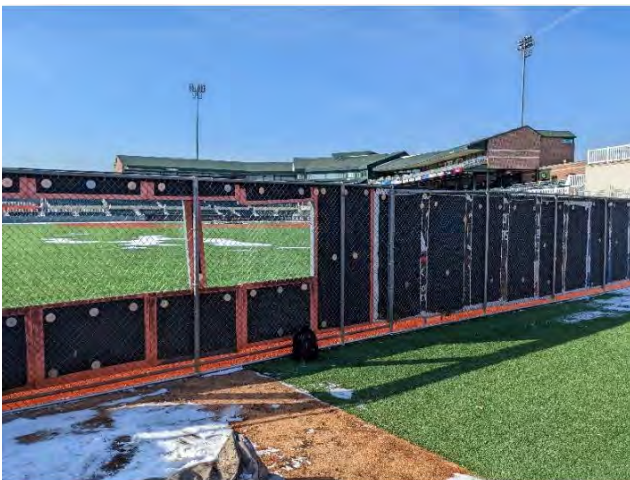
LEFT FIELD BULLPEN – 3RD BASE DUGOUT NOT VISIBLE FROM THE PITCHING RUBBER LOCATED FARTEST FROM THE FIELD.

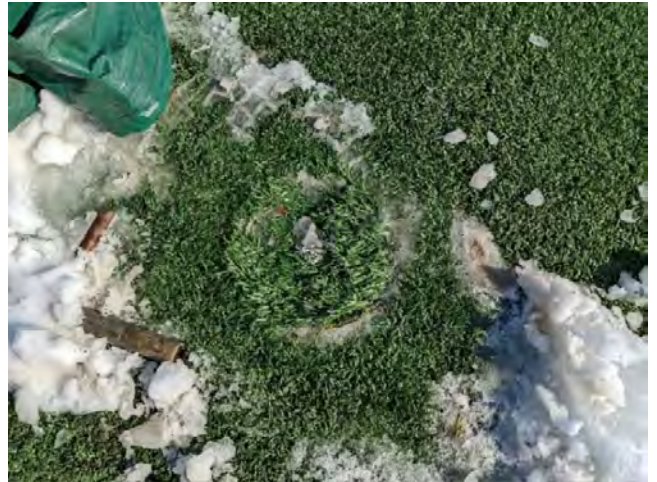
QUICK COUPLER BEHIND PITCHERS MOUND – NEED TO REPLACE BROKEN VALVE BOX LID.

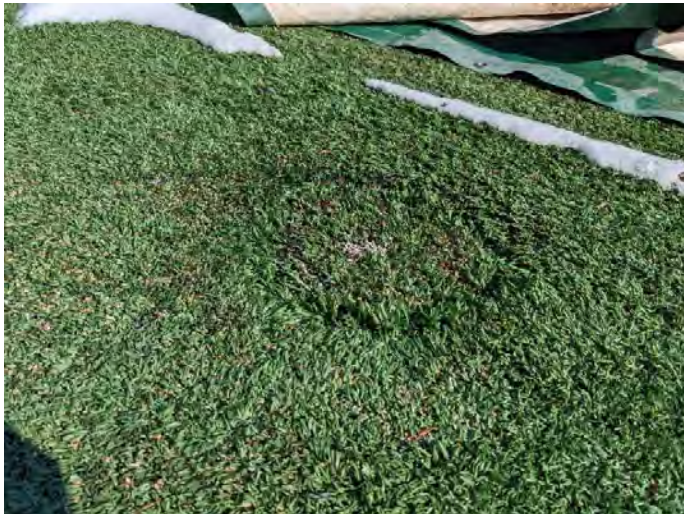
QUICK COUPLER BEHIND HOME PLATE – THE VALVE BOX IS INSTALLED TOO LOW WHICH CAUSES AN UNEVEN SURFACE.
