**RIPKEN STADIUM STRUCTURAL REPAIR
CITY OF ABERDEEN, MARYLAND**

STRUCTURAL CONDITION REPORT

RIPKEN STADIUM LEFT FIELD RAMP RETAINING WALL

HCEA JOB NO.18317A

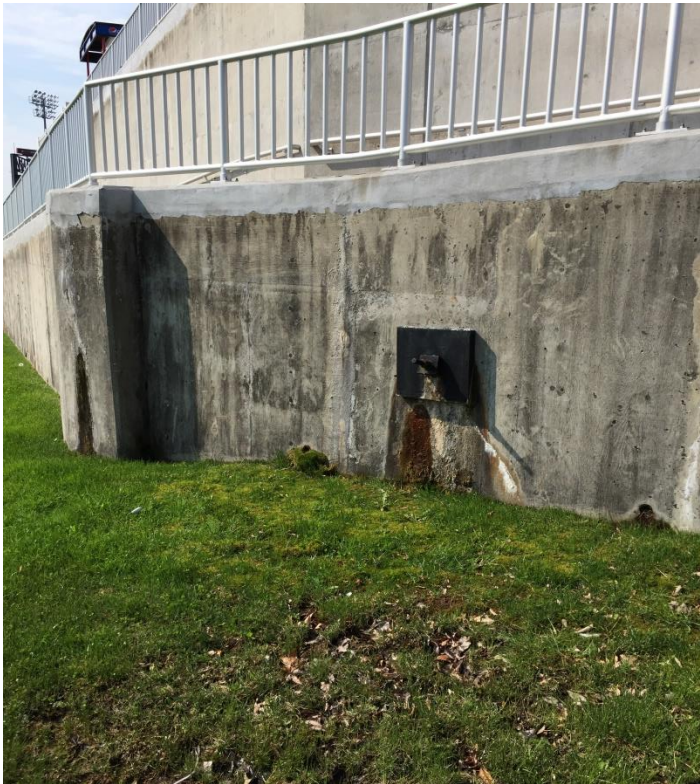
Pilaster and tieback anchor plate

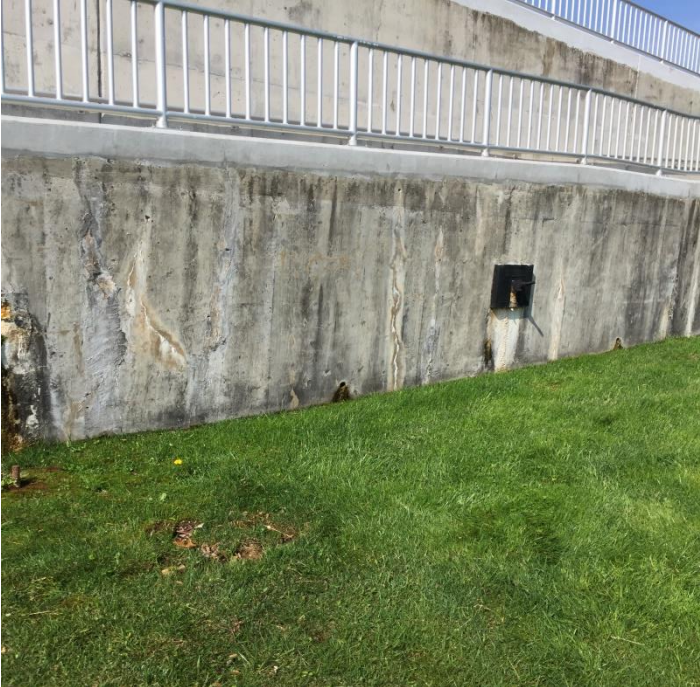
Wall cracks and water seepage

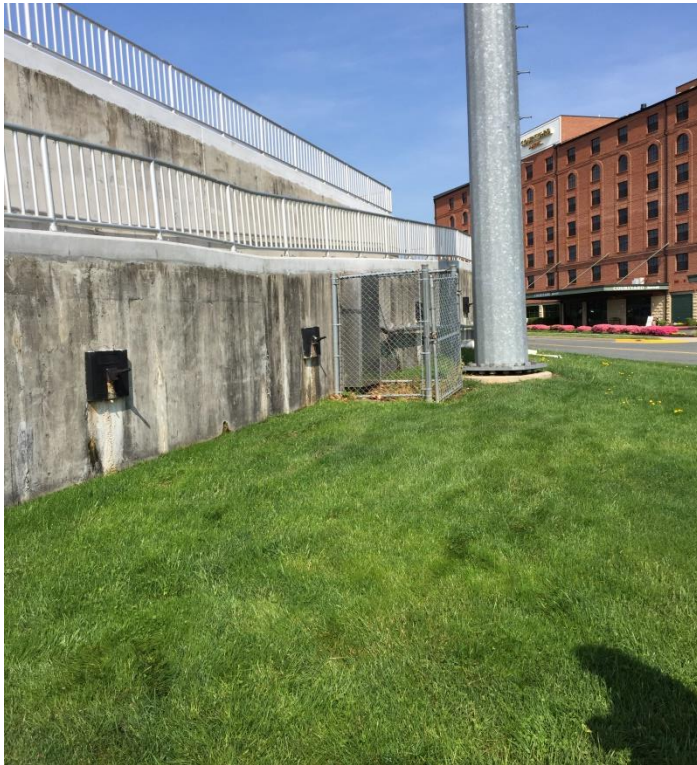
Existing tiebacks and light pole

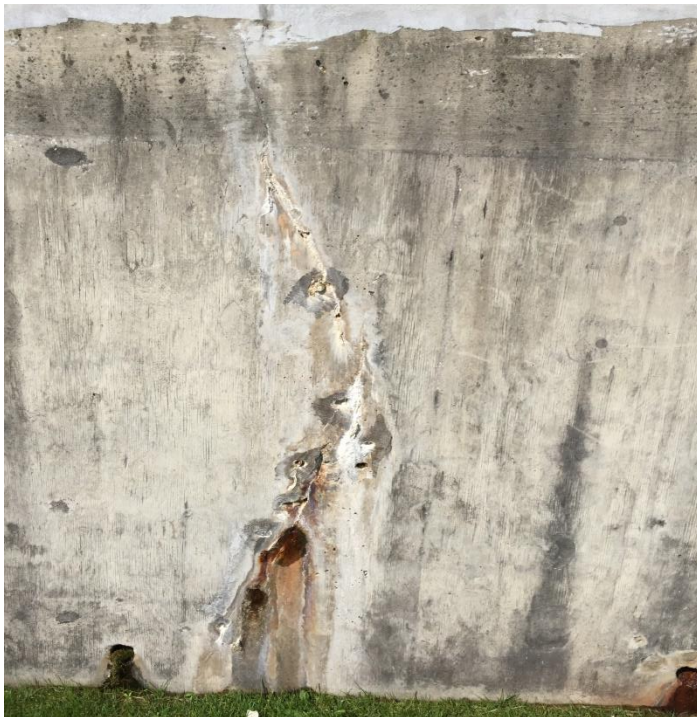
The lower concrete retaining wall along the ramp is in poor condition with noticeable lateral deflection and numerous cracks and spalls. There is evidence of previous crack repairs using epoxy injection and concrete pilasters added to the outside face of the wall. Nine tieback anchors were installed in 2005 through the lower retaining wall, below the upper retaining wall footing and into the soil behind the upper wall. These tiebacks were installed in an attempt to keep the lower wall from rotating outward due to the lateral soil pressures from the retained soil and surcharge loading from the upper retaining wall footing. It is our opinion that the lower retaining wall was not adequately designed to support the surcharge loading applied to it from the upper retaining wall, and the tiebacks were added as a remedial solution to this problem three years after the stadium opened.

Previous crack repair by epoxy injection

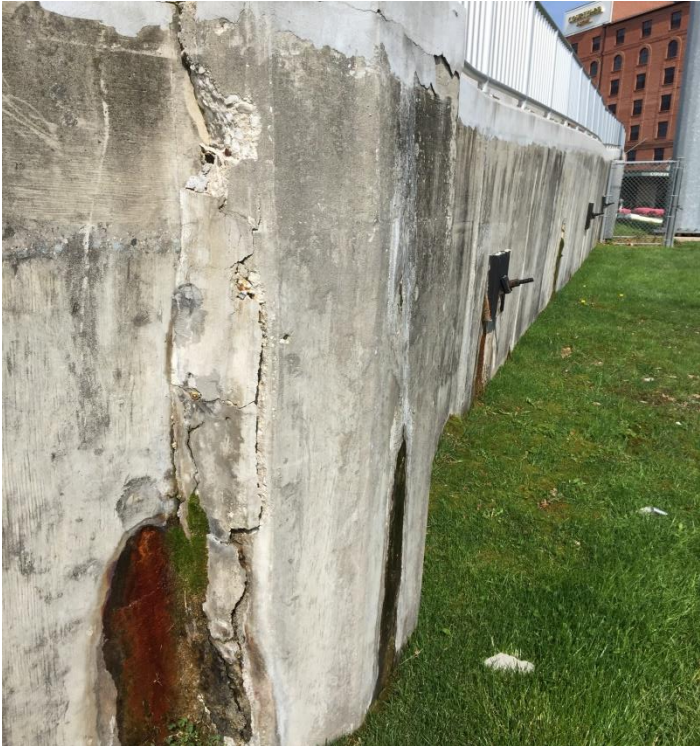
Cracks and spalls at pilaster

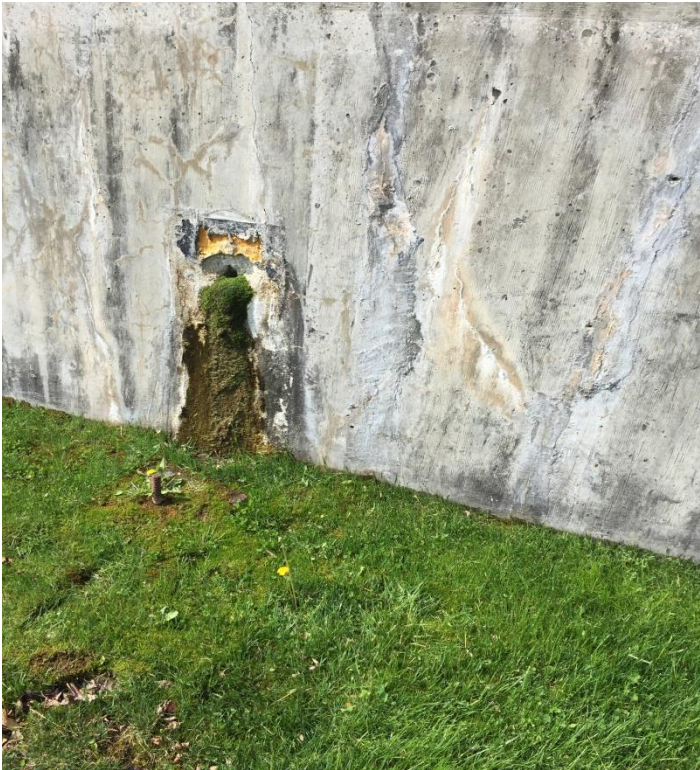
Failed tieback (note anchor plate and portion of tieback on ground)

Provide a new concrete wall in front of the existing lower wall along the ramp. This wall will be placed directly against the existing wall. In order to construct this wall, tiebacks will be installed at approximately 9 feet on center through the existing low wall and extend through the new wall. This will stabilize the existing wall while excavating for the new wall foundation and provide additional lateral support for the new wall. We recommend that this new wall extend from the existing stairs at the bottom of the ramp to approximately 35 feet from the beginning of the ramp at the high end. Refer to Options 1 and 2 sections attached.

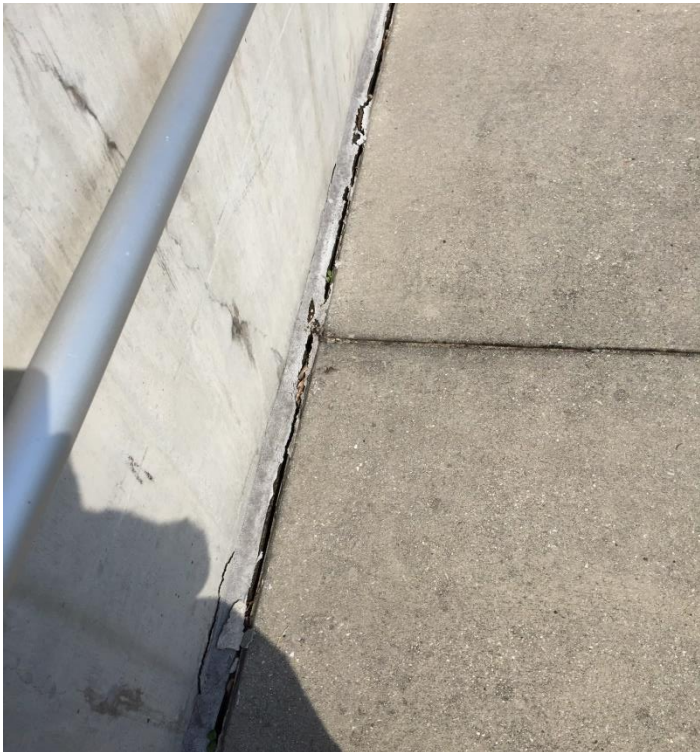
There are gaps between the ramp slab and the upper retaining wall and between the ramp slab and the lower retaining wall as result of the lateral movement in the lower retaining wall. The flexible sealant between the edge of the slab and the face of the walls has failed as a result of this movement, allowing surface water runoff to saturate the subgrade under the ramp. This additional water increases the lateral pressures on the wall causing further movement. There are also areas where differential settlement in the slab subgrade has resulted in uneven surfaces across joints.

Failed joint sealant and gap between ramp and upper wall

Remove the existing joint sealant between the ramp slab and the walls and replace with new expansion joint material and joint sealant to prevent surface water runoff from penetrating the subgrade below the slab. Replace, as needed, and maintain the joint sealant between the plaza level slab and the upper retaining wall.

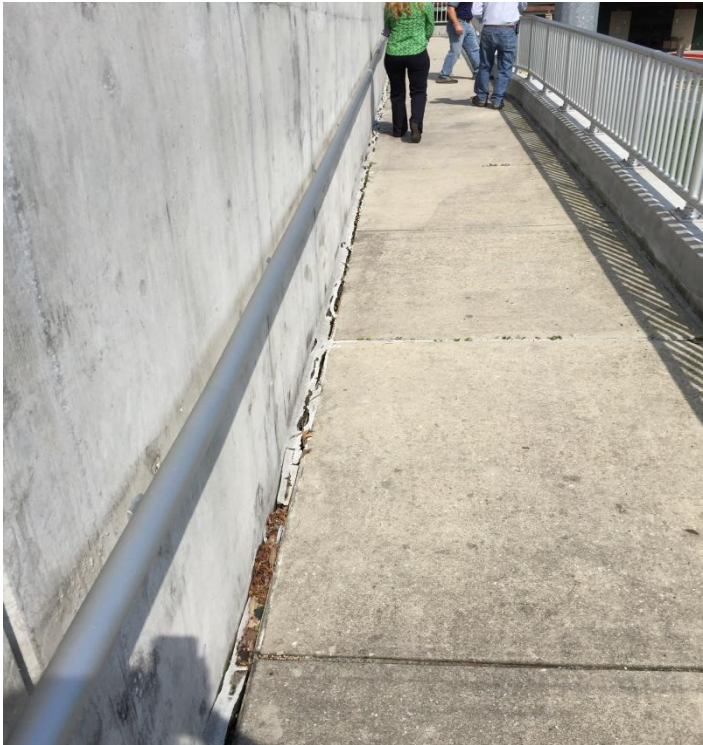
Gap between ramp slab and upper wall

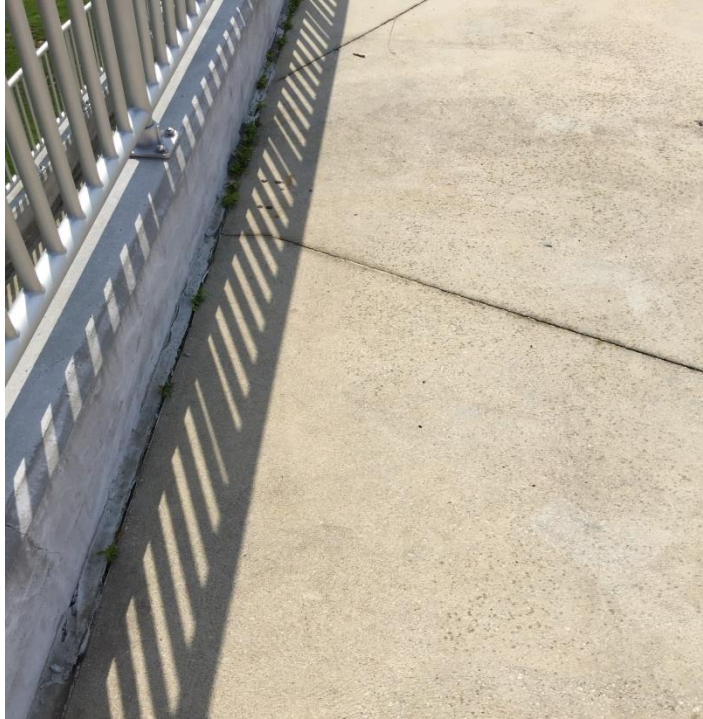
Failed joint sealant and gap between ramp and lower wall
