**ABERDEEN COMMUNITY SERVICES BUILDING
FABRIC STUDY/FACILITIES ASSESSMENT REPORT**

**34 North Philadelphia Blvd.
Aberdeen, Maryland 21001**

Prepared For:
City of Aberdeen
Department of Planning and Community Development

Submitted:
October 21, 2015

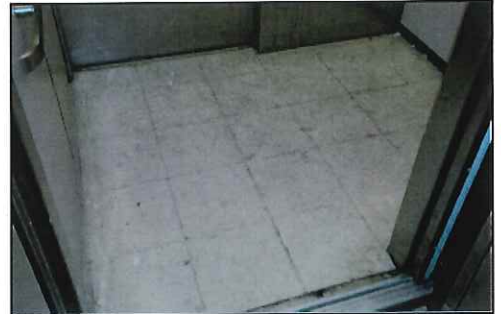
Elevator

Dimensionally, the elevator meets ADA size requirements. It appears to be in good working condition and has a recent certification, but cab finishes need replacing and an inspection performed. The elevator machine room is on an upper floor and is not accessible from the elevator lobby, however, it is clean and the equipment appears to be in good condition.

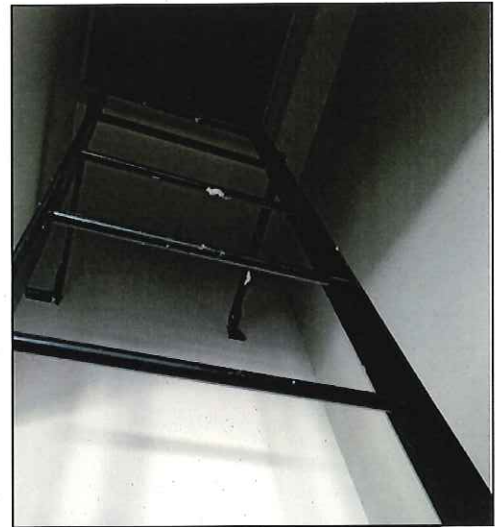
Roof access is gained through a hatch and ship's ladder that connects the third floor to the roof. Access to this hatch is only through the security office that lies adjacent to the north stair on the third floor. The ship's ladder and hatch are securely fastened to the structure and in general, appear to be in good condition – we were able to safely use it to access the roof – however, there are signs of water damage at the bottom of the ladder.

Ship's Ladder/Roof Access

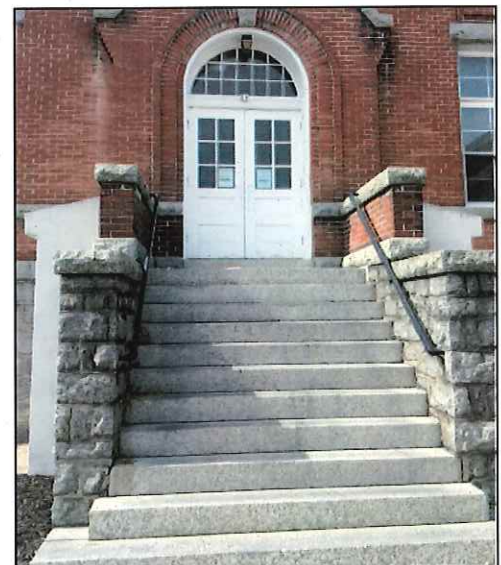
The north exterior entrance stair is concrete with steel pipe handrails, and is in solid, but weathered condition. The nosings are worn and spalling in many places, but there are no major visible structural concerns. Tread and riser dimensions appear to be within the allowable code requirements. The steel pipe handrails are structurally sound, but are in violation of height and extension requirements.

Exterior Stair

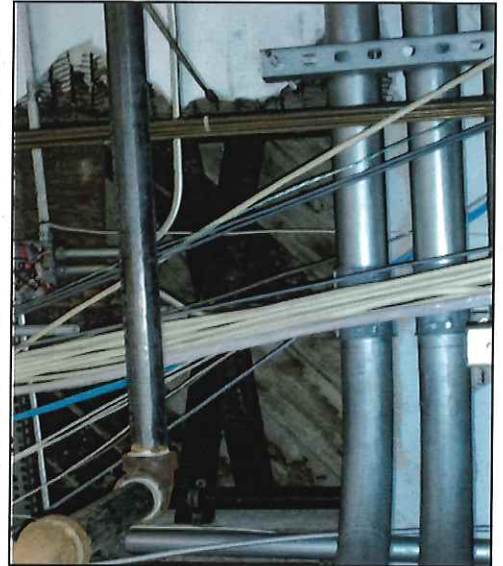
Opening in Ceiling Showing the Exposed Wood Plank Flooring

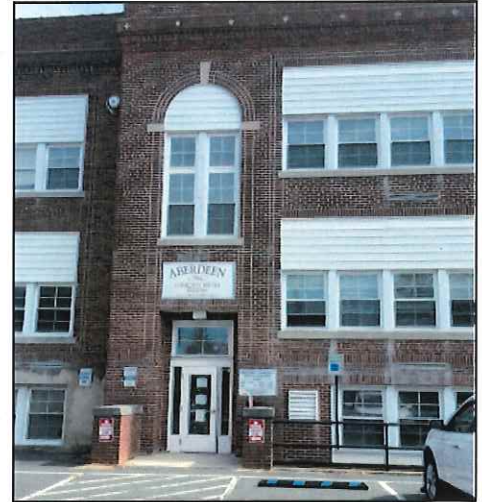
Based upon field observation and measurements of the existing structure, the entire exterior envelope appears to be 4" brick veneer backed by 8" masonry bearing walls. There appears to be no air space between the brick and concrete block, rendering it prone to moisture infiltration, and in fact, there was efflorescence observed over swathes of brick. The exterior mortar joints on brick veneer are not crumbling, however, long exposure to weather has eroded them.

Weathered Brick Joints and Obvious Efflorescence

The exterior masonry walls are in good structural condition and need minor repairs to restore the character of the building. All brick and cast stone joints should be re-pointed. Testing on existing mortar and brick should be done prior to selecting new mortar type as some types of older bricks can quickly deteriorate when paired with new type-N mortars.

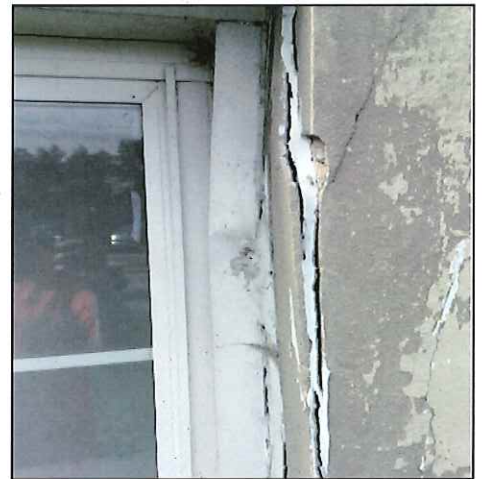
Some of the masonry near grade has been removed and patched with concrete or non-matching masonry, and should be replaced. Additionally, the lower level parking shows minor but extensive cracking and spalling around window and door openings. Some of the grade-level stone and cast stone show signs of significant erosion and vandalism, and should be repaired or replaced.

Exterior Lower Wall Crack/Parging and Attempted Repair

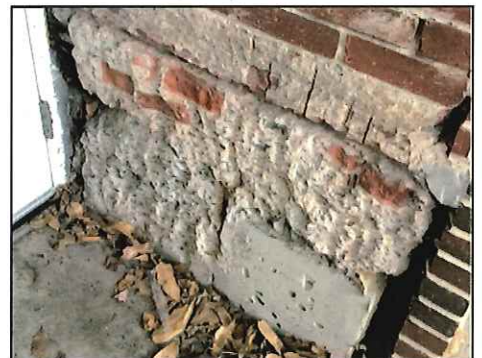
Exterior Degrading Brick and Attempted Repair

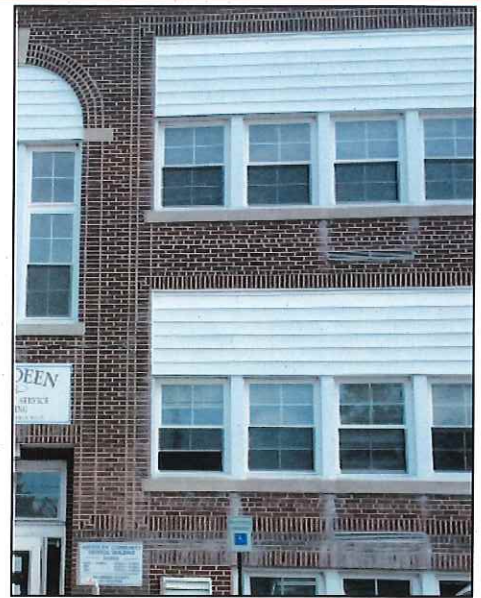
Lowered Original Window Openings

We would recommend that all of the existing windows and infills be removed, and new commercial-grade energy-efficient windows that fill the complete rough opening be installed wherever possible. There is approximately 6,000 S.F. of windows in the project which would constitute a significant cost. Additionally, there may be cost and labor intensive remediation of the steel lintels required if any are found to be structurally compromised due to weathering.

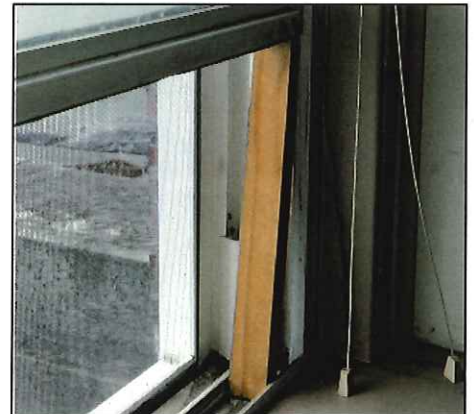
The windows are of consistent look and manufacture, but they are of poor quality and many of the windows suffer from hardware failure making them difficult or impossible to operate. There are multiple units with missing or cracked glazing, damaged sashes/frames, and rotted and leaking seals. Additionally, the existing windows are much smaller than the original masonry rough openings, and share the rough opening with un-insulated infill walls of aluminum siding. There are numerous windows that have been removed or modified for various HVAC and utility components, and in several cases, those penetrations are allowing water infiltration. Additionally, many of the interior sills and jambs show signs of seal failure and water infiltration. Selective demolition will reveal more information about how the windows were installed and what precautions were taken to mitigate moisture penetration during window replacement.

Inoperable Window Condition

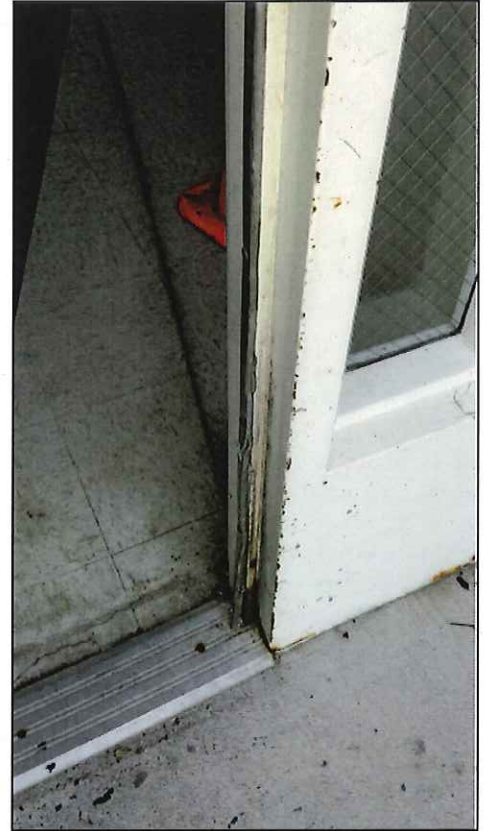
The existing exterior doors are a mix of wood doors and frames and hollow metal doors and frames. The glazed double entry/exit doors tend to be wood, and the unglazed single man doors tend to be hollow metal. The wood doors appear to be operable and in fair condition, and have been outfitted with wired glass. The wood door frames appear to be the original design, and while they appear weathered, they could be restored and modified to function appropriately. The hollow metal doors and frames show damage and signs of rust and corrosion. Weather seal failure and threshold failure is common amongst door openings, as well as locations where the door leaf no longer fits the frame correctly, and daylight is visible around the door leaf edges.

Damaged and Rusted Frame

We recommend all exterior wood doors be evaluated for restoration, and all hollow metal doors and frames be removed. All door hardware including but not limited to: levers, knobs, latches, pulls, plates, closers, panic hardware, and hinges should be removed and replaced with code-compliant hardware.

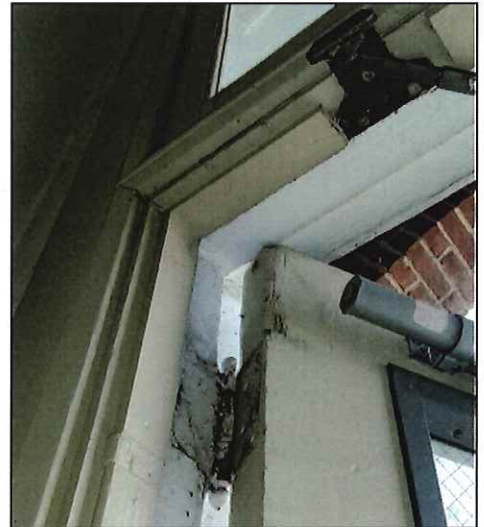
Door hardware is in poor condition and inconsistent across the exterior doors, and should be removed entirely. The door swing directions are consistent with the direction of egress, but some of the clear widths and minimum door leaf sizes need to be evaluated in a detailed code study to ensure they allow adequate egress width.

Damaged, Old and Rusted Hardware

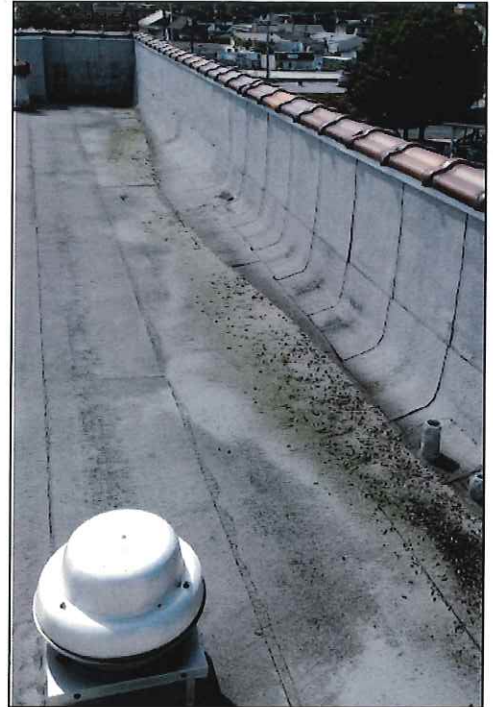
Stained Location from Ponding Water

Much of the existing flat and shingle roofs are in good condition and can be salvaged. Areas that are retaining water will need to be re-sloped to allow water to drain. Any small leaks and irregularities in the roofing and coping will need to be repaired. The roof has approximately 10-15 years of remaining lifespan and future replacement will be of moderate cost. The skylight should be removed, but should be replaced as an important historic detail.

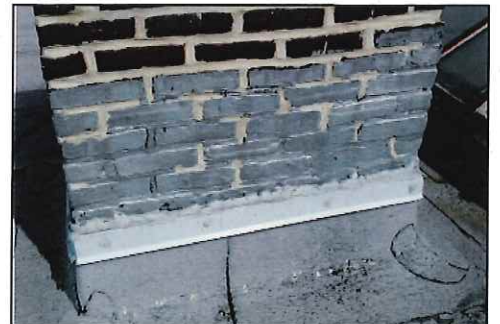
Repaired Flashing and Jointing

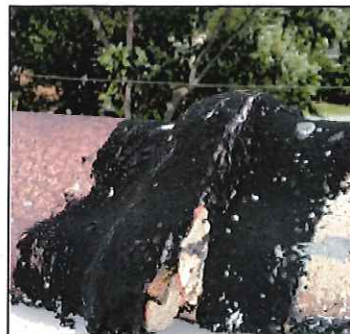
Patched Coping

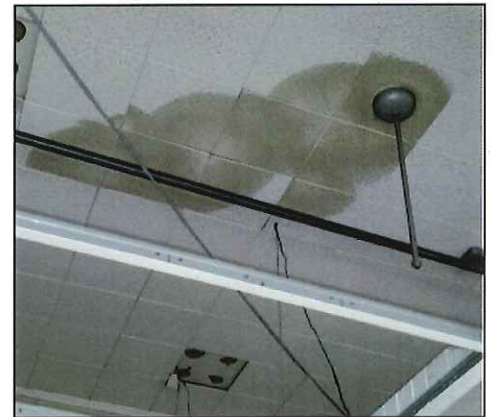
Water Damage and Falling Hard Ceiling

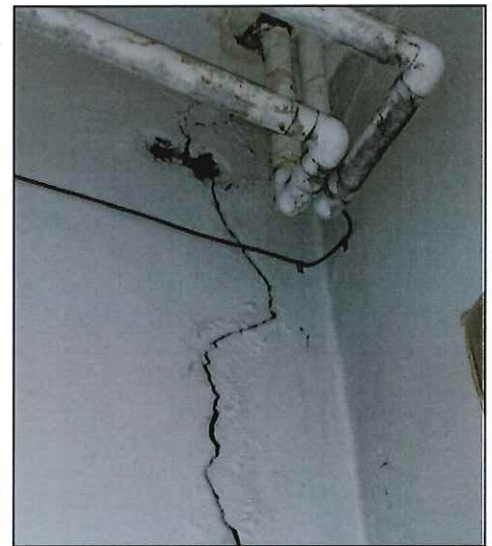
Water Cracking

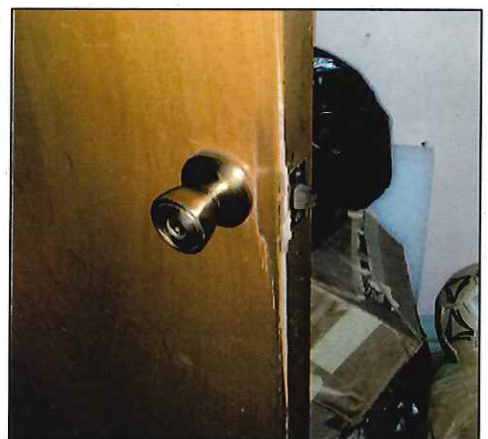
Damaged Door

In general, the interior corridor walls that were part of the original building design appear to be structurally sound, but most are covered in lead paint. It is our recommendation that these walls be stripped to the wood or masonry framing to allow for a full structural inspection and new finishes. The interior non-bearing walls are in various states of age and damage, and should likewise be stripped down to the rough framing. If it is not economically feasible to selectively demolish these walls, then we recommend the full removal of all non-structural interior partitions. The interior doors are also in various states of age and disrepair, and our recommendation is to remove all interior doors, frames, and hardware.

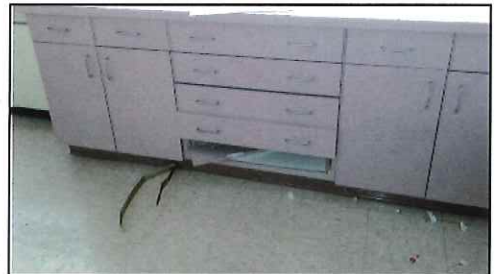
Worn Casework (2nd floor)

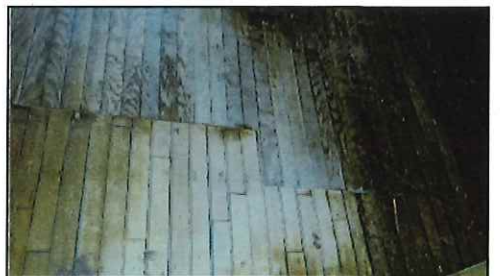
Worn Wood Floor (3rd floor)

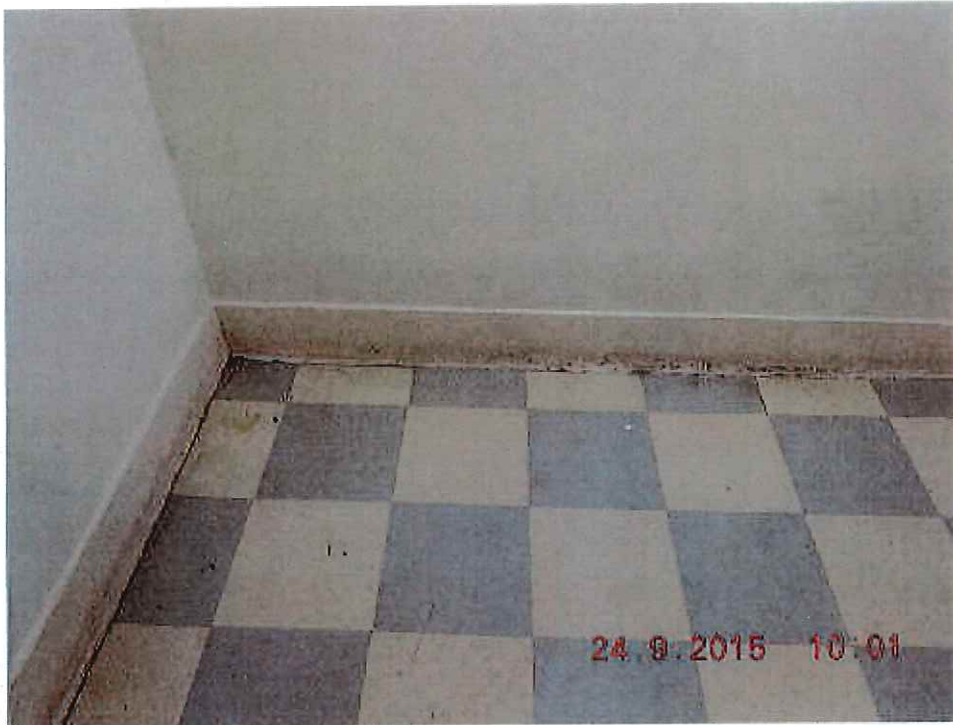
Photo 5 12" floor tile – negative. All 12" floor tiles were negative except those by the elevator lobby.

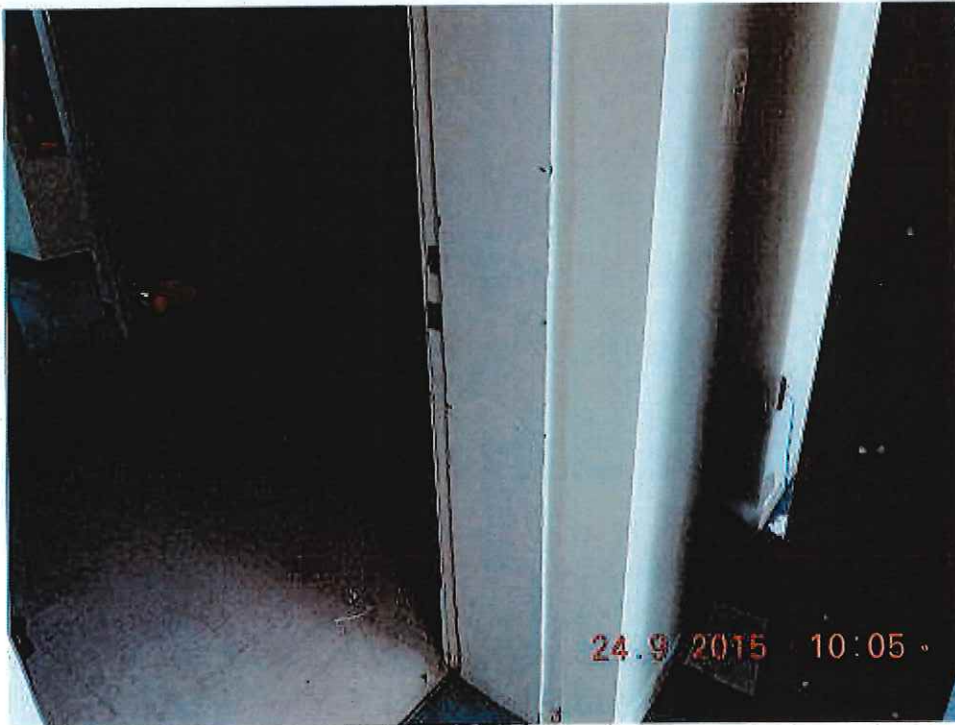
Photo 6 Lead paint on door trim, casings etc.

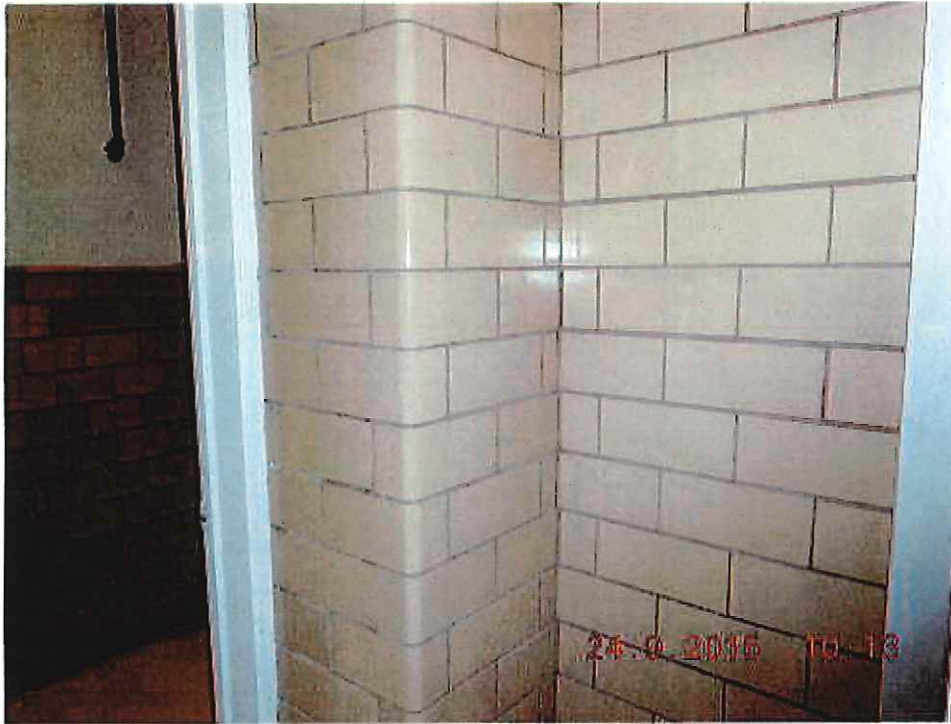
Photo 7 Kitchen glazed block wall has a lead paint component. NO other glazed block tested positive in the building.

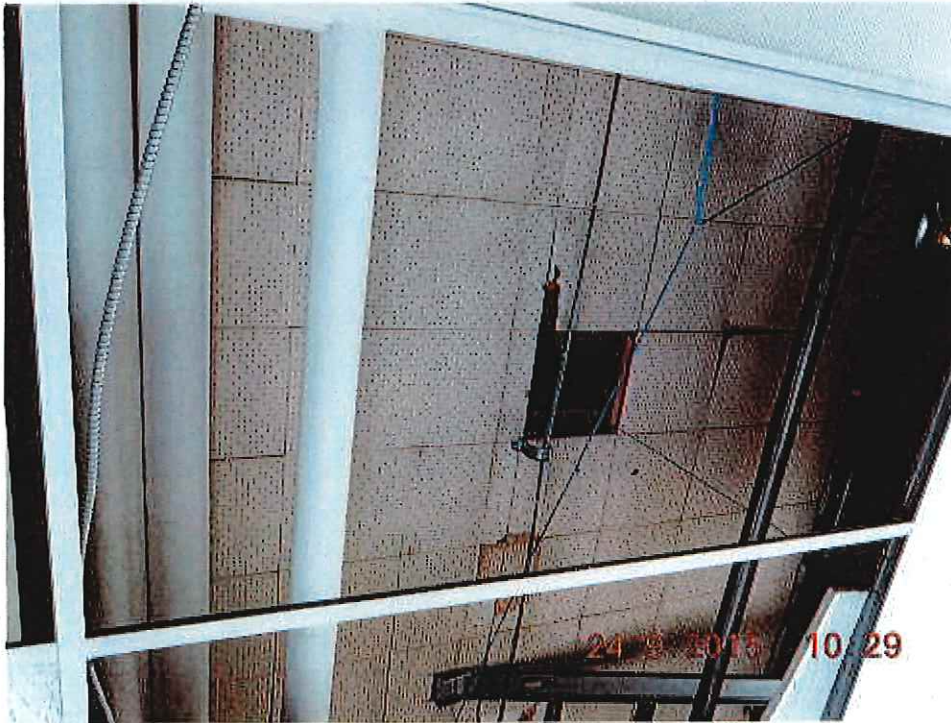
Photo 8 Spline ceiling tile was negative along with glue dots.

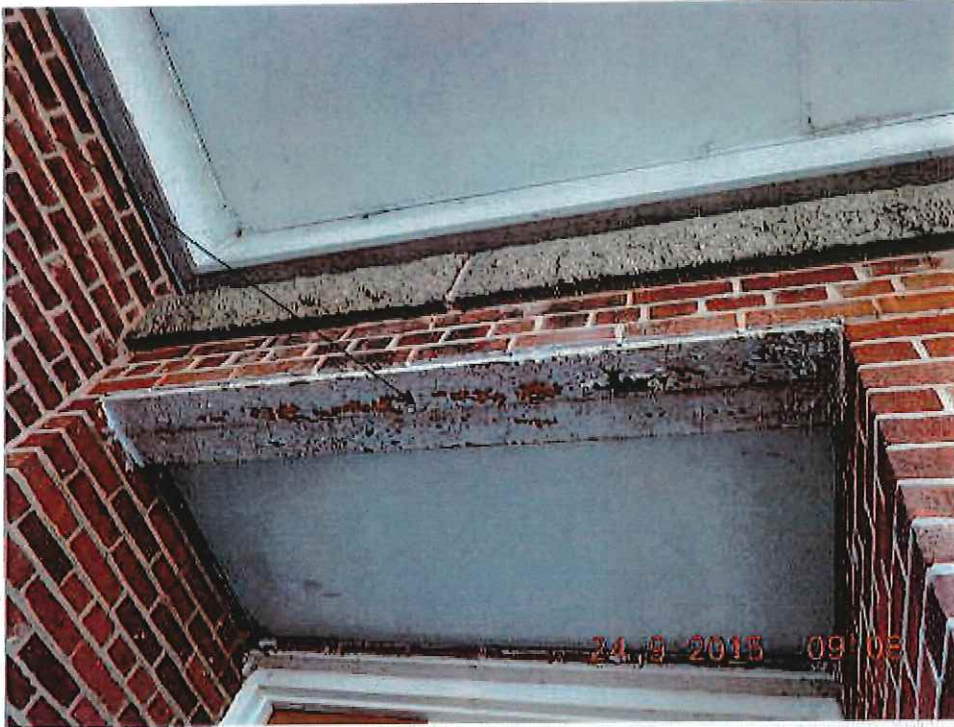
Photo 1 Exterior lintel on south side of rear by addition with lead paint in poor condition.

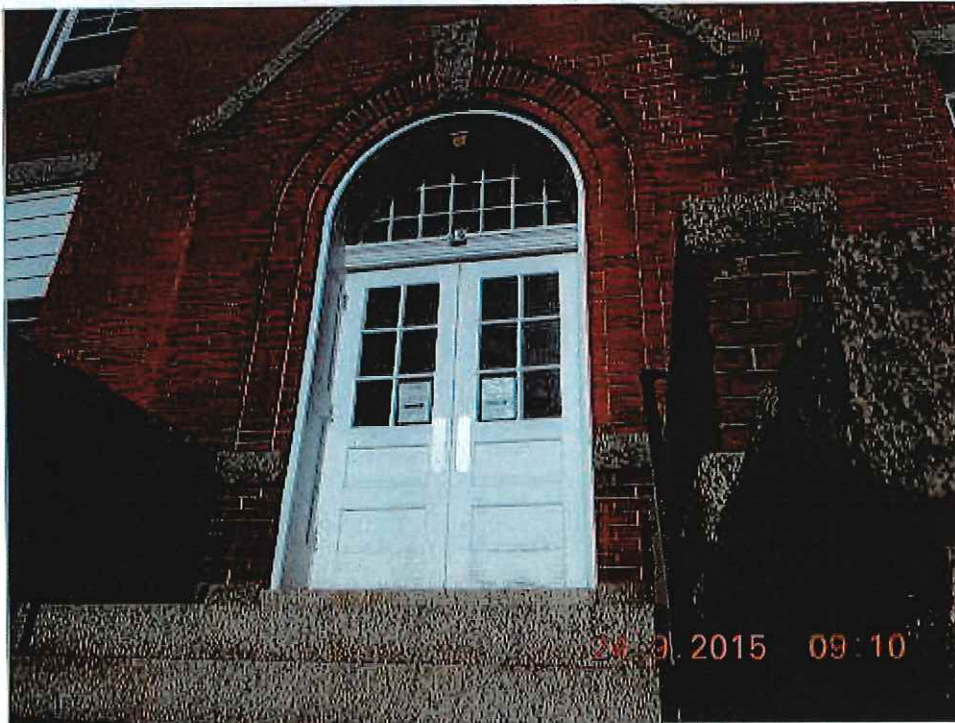
Photo 2 Door entrance with lead paint throughout on all surfaces.

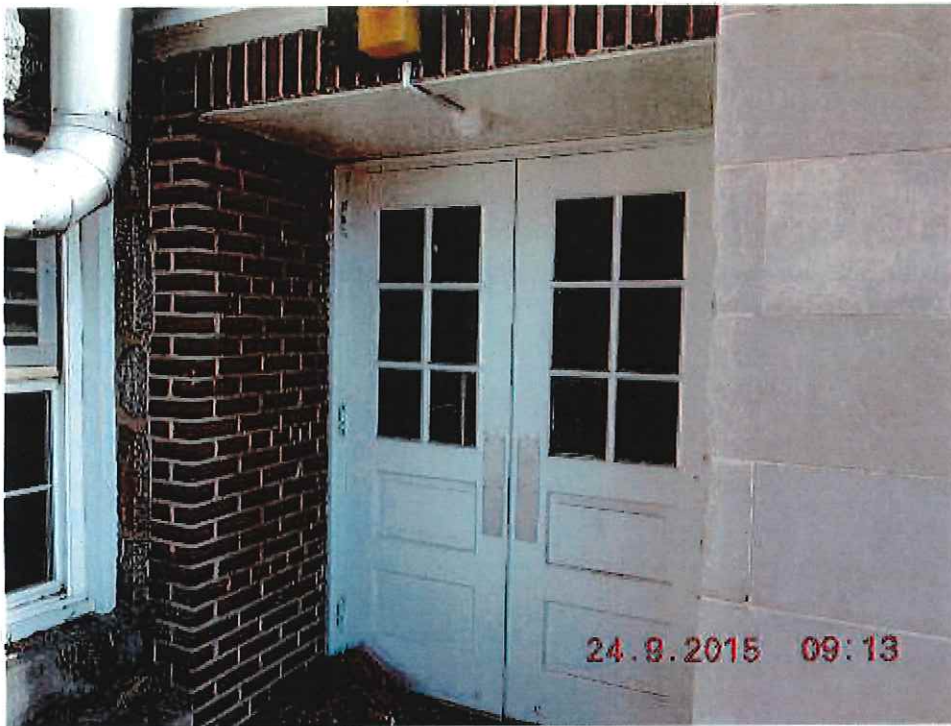
Photo 3 Lower level entrance with lead paint on wood and metal.

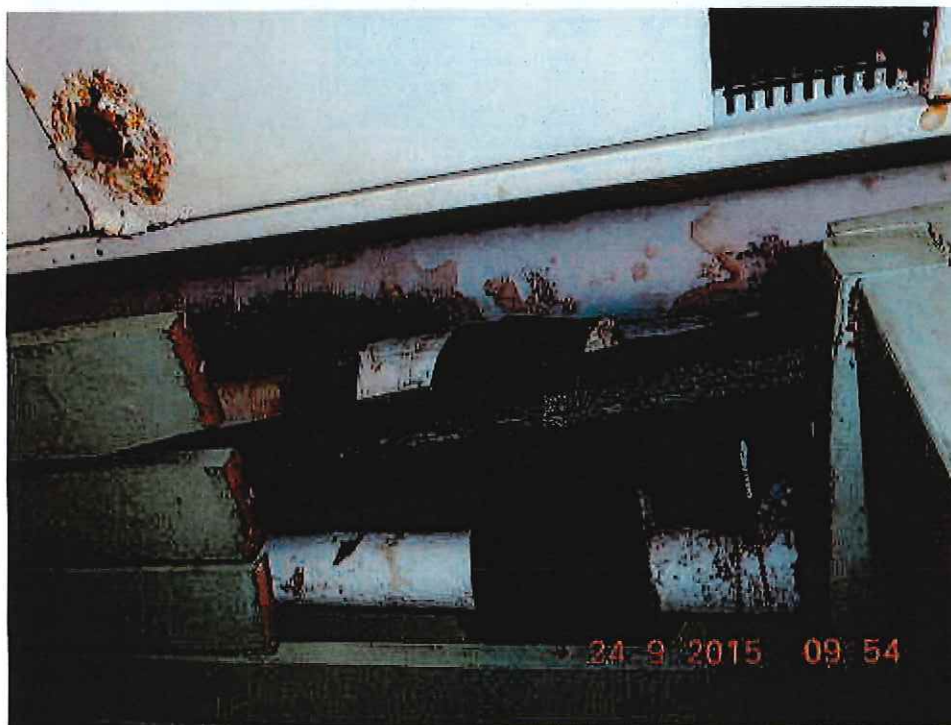
Photo 4 NO asbestos pipe insulation was identified.

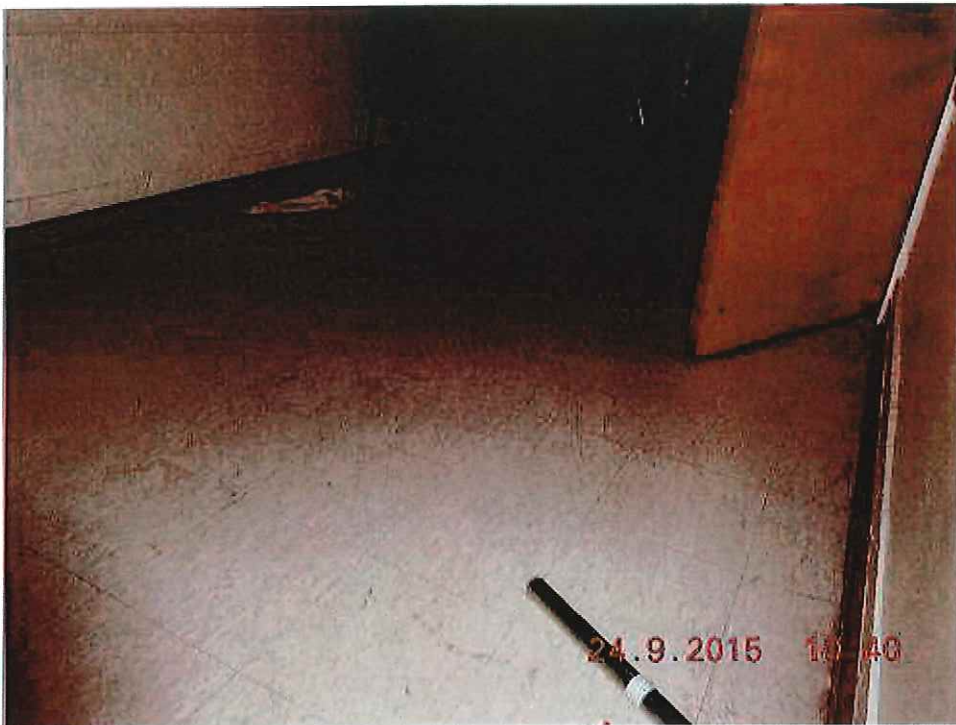
Photo 9 Non-asbestos 12" floor tile.

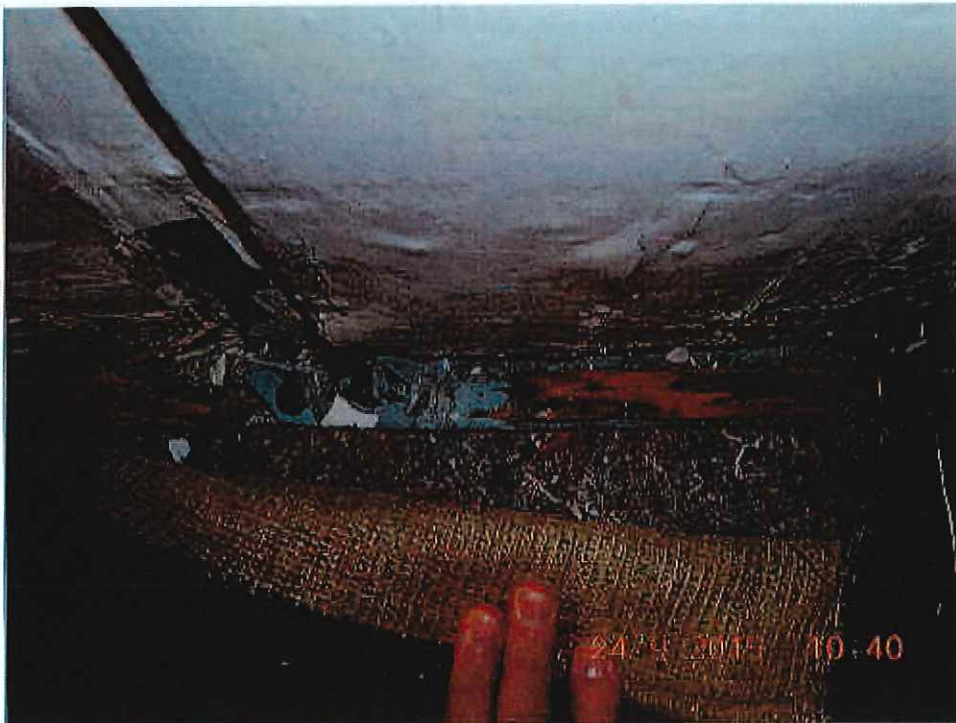
Photo 10 Nine (9") floor tile is present beneath most carpeting or beneath other 12" floor tile.

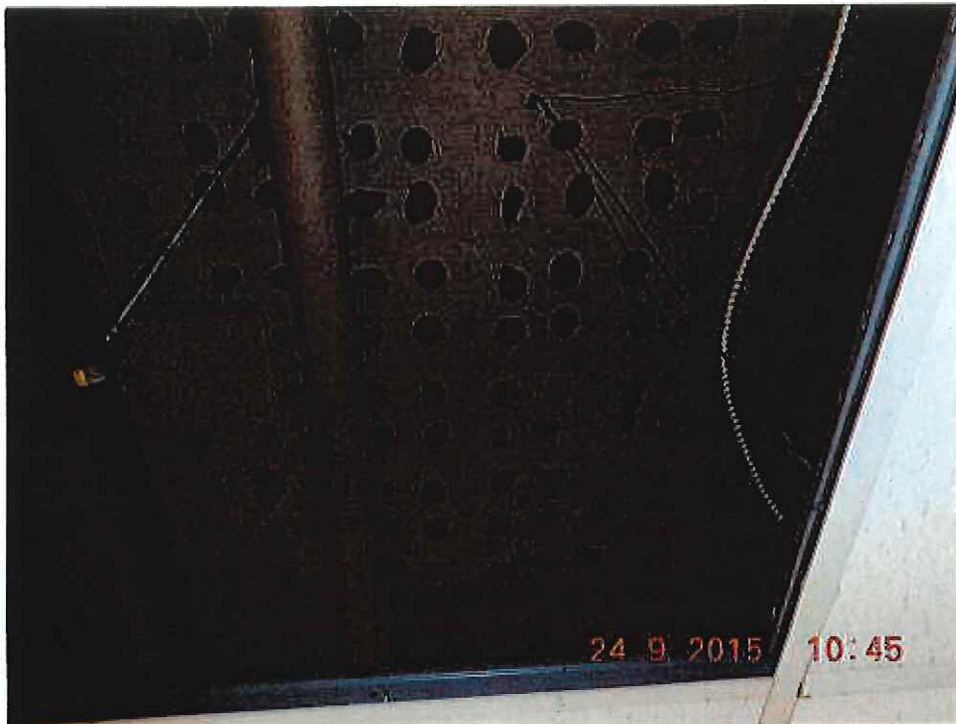
Photo 11 Glue dots were negative.

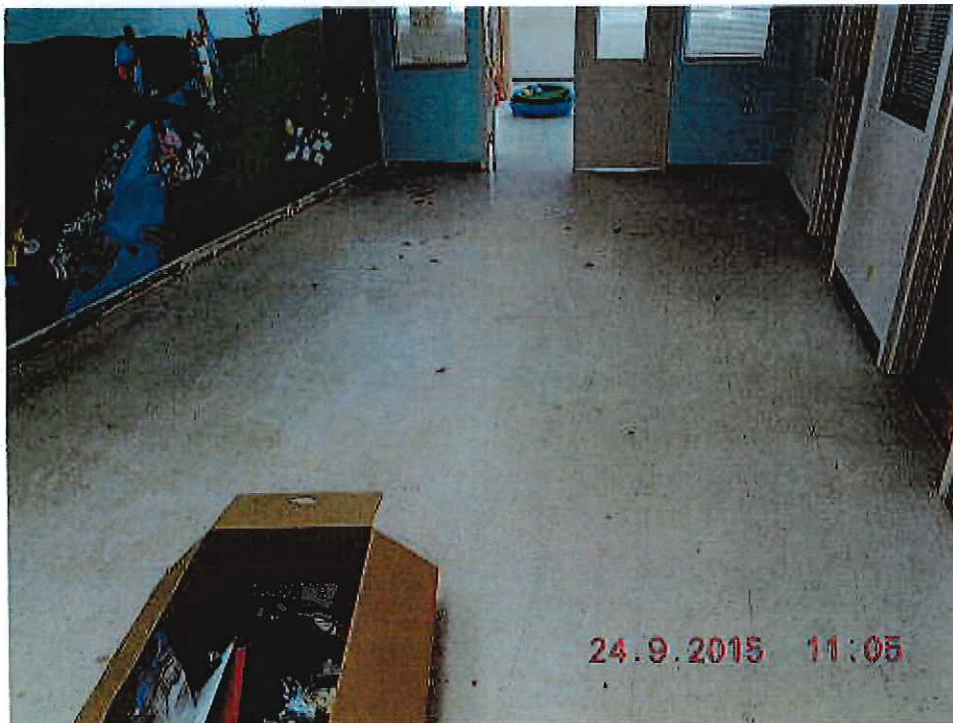
Photo 12 Much of this newer 12" floor tile is covering older 9" Vat/Mastic

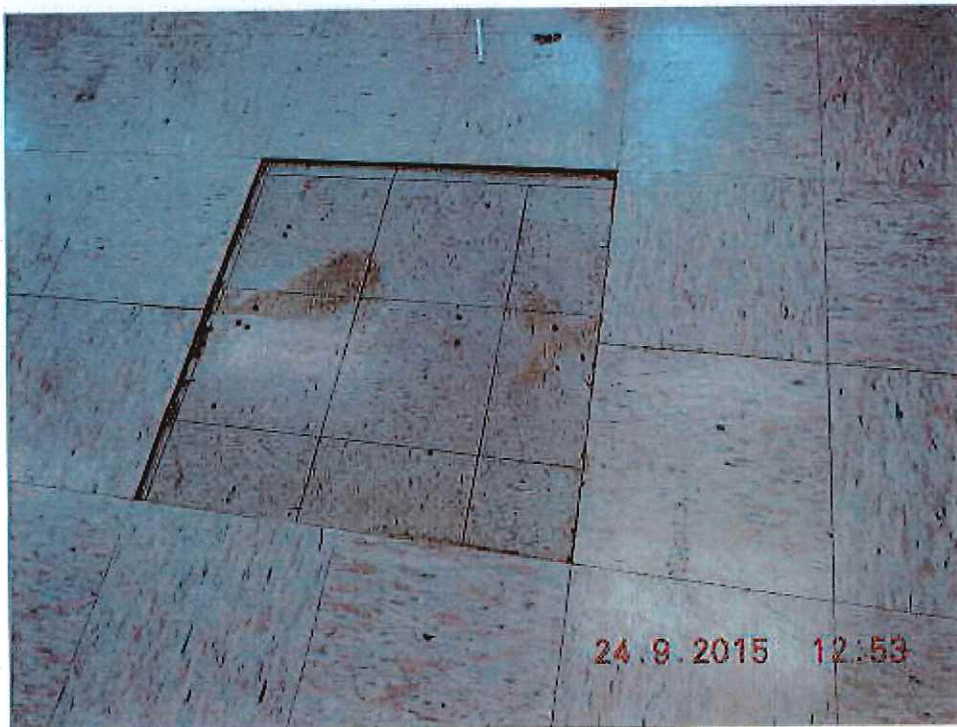
Photo 14 Typical with 12" VCT covering 9" VAT

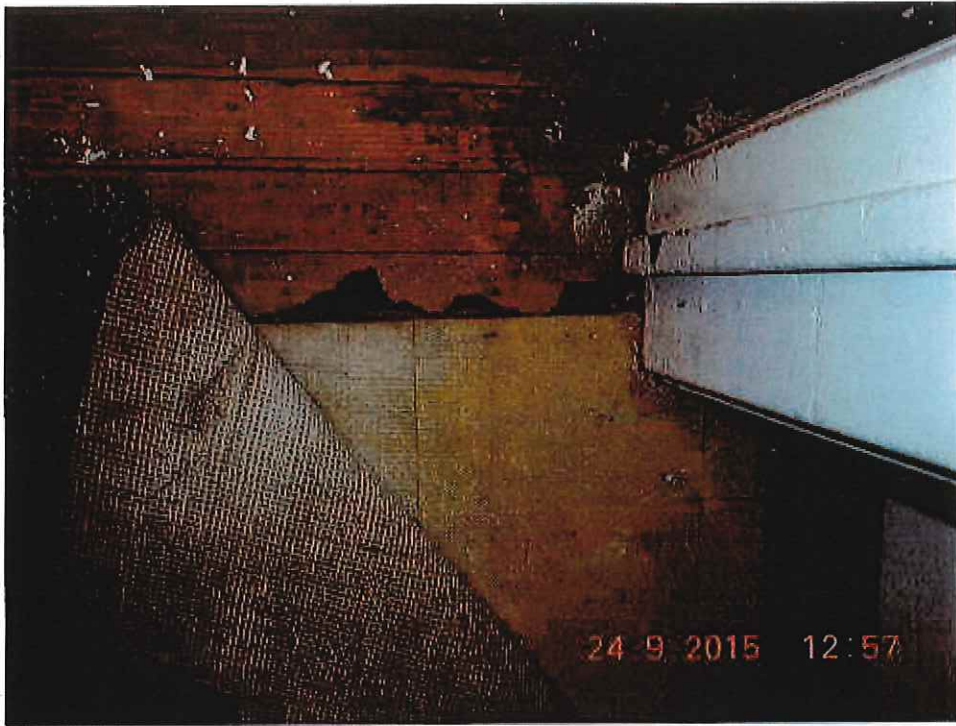
Photo 15 Typical with carpet covering 9" VAT

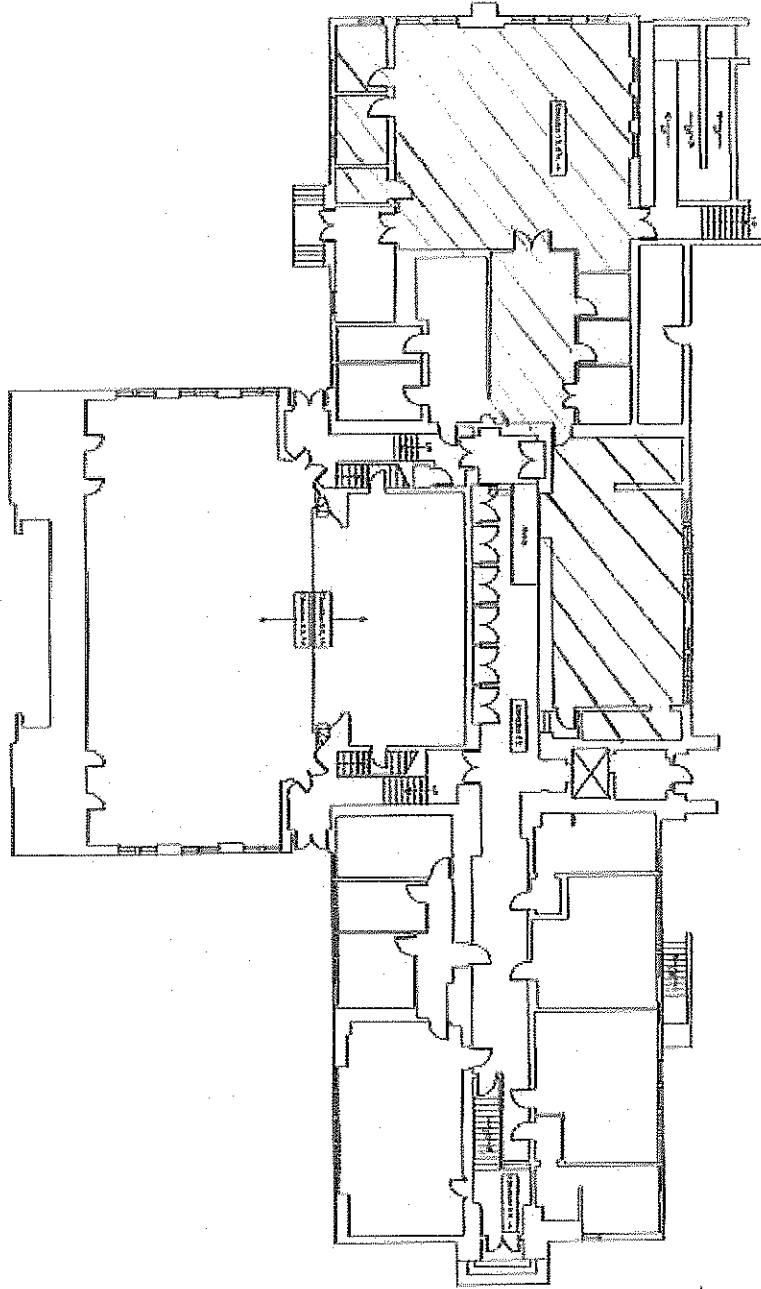
Drawing No.
 A1

VAT/MASTIC lies beneath carpet or VCT throughout

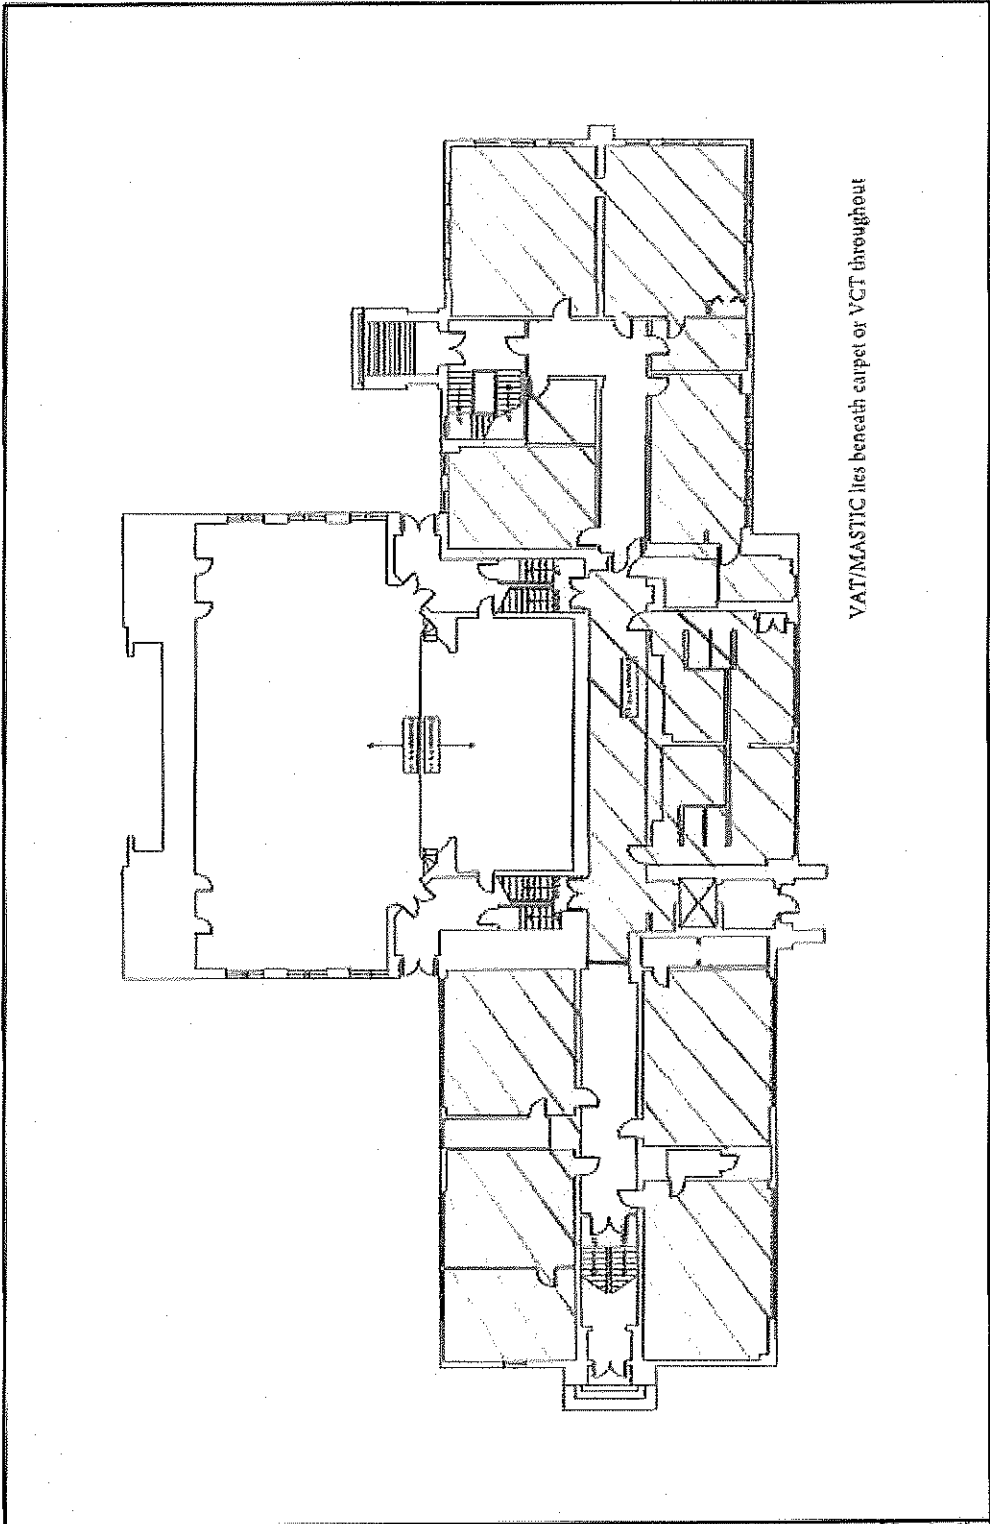
Drawing No.
 A2

VAT/MASTIC lies beneath carpet or VCT throughout

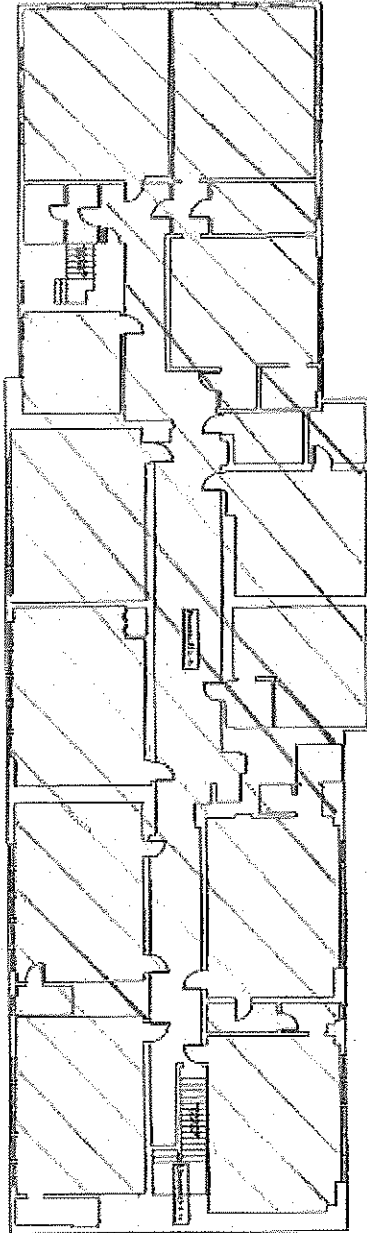
VAT/MASTIC lies beneath carpet or VCT throughout
