**REHABILITATION OF THE 250,000 GALLON, RIVETED STEEL, KROUSE
ELEVATED WATER TANK, ABERDEEN, MARYLAND**

INSPECTION REPORT

**250,000 GALLON RIVETED ELEVATED
KROUSE WATER TANK
ABERDEEN, MARYLAND**

Inspection Date: November 30, 2017

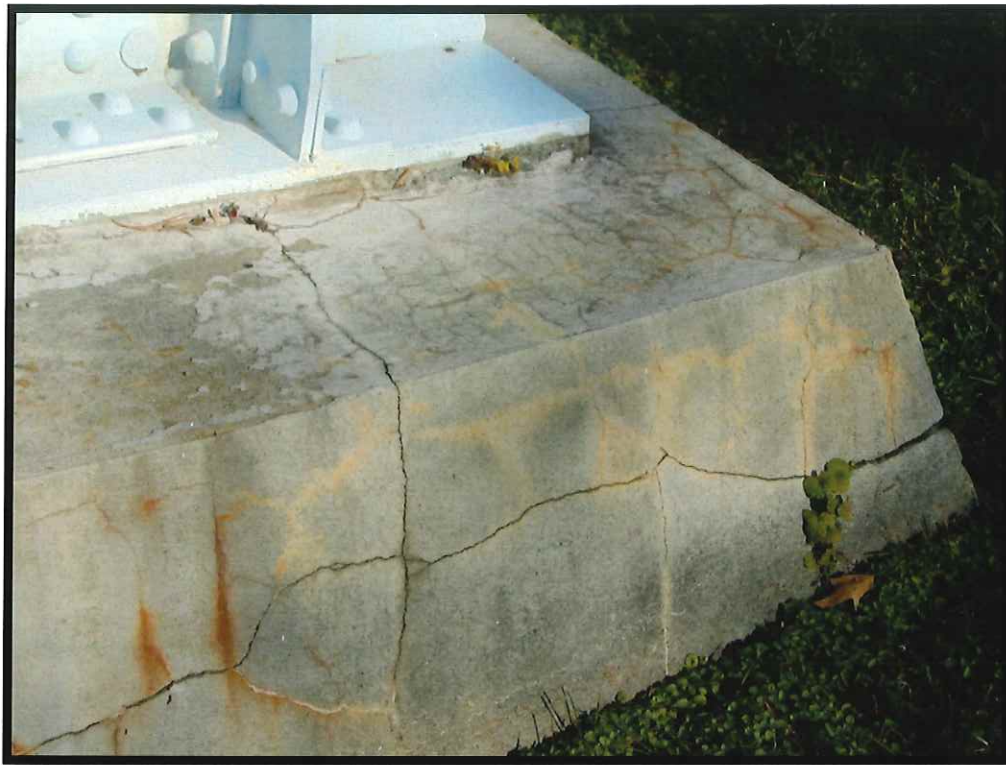
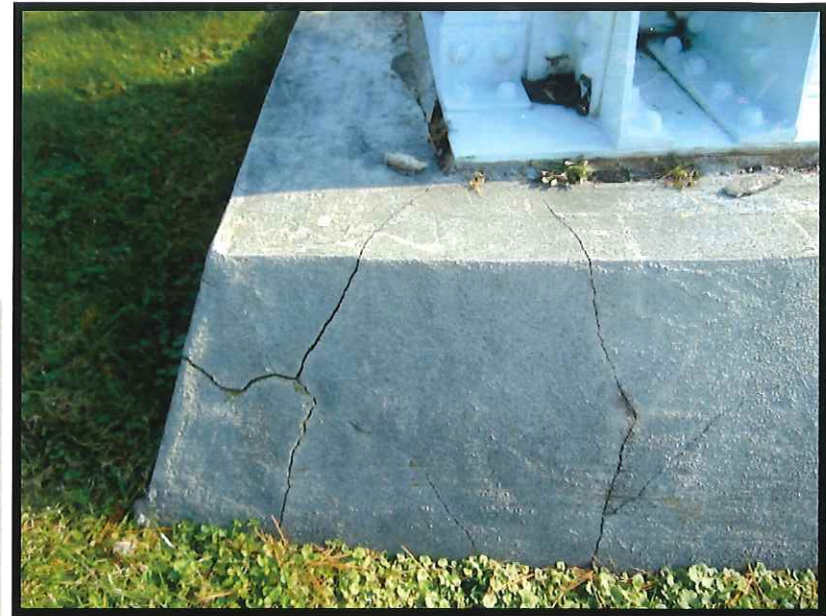
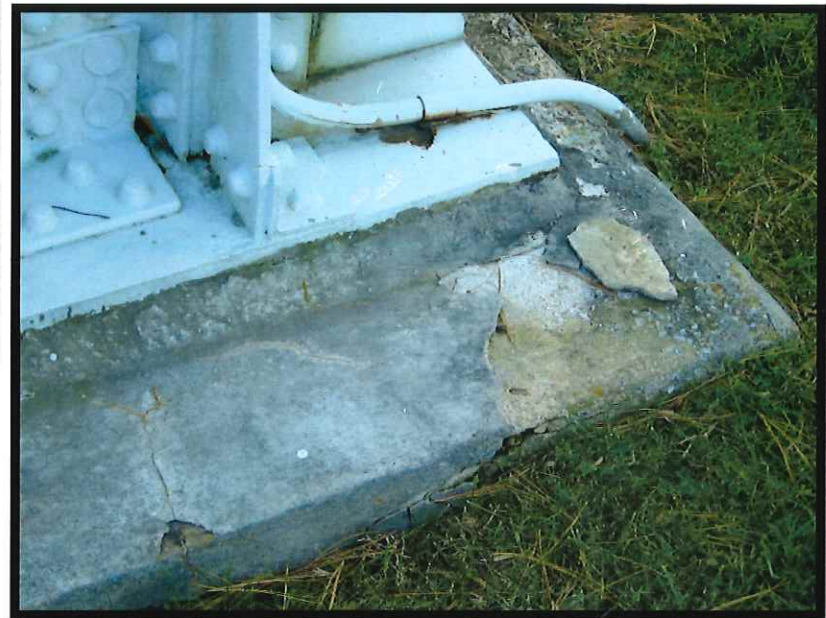
The concrete foundations appear to be in fair to poor condition. There is visible cracking on

many of the concrete foundations. Water and ice penetrating these areas will cause this situation to become more pronounced. At this time we do not believe the cracks to be structurally significant. Additionally, several of the foundations are covered by surrounding earth.

View of the concrete foundations, base plates, and anchor bolts.

1. Power wash the foundations. The stress cracks in the concrete foundations should be filled with Sikaflex 1a polyurethane caulk. The entire foundation should then be painted with an Epoxy Mastic Paint such as Sherwin Williams Macropoxy 646 Epoxy. [REDACTED]

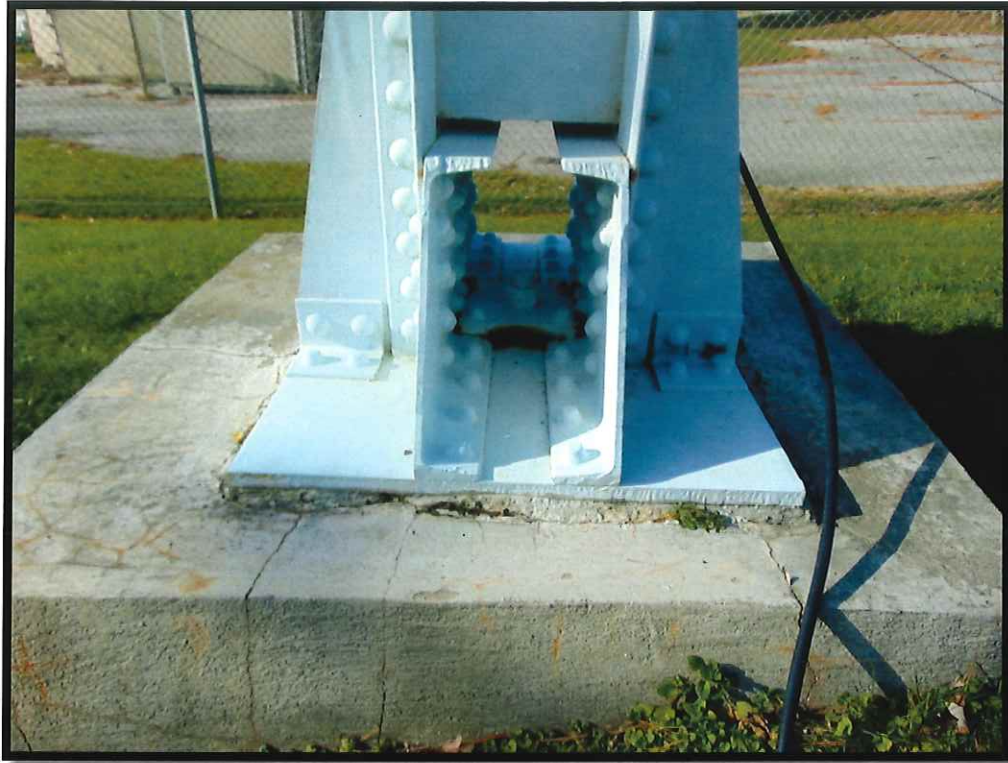
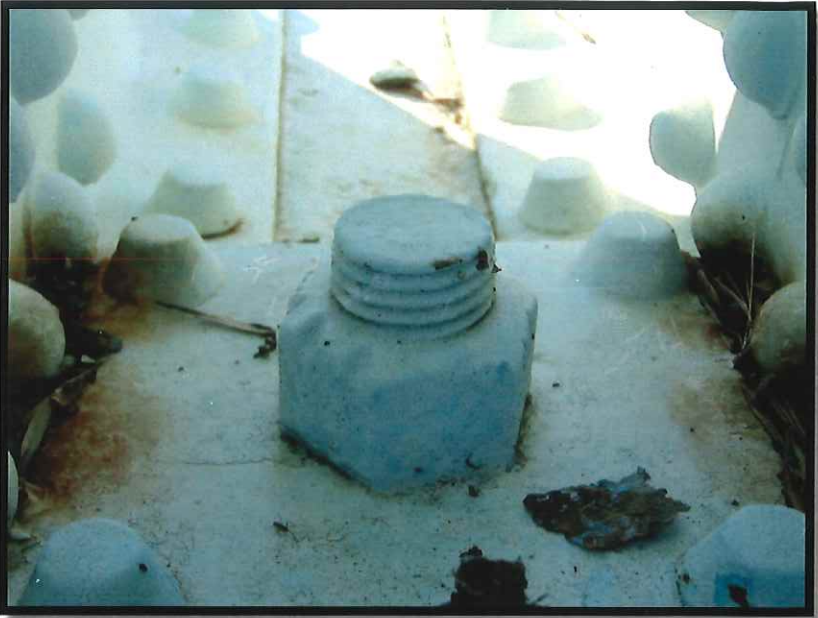
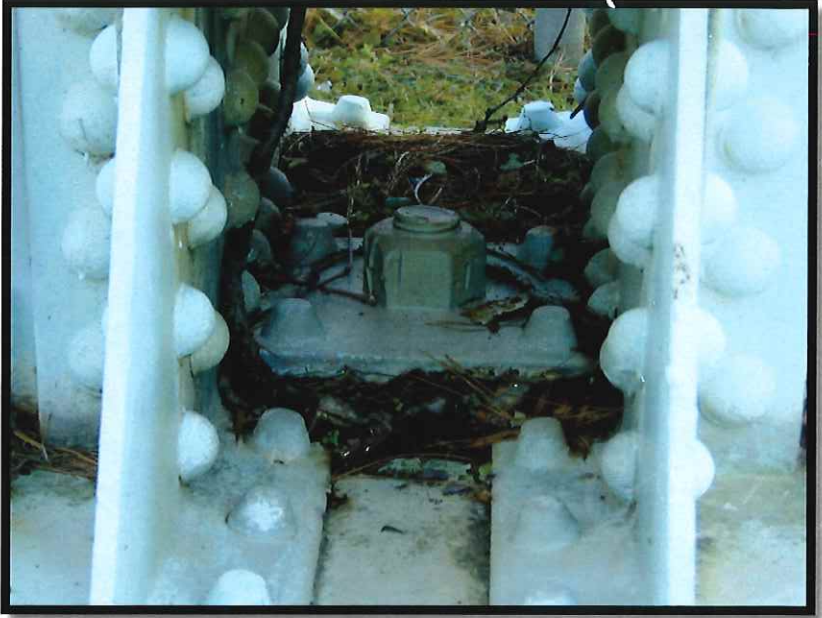
The base plates are in good condition and are securely fastened to the concrete foundations. There is surface rust occurring on less than 5% of observable base plate surfaces. Debris was present on the inner portions of the base plates near the anchor bolt.

Each column leg is equipped with one 1 3/4-inch anchor bolt. There is corrosion present on less than 5% of anchor nut and bolt surfaces.

View of the base plates, and anchor bolts.

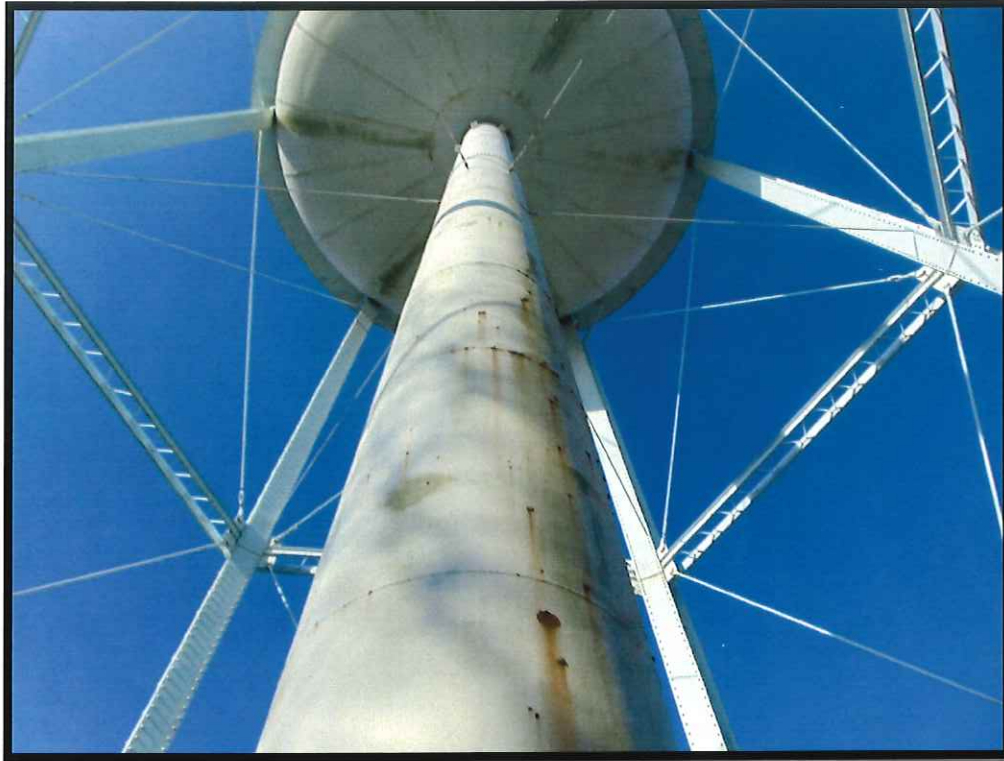
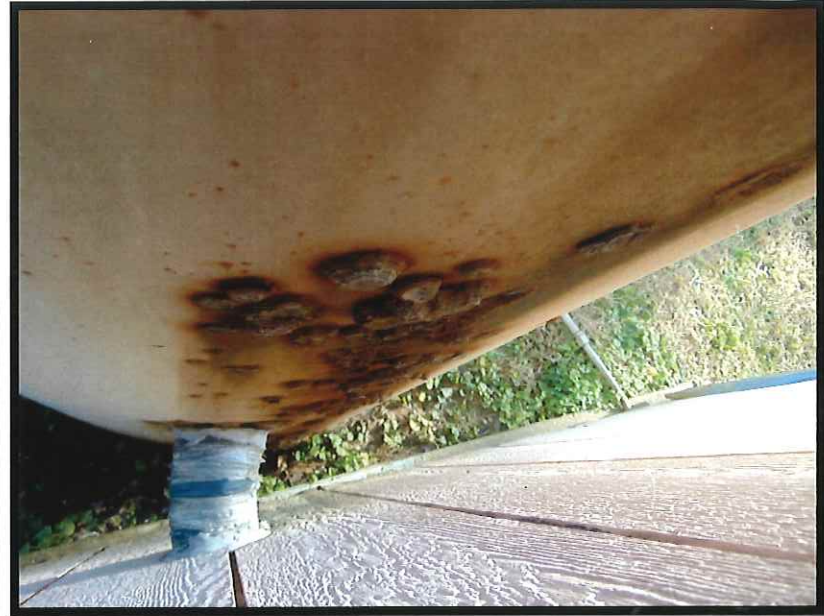
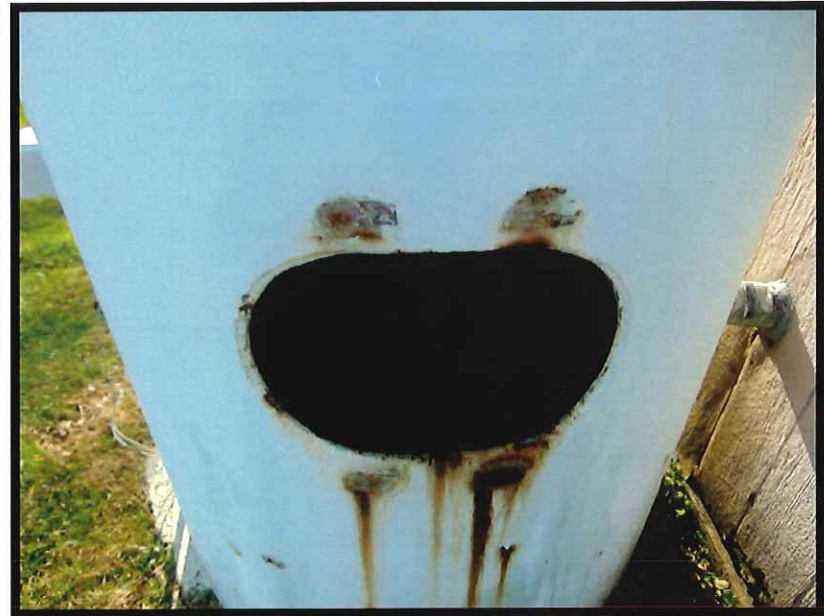
The riser column measures 4 feet in diameter and is in poor condition. Observed localized corrosion is present on approximately 15-20% of riser column surfaces. Pin point rust is evident, as is loss of steel.

The riser column is equipped with an oval-shaped manway measuring 18 inches in width and 12 inches in height. A new gasket was installed after the wash out of the tank interior.

View of the riser column and riser manway.

2. The structure adjacent to the riser column prevents full 360-degree access to the riser column. We recommend that when the structure is replaced it be moved further away from the riser column.

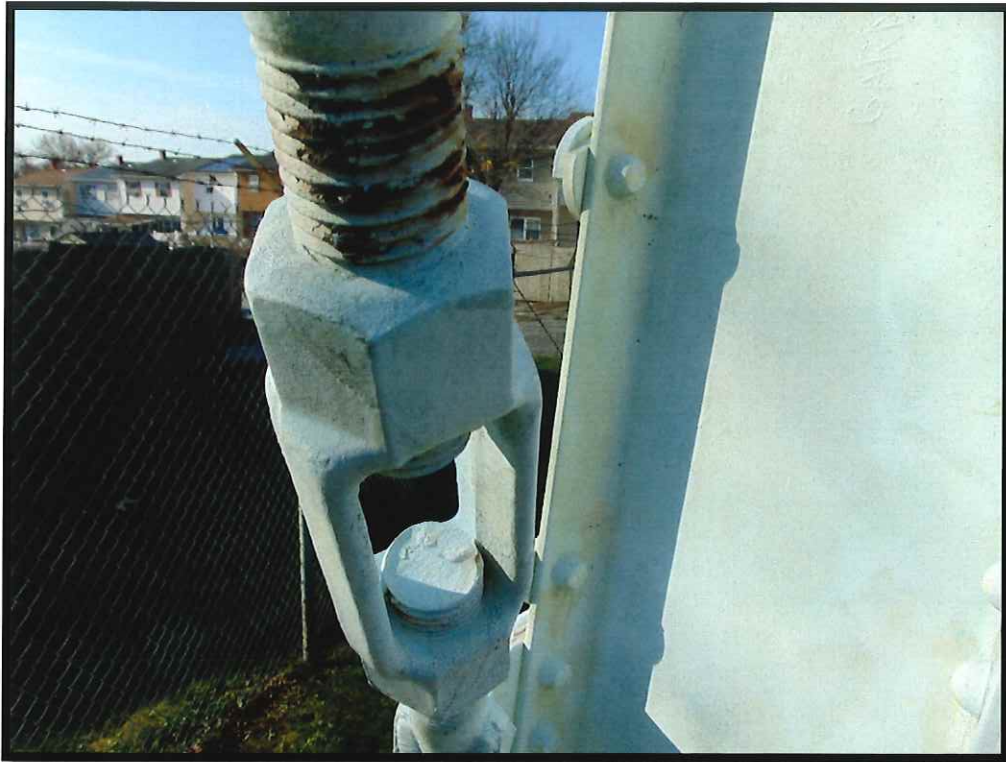
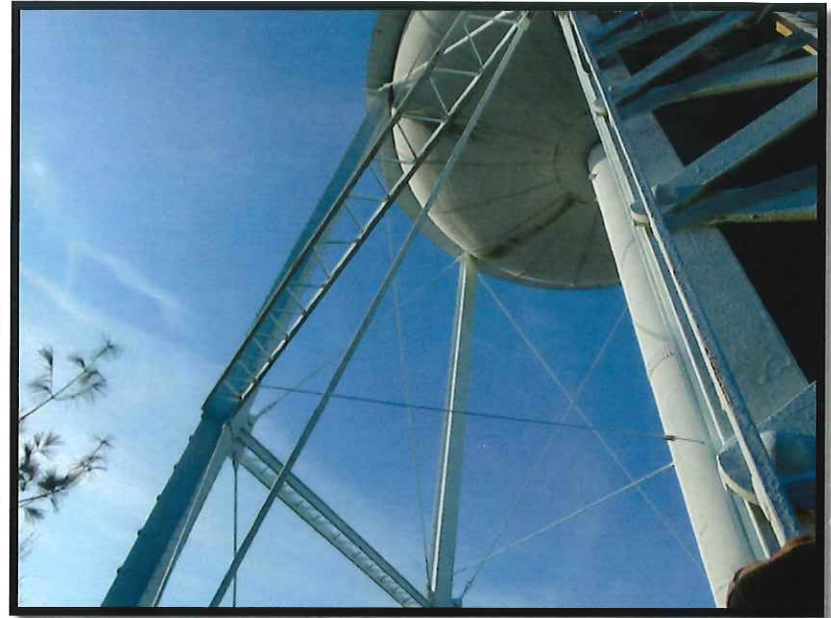
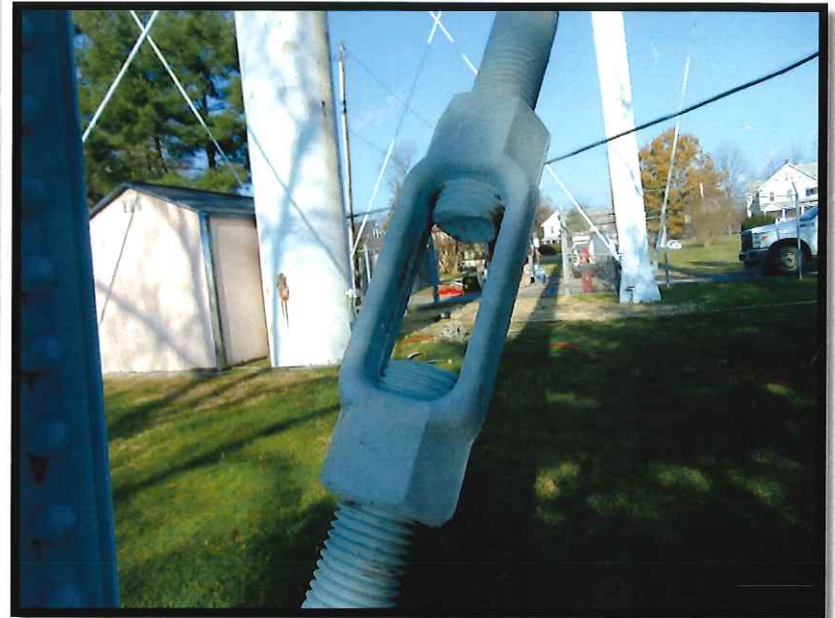
The tank is not missing any rods. The rods measure 1 3/4-inch in diameter and are securely attached to the column legs. Light surface rust was observed on the irregular surfaces of the rods (threads) not exceeding 5% of total rod surfaces. The laced struts are in good condition with no corrosion observed.

View of the wind rods and turnbuckles.

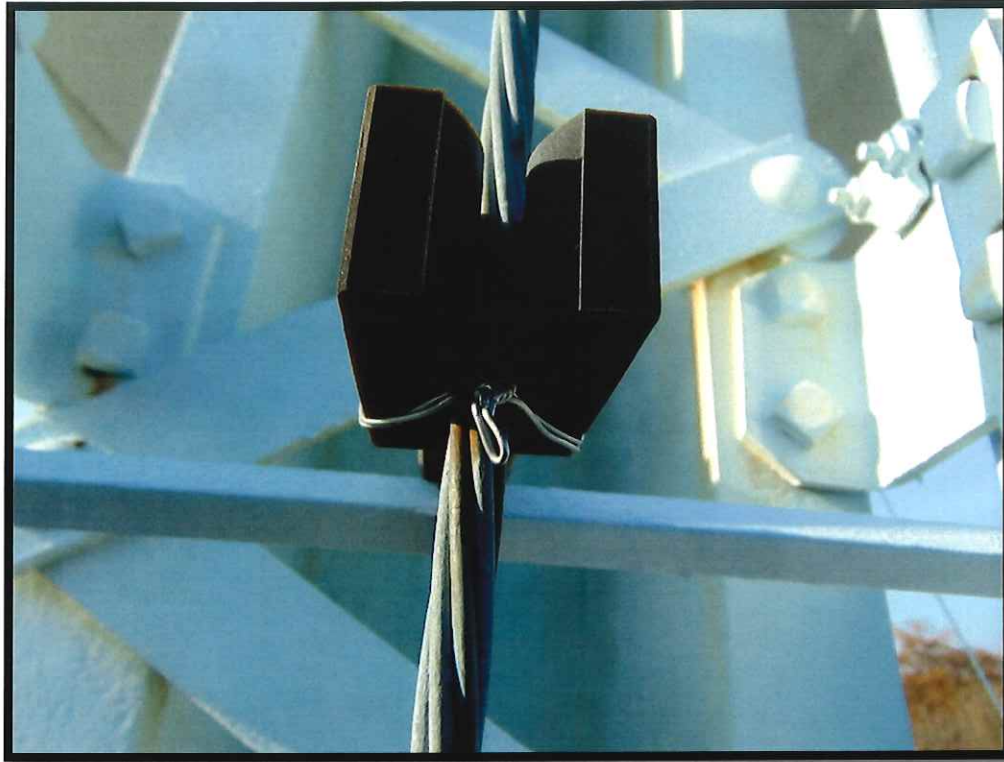
The access ladder is not equipped with a climb prevention device. Overall, corrosion exists on less than 5% of the ladder surfaces.

View of the access ladder, climb prevention plate, fall prevention cable, and cable stay.

4. The bottom of the column access ladder does not have a ladder guard installed. We recommend installing a ladder guard equipped with a locking mechanism to prevent trespassing. [REDACTED]

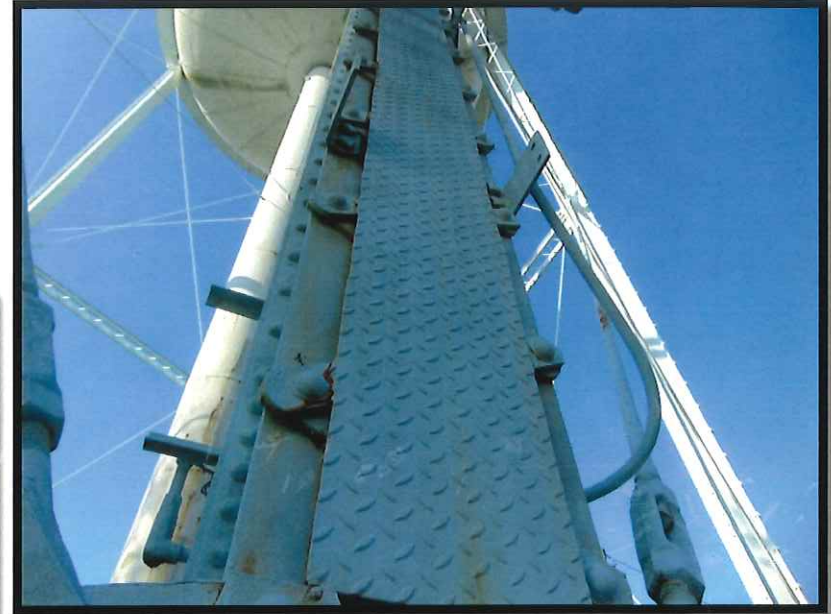
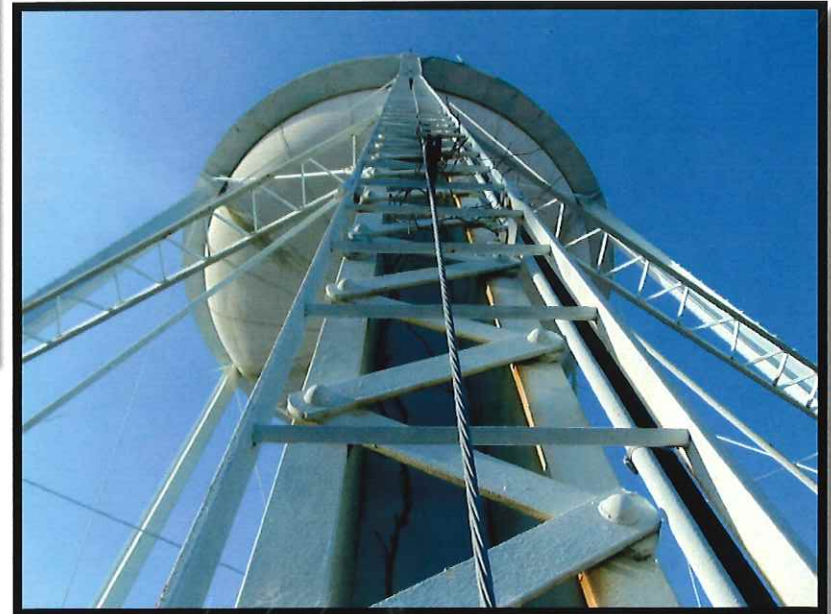
25 feet apart designed to hold the safety cable in place. One of these standoffs has a piece of steel wire holding the fall prevention cable in place. This standoff prevents the climber from proceeding without detaching from the cable and reattaching on the other side of the obstruction.

Pictured above is the cable stay where a wire has been implemented in order to prevent the fall prevention cable from pulling out.

5. The ladder is equipped with a series of guides that are designed to hold the fall prevention cable in place. One of these guides fails to hold the cable; on the guide is a piece of wire that holds the cable permanently in place. At this juncture, the climber is required to detach from the fall prevention cable to bypass the guide. We recommend that this cable guide be replaced by one designed with a 90-degree angle at the location holding the cable. This will prevent the cable from becoming loose while also allowing the climber sufficient access without detaching from the safety cable. [REDACTED]

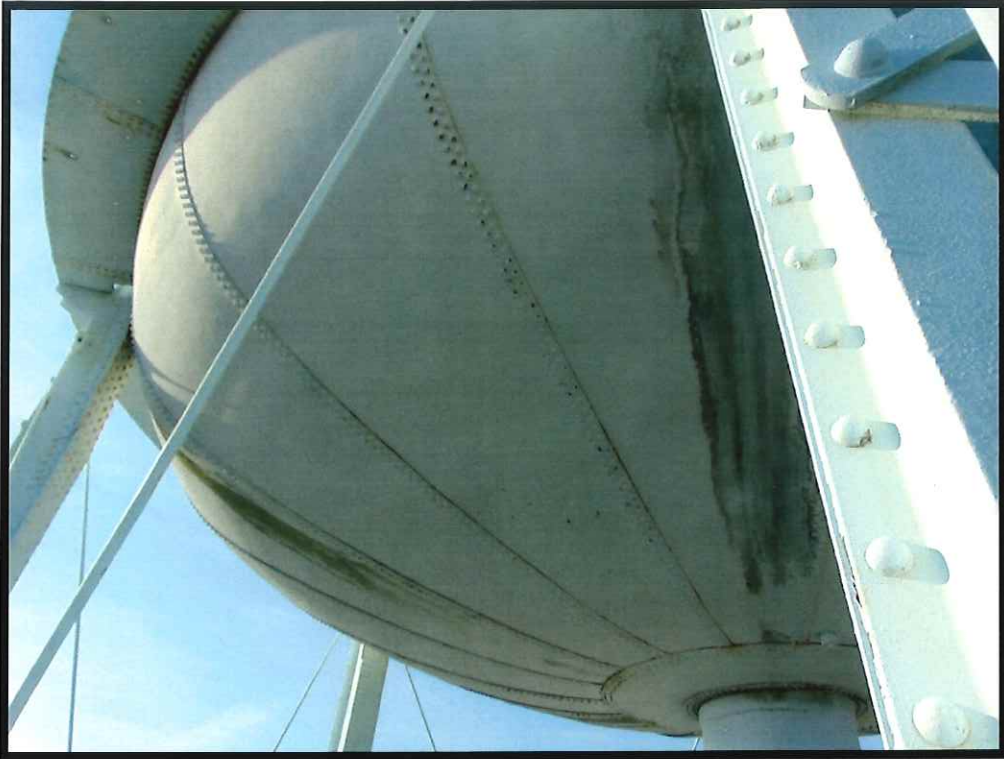
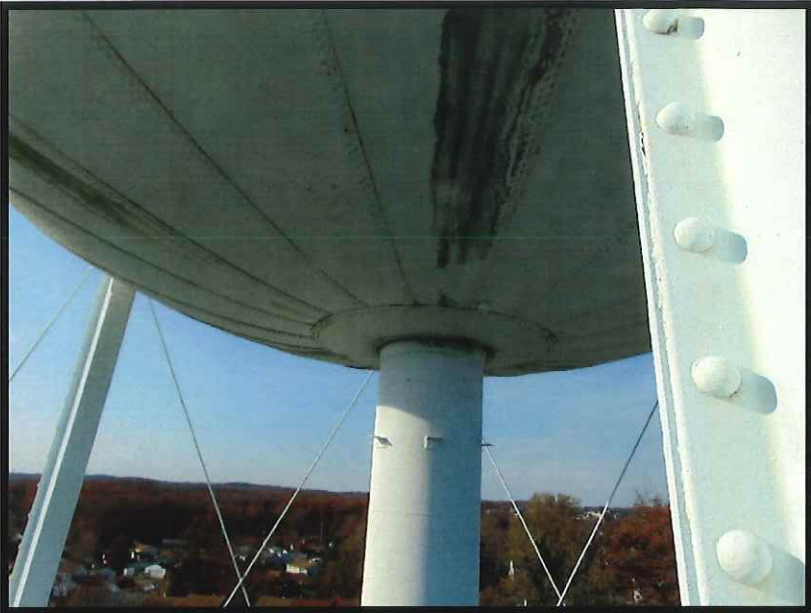
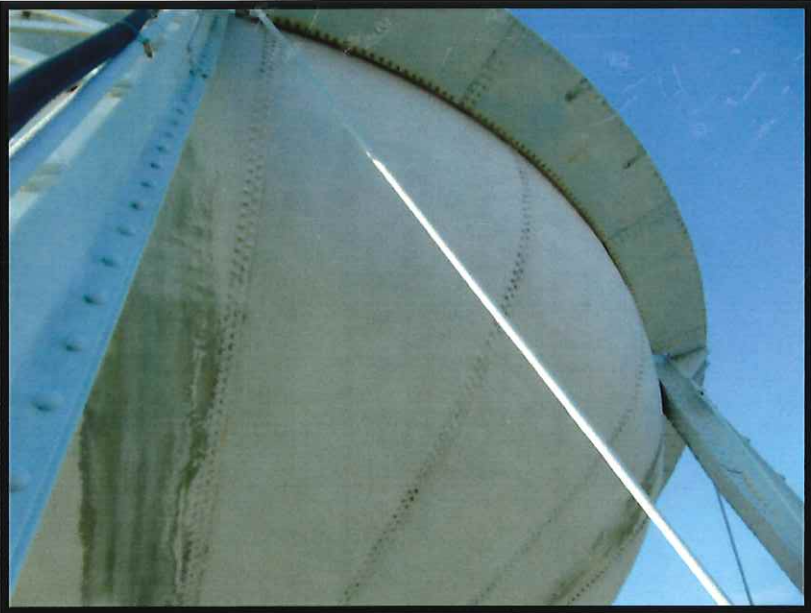
The tank bowl is in good condition with mildew observed on approximately 15-20% of bowl surfaces. Corrosion was observed on irregular surfaces (seams/overlapping sheets). Loss of adhesion was observed on rivets on the tank bowl.

The underside of the catwalk is in good condition. Corrosion was observed on approximately 20% of surfaces.

View of the tank belly and underside of the catwalk.

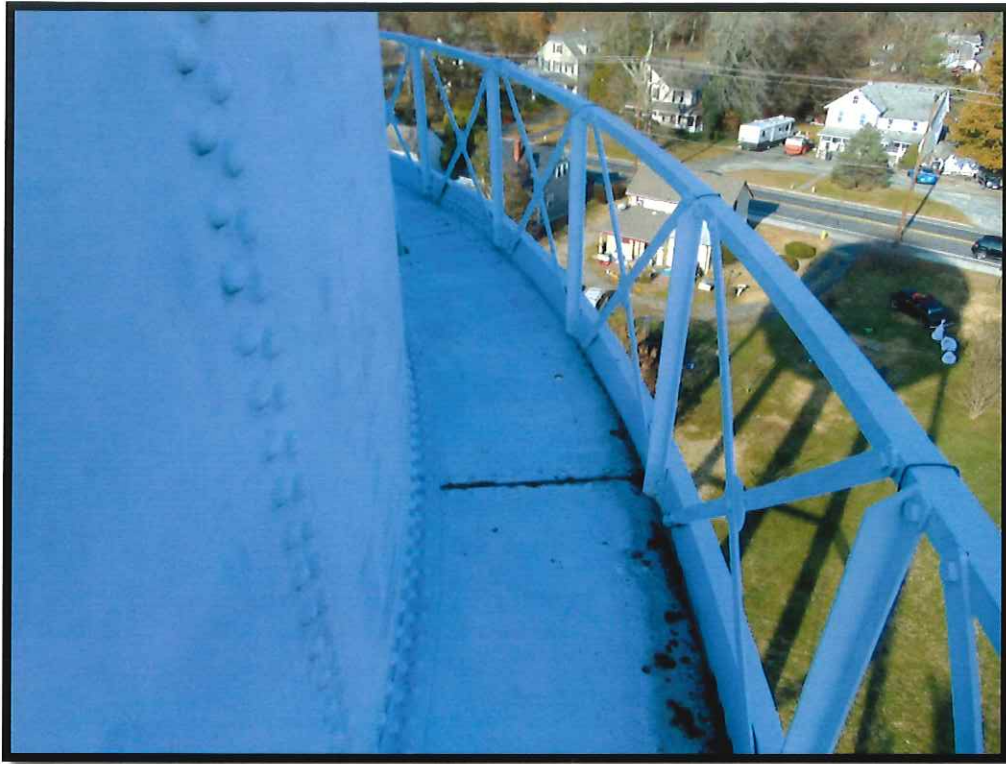
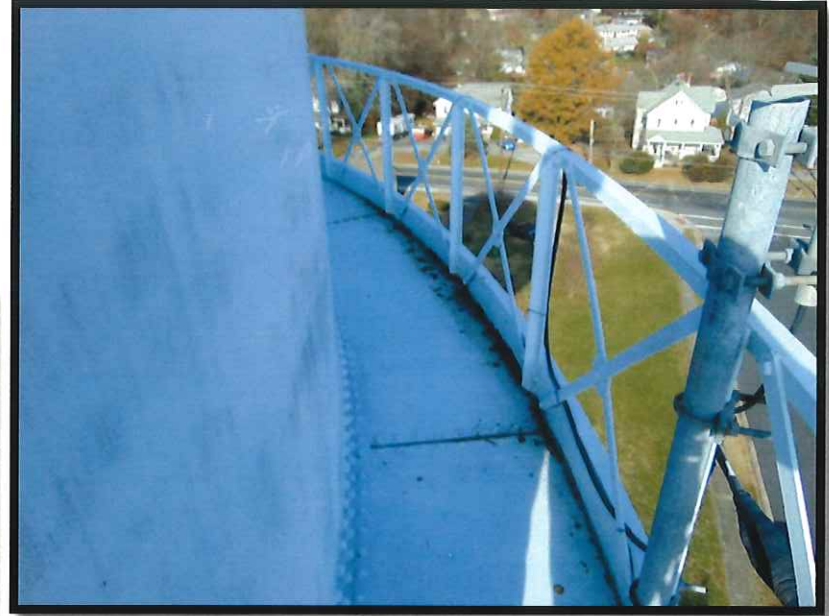
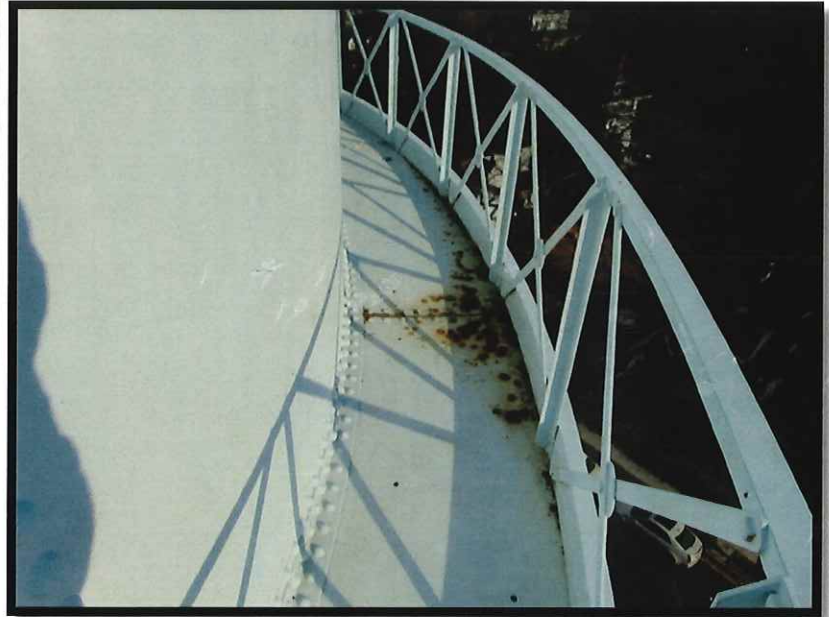
The catwalk balcony is equipped with a toe plate, supports and a hand rail that are fastened to the catwalk. The catwalk balcony measures 27 inches in width; the toe plate measure 7 inches in height; the hand rail measures 36 inches in height, and its support rails intersect 19 inches from the catwalk floor. Although current OSHA safety regulations state that the hand rail height must be 42 inches, it is our understanding based on the referenced interpretation, structures existing 60 days prior to the 42" regulation will not be cited by OSHA¹. Effectively, no remediation is necessary for the handrail structure.

The catwalk floor is in fair condition with localized corrosion on approximately 15% of surfaces. The catwalk floor is equipped with weep holes to prevent pooling.

View of the catwalk and handrail.

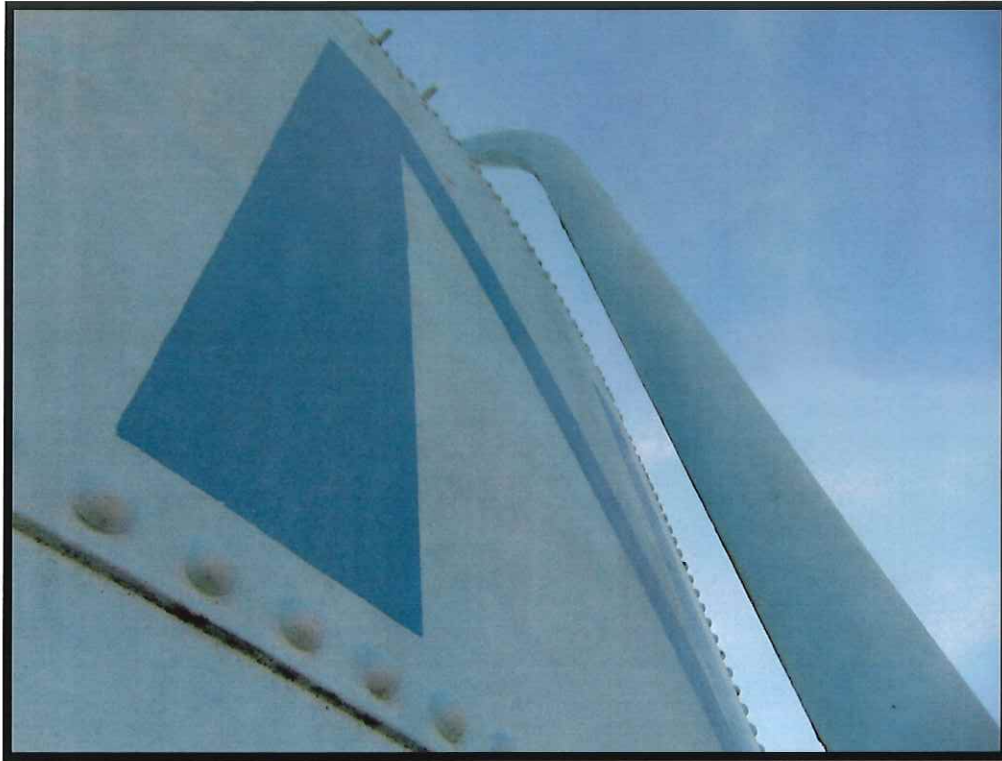
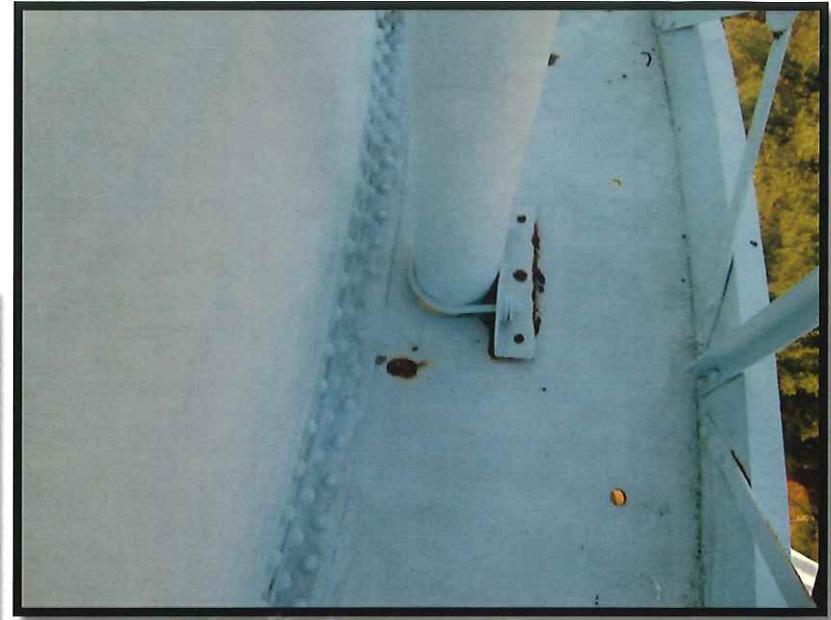
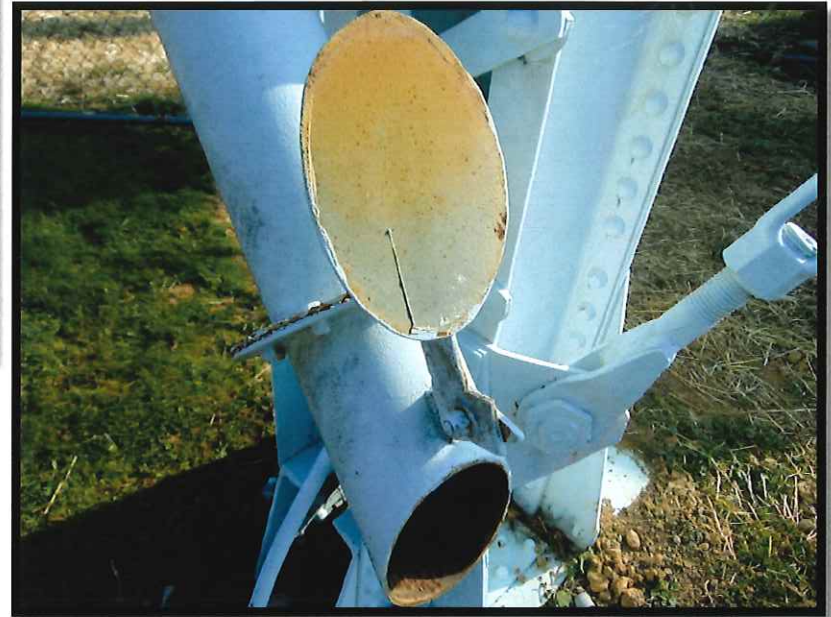
The tank is equipped with an overflow pipe that extends through the knuckle (the area where the roof and shell wall meet), curves downward, extends through an opening in the catwalk floor, and extends outward where it attaches to the column leg. The overflow pipe continues adjacent to the column leg to grade. The discharge end of the overflow pipe is covered with a screen and a flapper. Both the screen and flapper are securely attached.

View of the overflow pipe and discharge end.

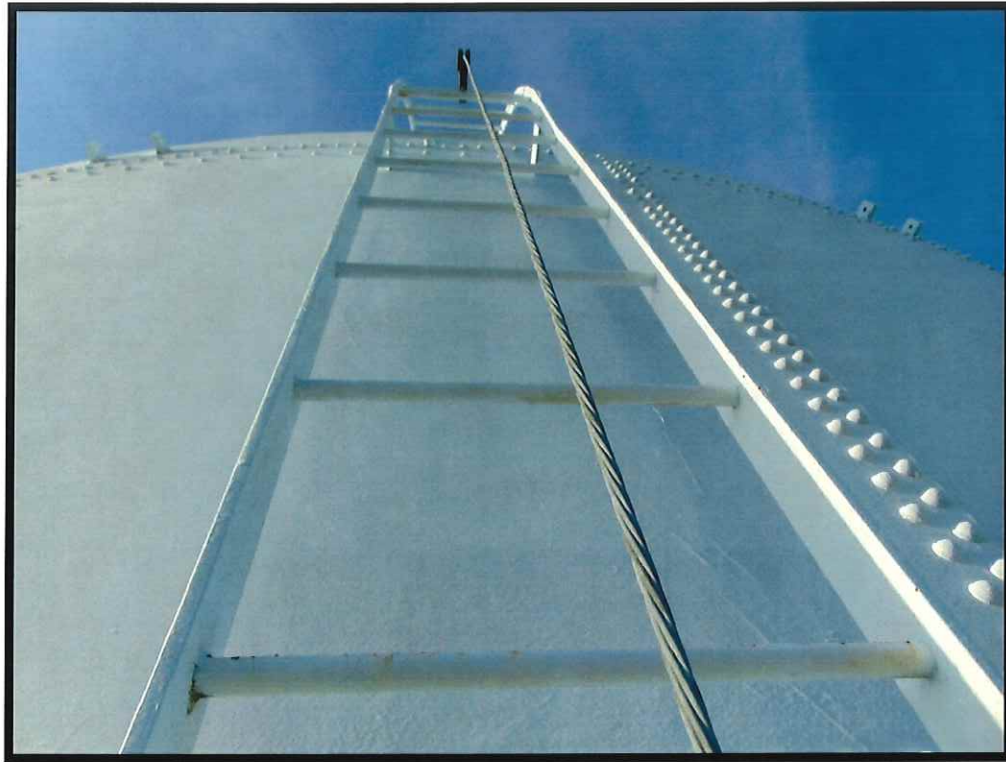
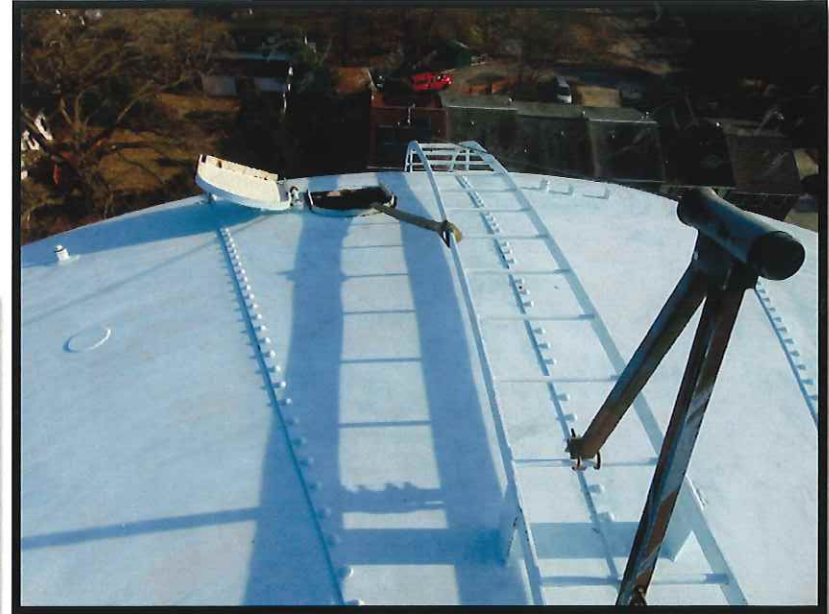
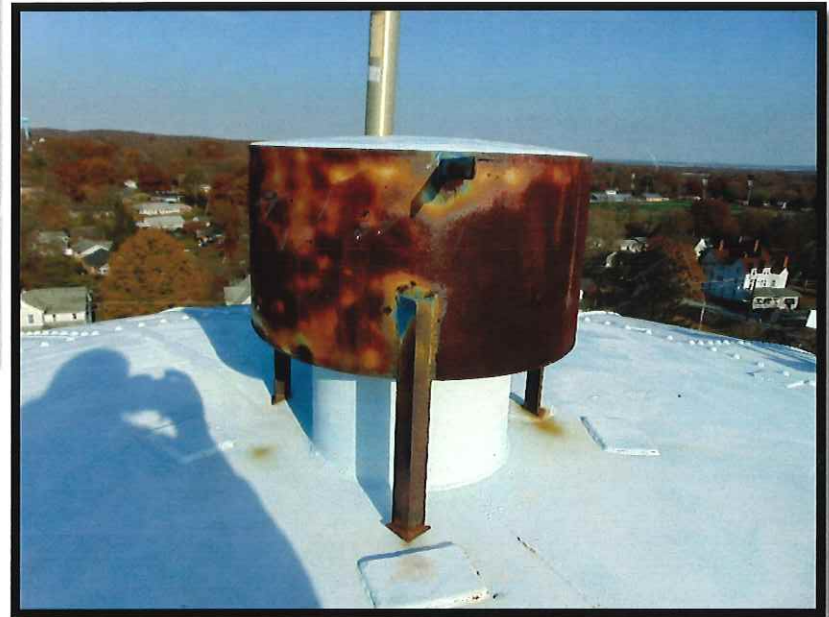
The tank is equipped with a standard roof vent. Proper ventilation is inhibited by a steel shroud that appears to function as an antenna mount. Corrosion is present on over 95% of shroud surfaces. The existing vent and its surrounding structure should be removed and replaced with a frost free aluminum vent.

View of the shell/roof ladder and roof vent/vent shroud.

6. The roof vent and its shroud should be removed and replaced with an aluminum, frost-free roof vent. [REDACTED]
7. The "church window" style access hatch and its inadequate curbing should be replaced with an access hatch that meets AWWA recommendations. Since the existing hatch measures 26 inches in length, we recommend that a 30-inch square hatch with a curb of at least 4 inches in height be installed as a replacement. Additionally, the new hatch lid should have a downward overlap around the outside of the perimeter of the curb measuring at least 2 inches. We recommend that the new hatch be equipped with a hasp and locking mechanism. [REDACTED]

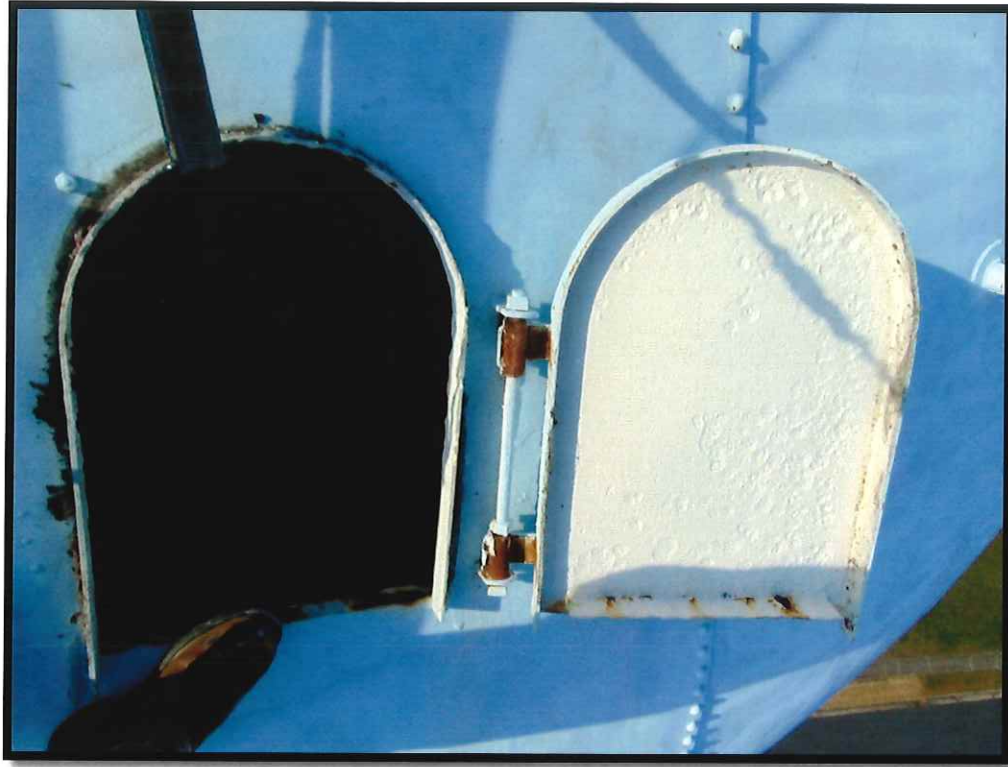
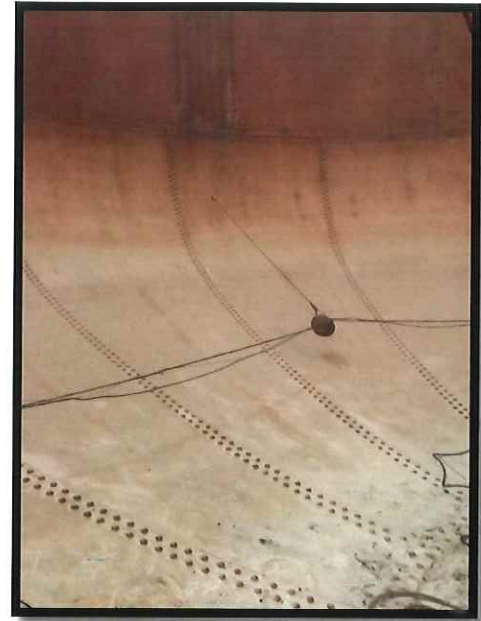
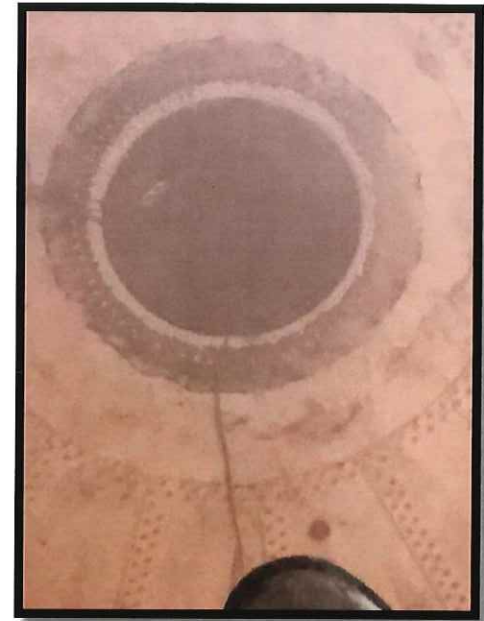
The tank roof is equipped with a "church window" style access hatch that measures 26 inches in height and 18 inches in width. The access hatch has a lip/curb between the top and side portions of the lid and the roof, but not on the bottom portion. The existing curb measures approximately 2 inches in height. The American Water Works Association (AWWA) recommends that the primary roof opening be square or round and measure 24 inches or 30 inches. Additionally, the AWWA recommends a curb height of 4 inches, with 2 inch downward cover overlap on the hatch, to prevent the entry of foreign debris. The hinges are functioning properly.

View of access hatch and tank interior.

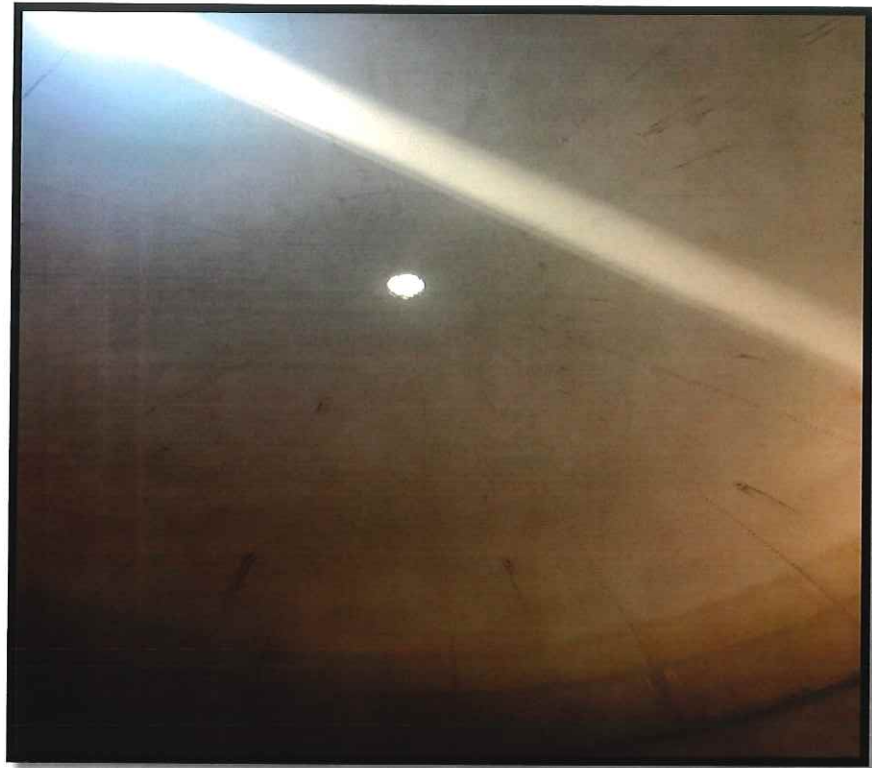
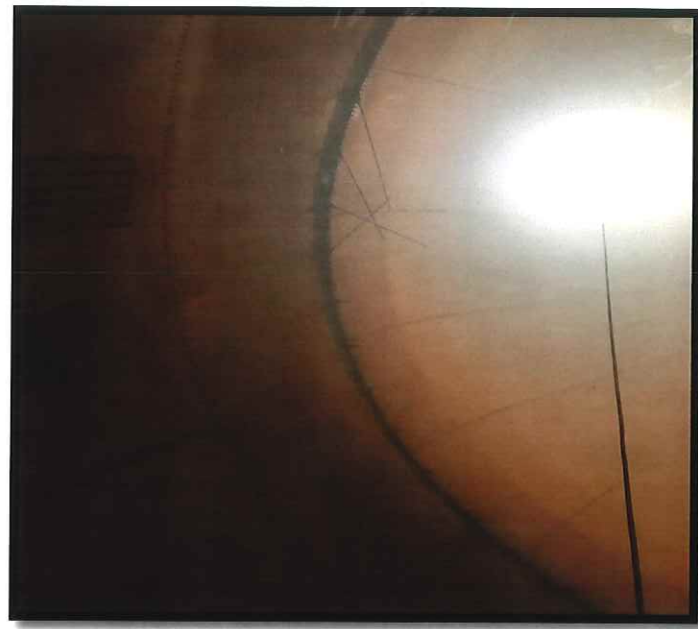
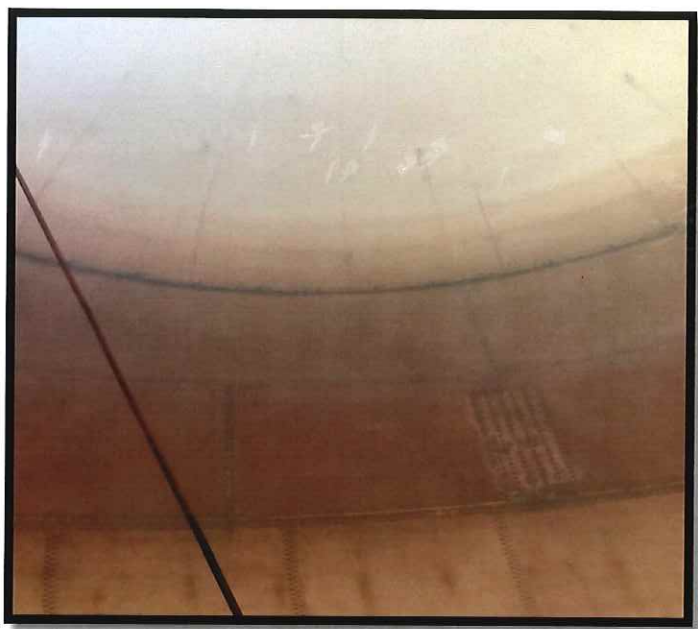
The tank interior is in fair condition with observed staining consistent with elements in the water. Remnants of spider rods that were once mounted to the interior of the tank, are still attached in one area along the interior wall painter's ring. These spider rods were used when the tank was initially built to hold the shape of the bowl but are no longer necessary. They are usually removed, as they are an obstruction when doing interior maintenance and are a source of rusting. All have been removed except for this small section.

View of the interior roof and left behind spider rods.

10. At some point, spider rods were removed from the interior of the tank. Remnants from some of the spider rods remain in the tank and are still attached around the painter's ring on the tank interior. We recommend that these be removed. [REDACTED]
