**REHABILITATION OF THE 250,000 GALLON, RIVETED STEEL, KROUSE
ELEVATED WATER TANK, ABERDEEN, MARYLAND**

INSPECTION REPORT

**250,000 GALLON RIVETED ELEVATED
KROUSE WATER TANK
ABERDEEN, MARYLAND**

Inspection Date: November 30, 2017

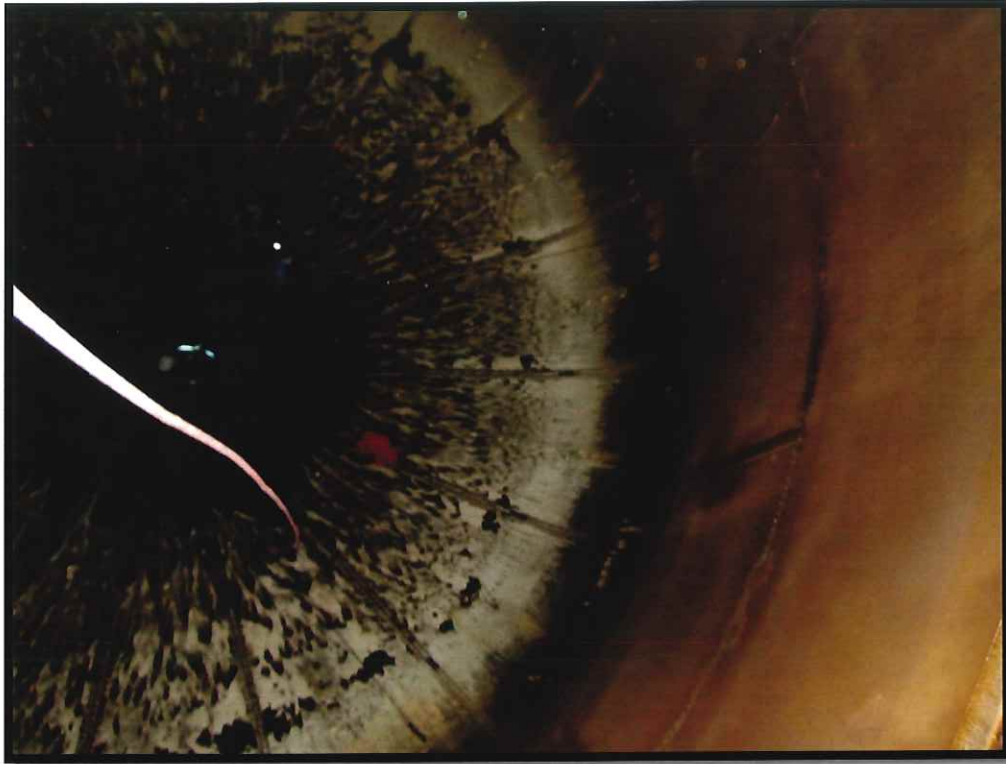
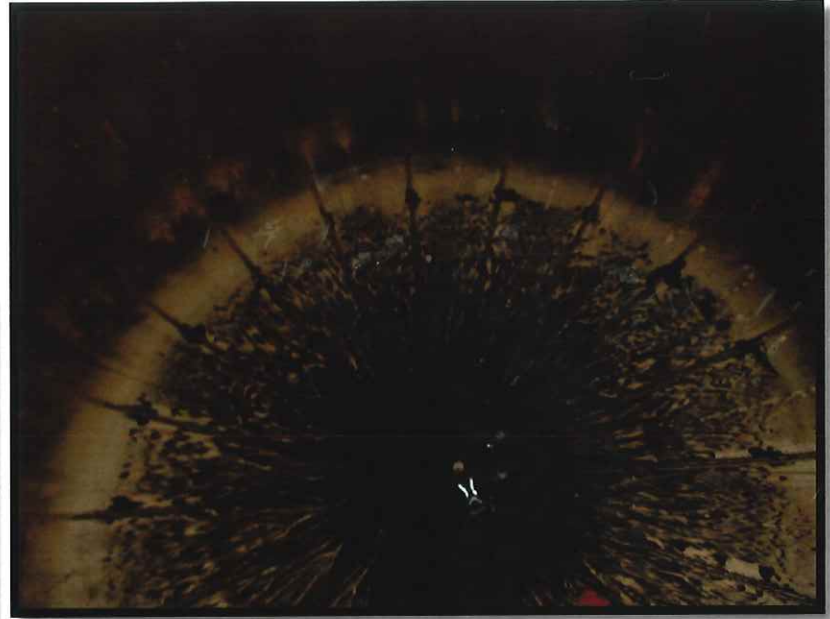
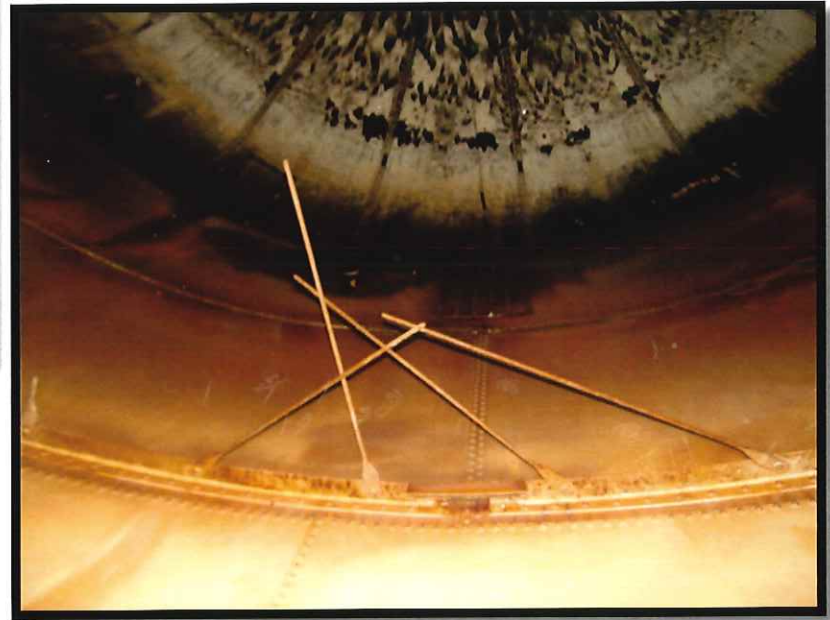
The tank interior is in fair condition with observed staining consistent with elements in the water. Remnants of spider rods that were once mounted to the interior of the tank, are still attached in one area along the interior wall painter's ring. These spider rods were used when the tank was initially built to hold the shape of the bowl but are no longer necessary. They are usually removed, as they are an obstruction when doing interior maintenance and are a source of rusting. All have been removed except for this small section.

View of interior pictures pre-washout
and left behind spider rods.

10. At some point, spider rods were removed from the interior of the tank. Remnants from some of the spider rods remain in the tank and are still attached around the painter's ring on the tank interior. We recommend that these be removed. [REDACTED]

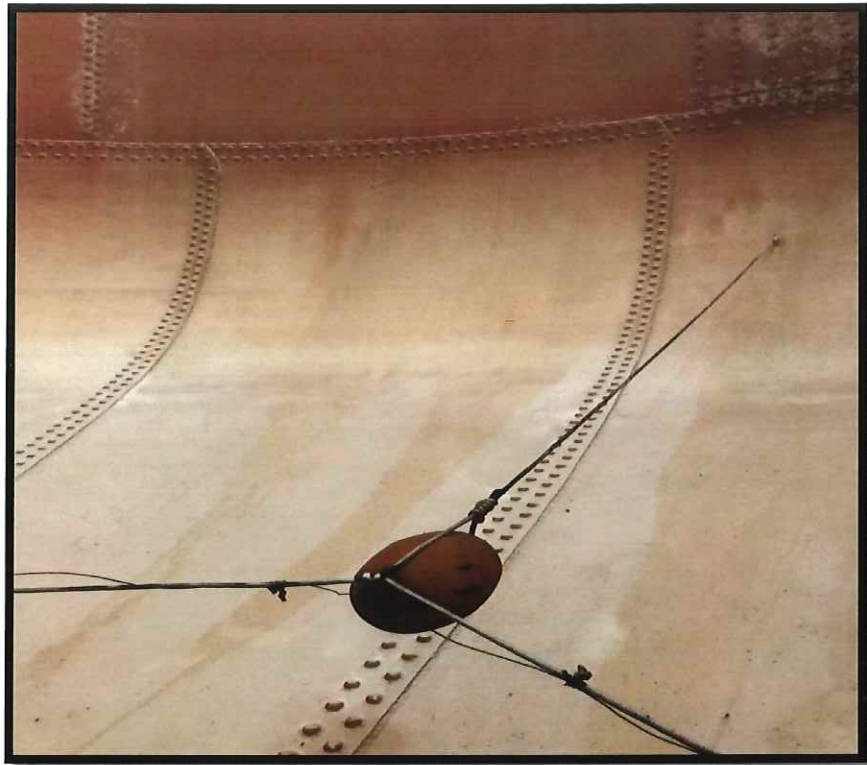
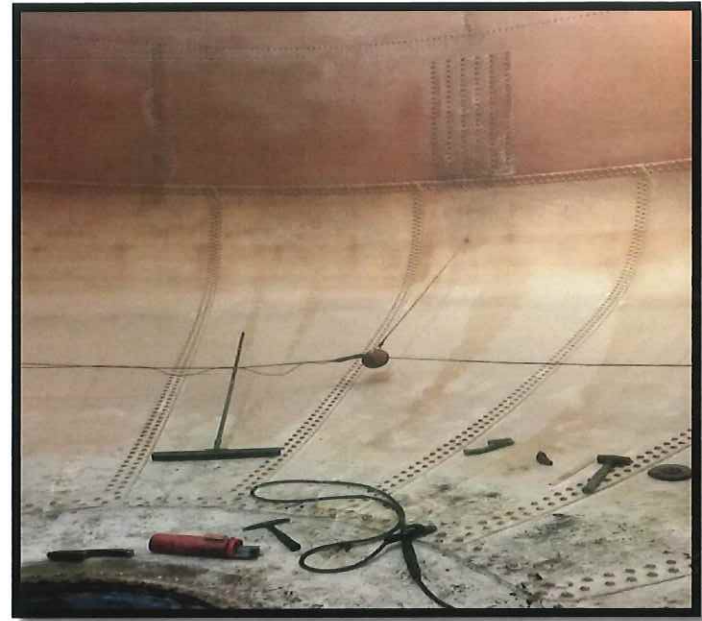
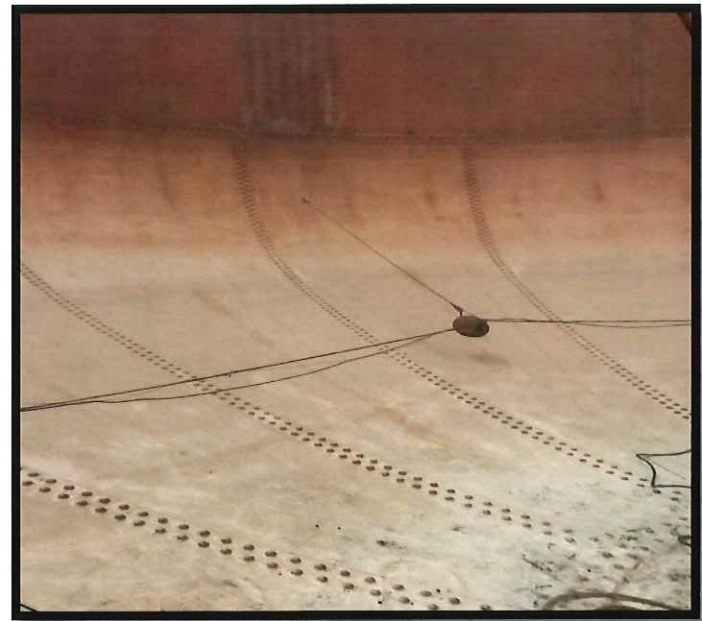
The tank is equipped with a cathodic protection system that is no longer in use.

View of interior pictures post-washout showing remnants of cathodic protection system.

9. The tank is equipped with a cathodic protection system that is not currently in use. We recommend that the cathodic protection components be removed. [REDACTED]
