# CITY OF ABERDEEN

## National Pollutant Discharge Elimination System General Permit For Discharges From Small Municipal Separate Storm Sewer Systems

General Discharge Permit No. 13-IM-5500 / General NPDES Permit No. MDR055500

## FISCAL YEAR 2021 MS4 GENERAL PERMIT PROGRESS REPORT YEAR 3

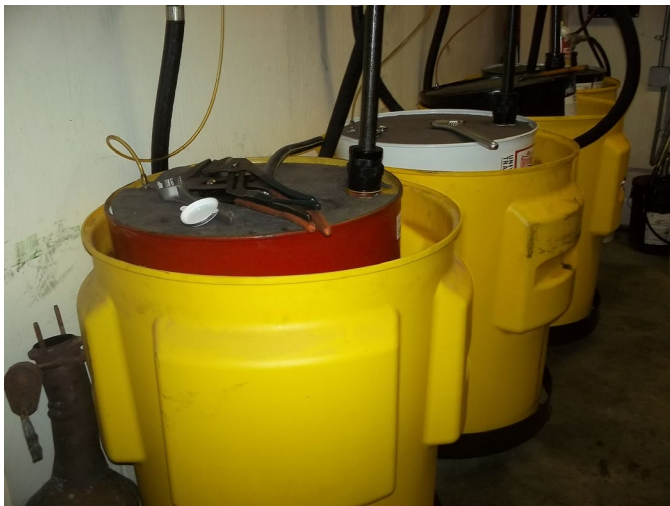
*Comprehensive Site Compliance Inspection  
Public Works Maintenance Shop – 06/05/20  
Chemical Drums on Rolling Spill Decks*

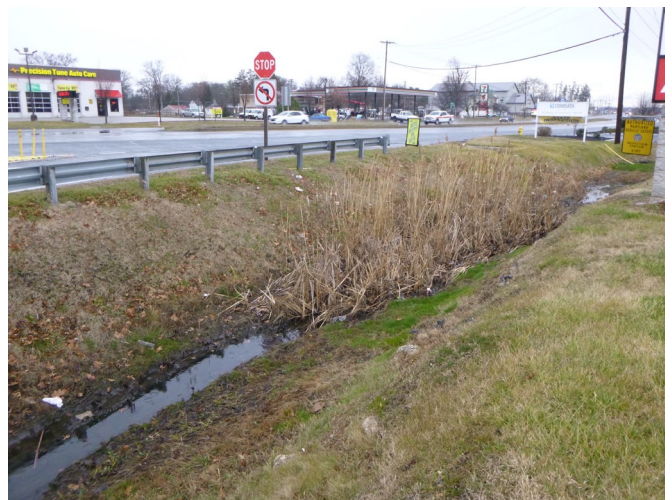
*Chesapeake Bay Restoration – Hotspot Site Investigation  
HSI 16 Area for BMP – 02/10/20  
Thompson's Auto Repair Center / Budget Rental*

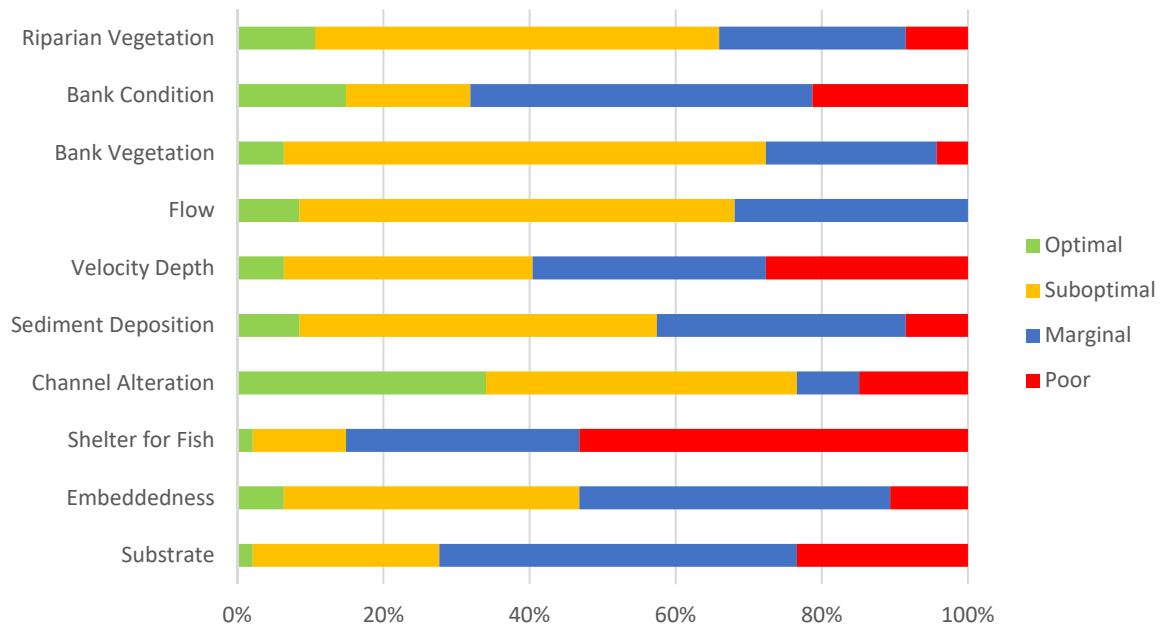
**FIGURE 6: PROPORTION OF REACHES PER ASSESSMENT CATEGORY**

Shelter for fish and benthic macroinvertebrate substrate scores were similar throughout the sites, with majority of the sites scoring in the 'poor' or 'marginal' categories.

Stream channel erosion is a major factor leading to impaired habitat conditions. Erosion sites were described as channel widening and downcutting processes. As the stream channels widen and down cut, the ability to effectively transport sediments (eroded bank material and from runoff over land) is reduced, leading to reduced scores for several habitat parameters including flow, velocity, embeddedness and macroinvertebrate habitat.
