## **CITY OF ABERDEEN**

### **NATIONAL POLLUTANT DISCHARGE ELIMINATION SYSTEM**

## **FISCAL YEAR 2018 ANNUAL REPORT**

KCI TECHNOLOGIES, INC.

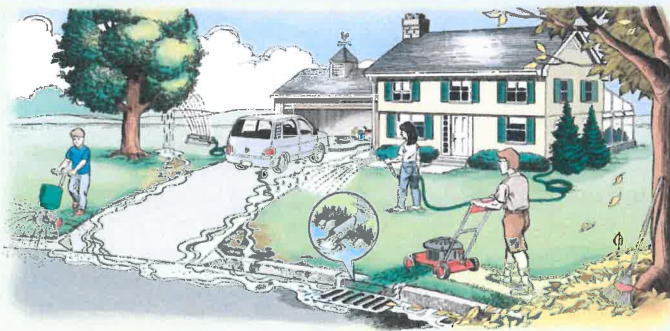
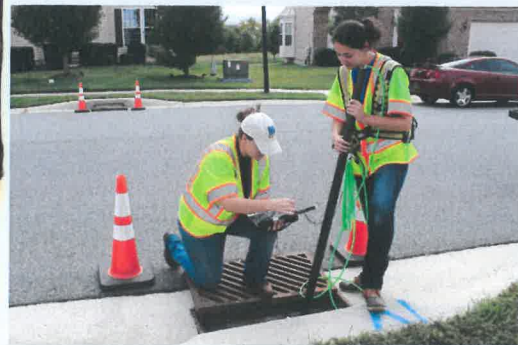
### Stormwater System (MS4)

The Municipal Separate Storm Sewer System (MS4) is a publicly-owned stormwater drainage system designed to convey stormwater. MS4 structures include inlets, conveyance pipes, manholes, and outfall pipes. The important point to remember is that the MS4 flows untreated to streams, lakes, rivers, and ponds.

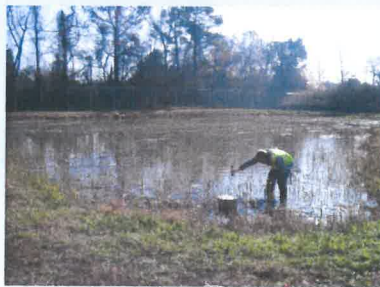
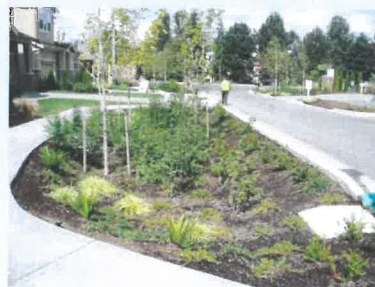
### Best Management Practices – Post Construction Stormwater Management

The City of Aberdeen administers its own Stormwater Management Program that follows the Maryland Environment Article statute and the Code of Maryland Regulations (COMAR). The City conducts triennial inspections of all Best Management Practices (BMPs) to ensure proper function and maintenance.

BMPs are designed to control water quantity and quality. BMP types include ponds, infiltration/filtering such as grass swales and bioretention, and hydrodynamic structures such as underground storage.

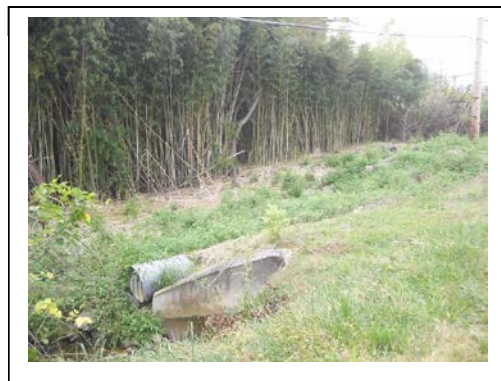
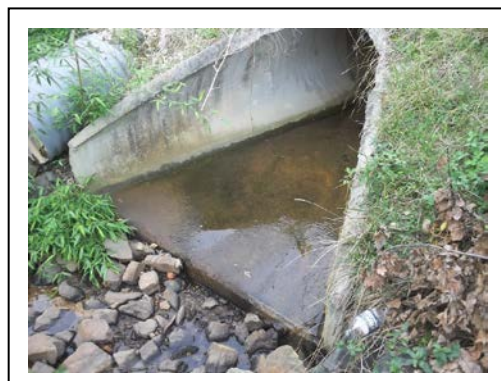
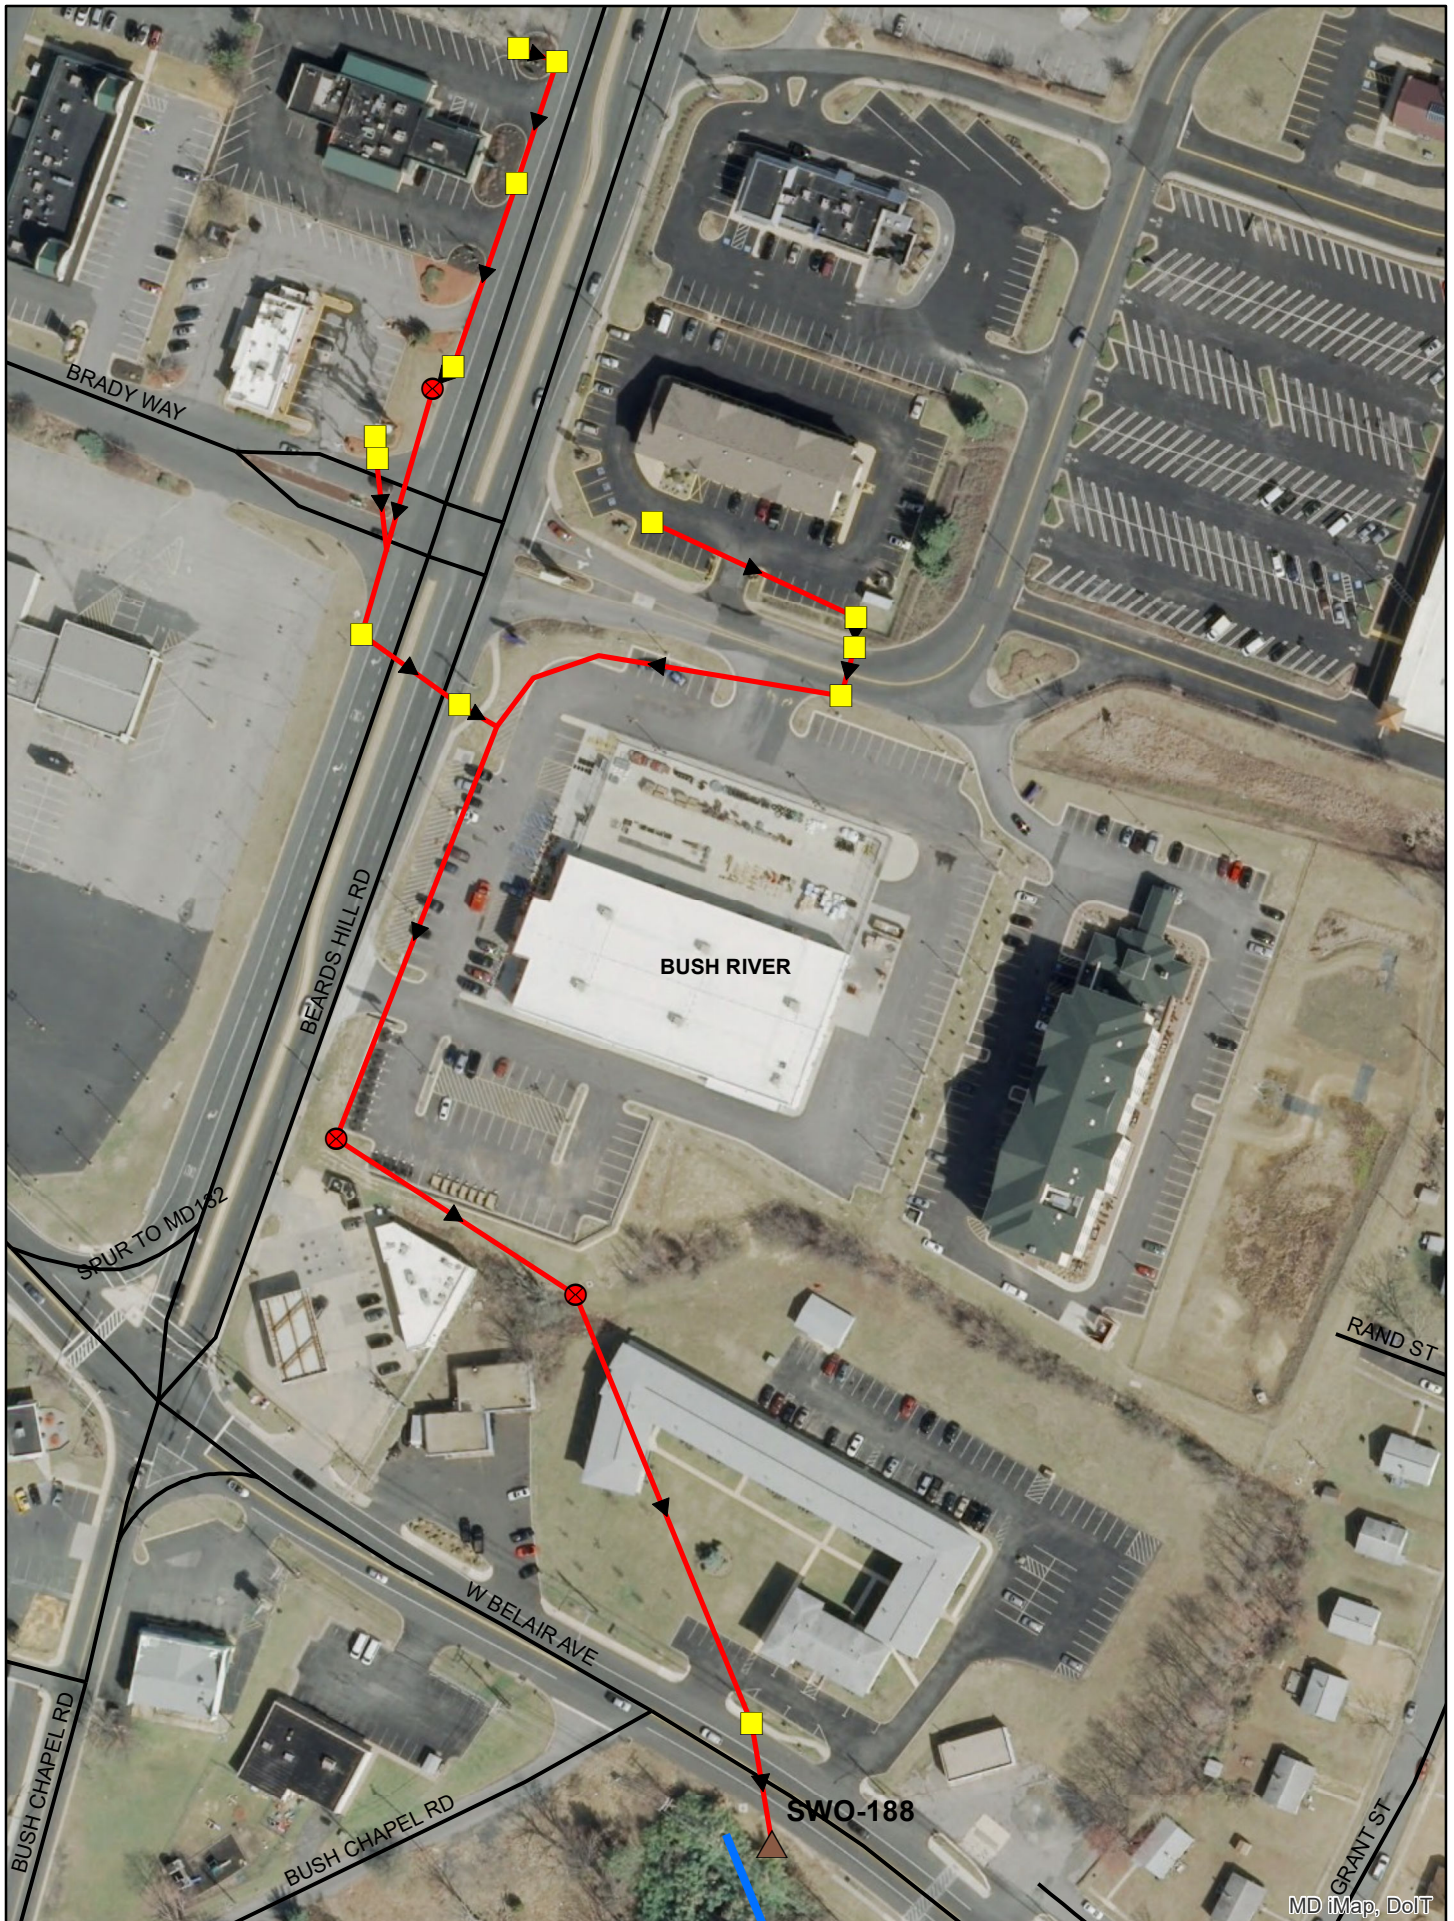
# 2018-1 SWO-188

☒ Flow ☐ Soap ☐ Cloudy  
☐ Staining ☐ Floatables (toilet paper, etc) ☐ Algae  
☐ Oil / Oil Sheen ☐ Dead Fish ☐ Precip w/in 72 hrs  
☐ Antifreeze ☐ Yard Waste ☐ Other: \_\_\_\_\_

Issue: Dry Weather Flow

Determination: No Evidence of Illicit Discharge; No Further Action Required.

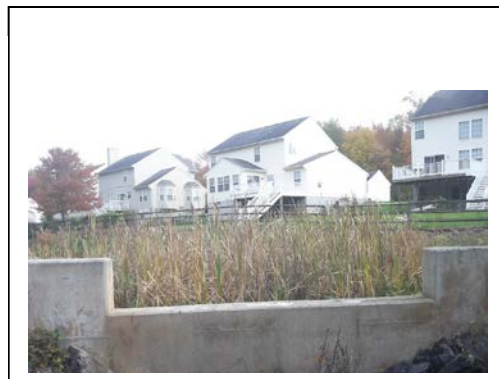
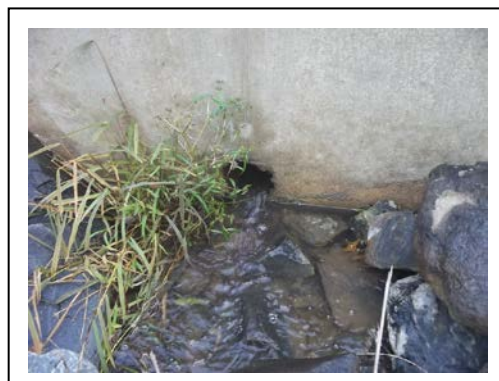
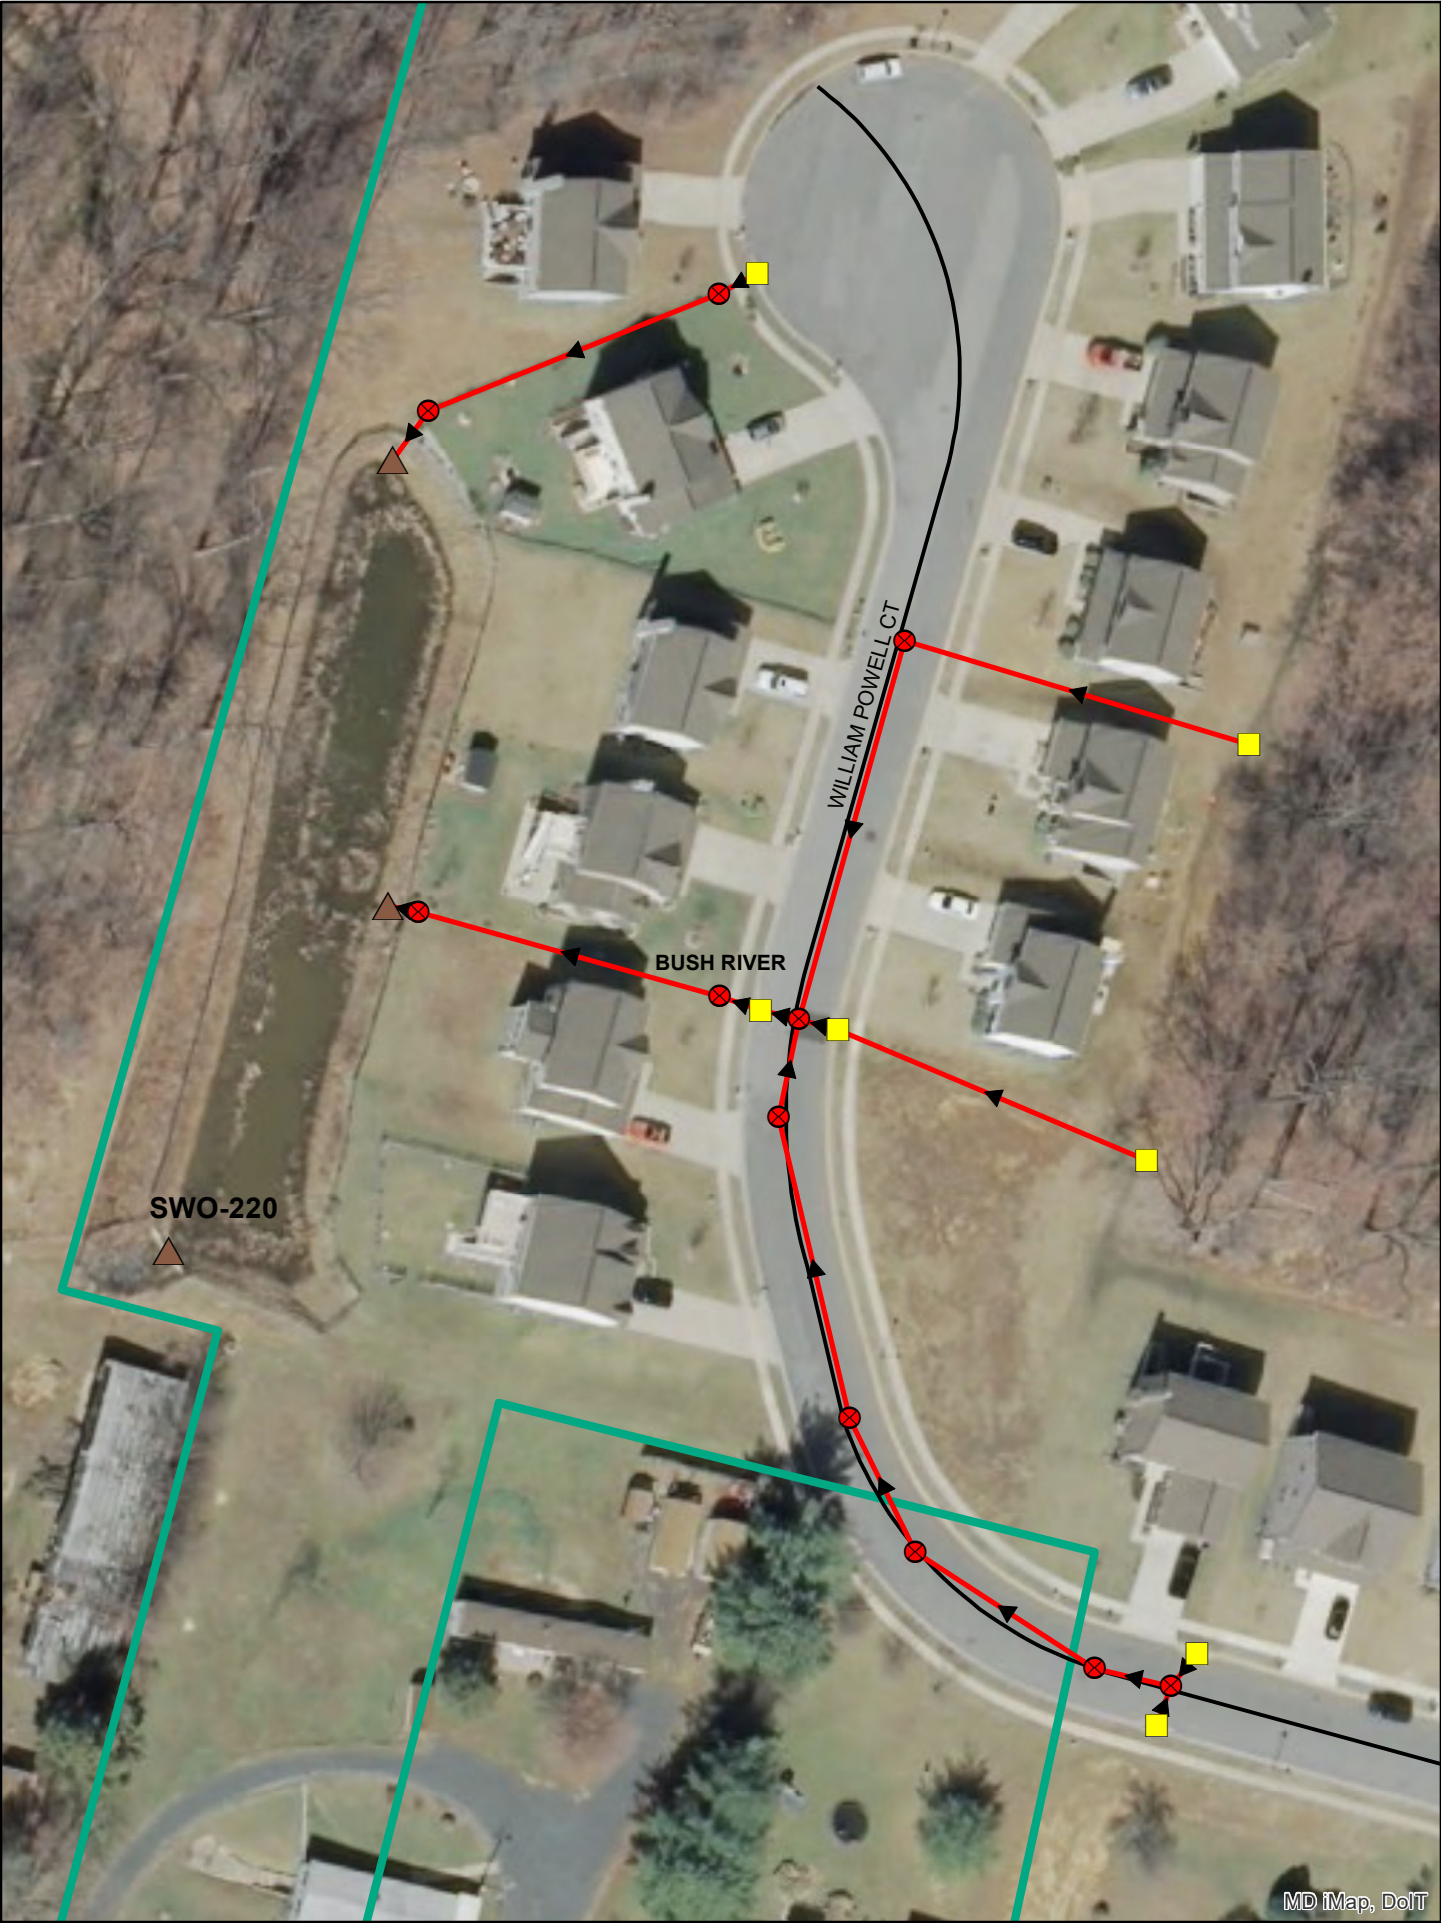
2018-2 SWO-220

☒ Flow ☐ Soap ☐ Cloudy  
☐ Staining ☐ Floatables (toilet paper, etc) ☐ Algae  
☐ Oil / Oil Sheen ☐ Dead Fish ☐ Precip w/in 72 hrs  
☐ Antifreeze ☐ Yard Waste ☐ Other: \_\_\_\_\_

Issue: Dry Weather Flow

Determination: No Evidence of Illicit Discharge; No Further Action Required.

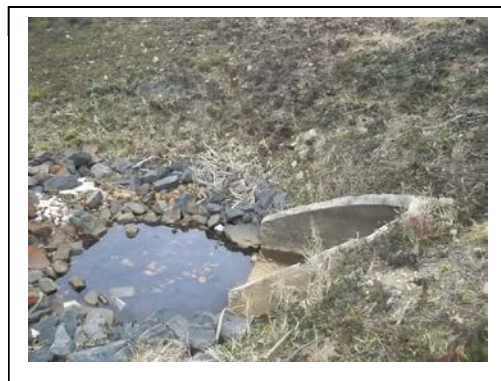
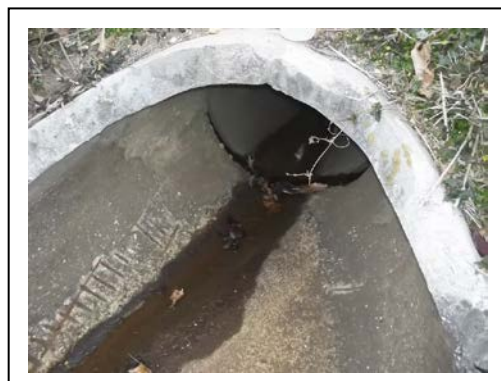
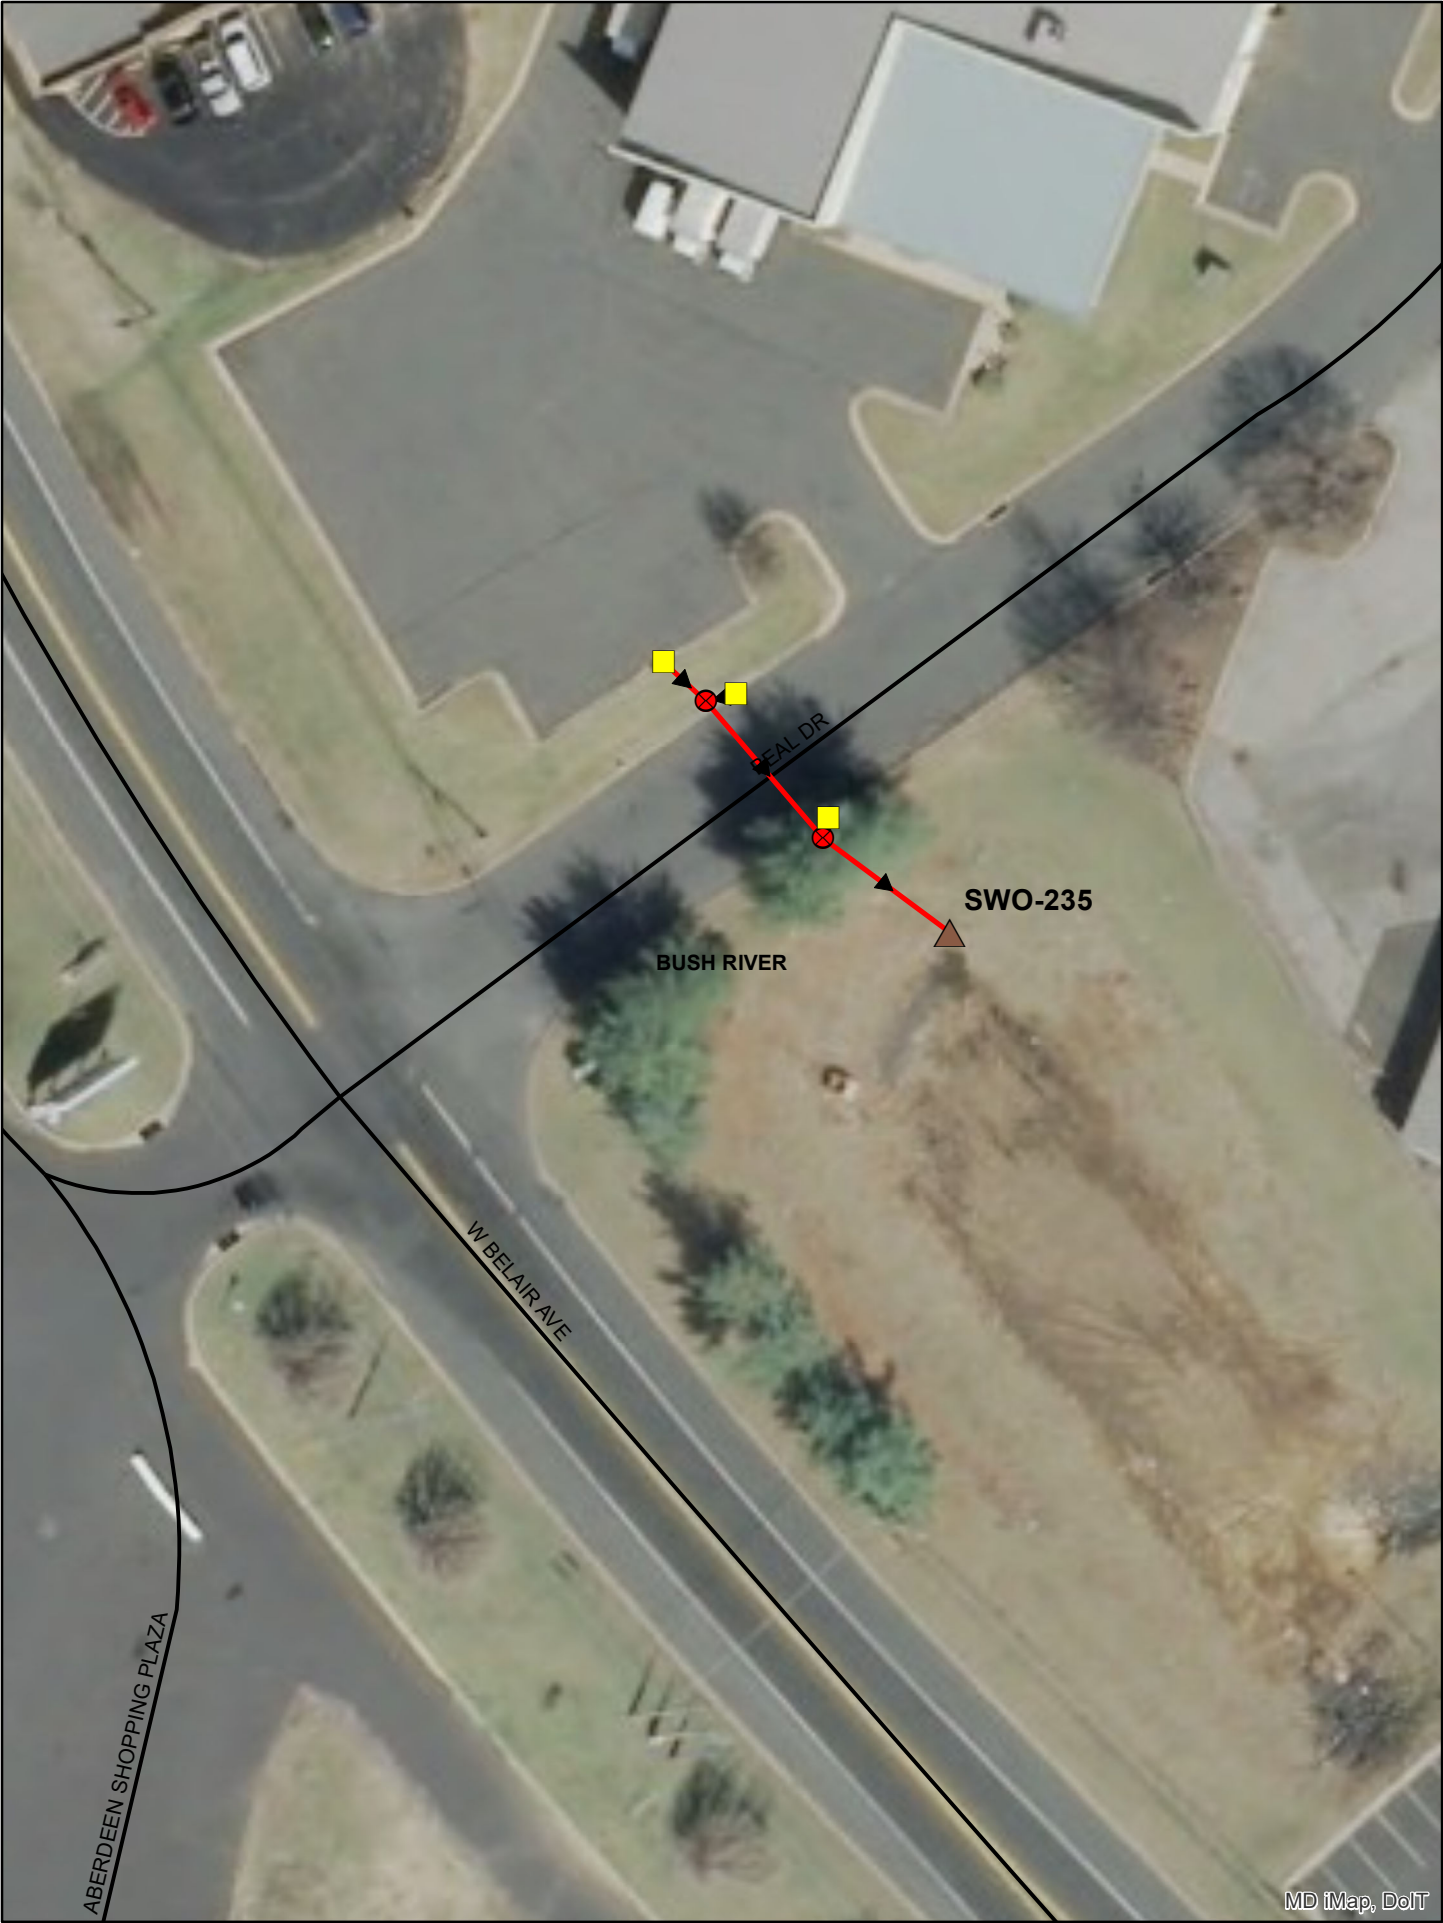
2018-3 SWO-235

☒ Flow ☐ Soap ☐ Cloudy  
☒ Staining ☐ Floatables (toilet paper, etc) ☐ Algae  
☐ Oil / Oil Sheen ☐ Dead Fish ☐ Precip w/in 72 hrs  
☐ Antifreeze ☐ Yard Waste ☐ Other: \_\_\_\_\_

Issue: Dry Weather Flow

Determination: No Evidence of Illicit Discharge; No Further Action Required.

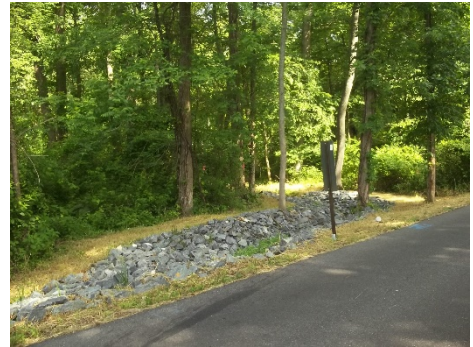
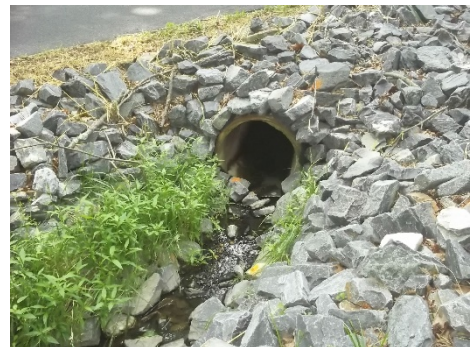
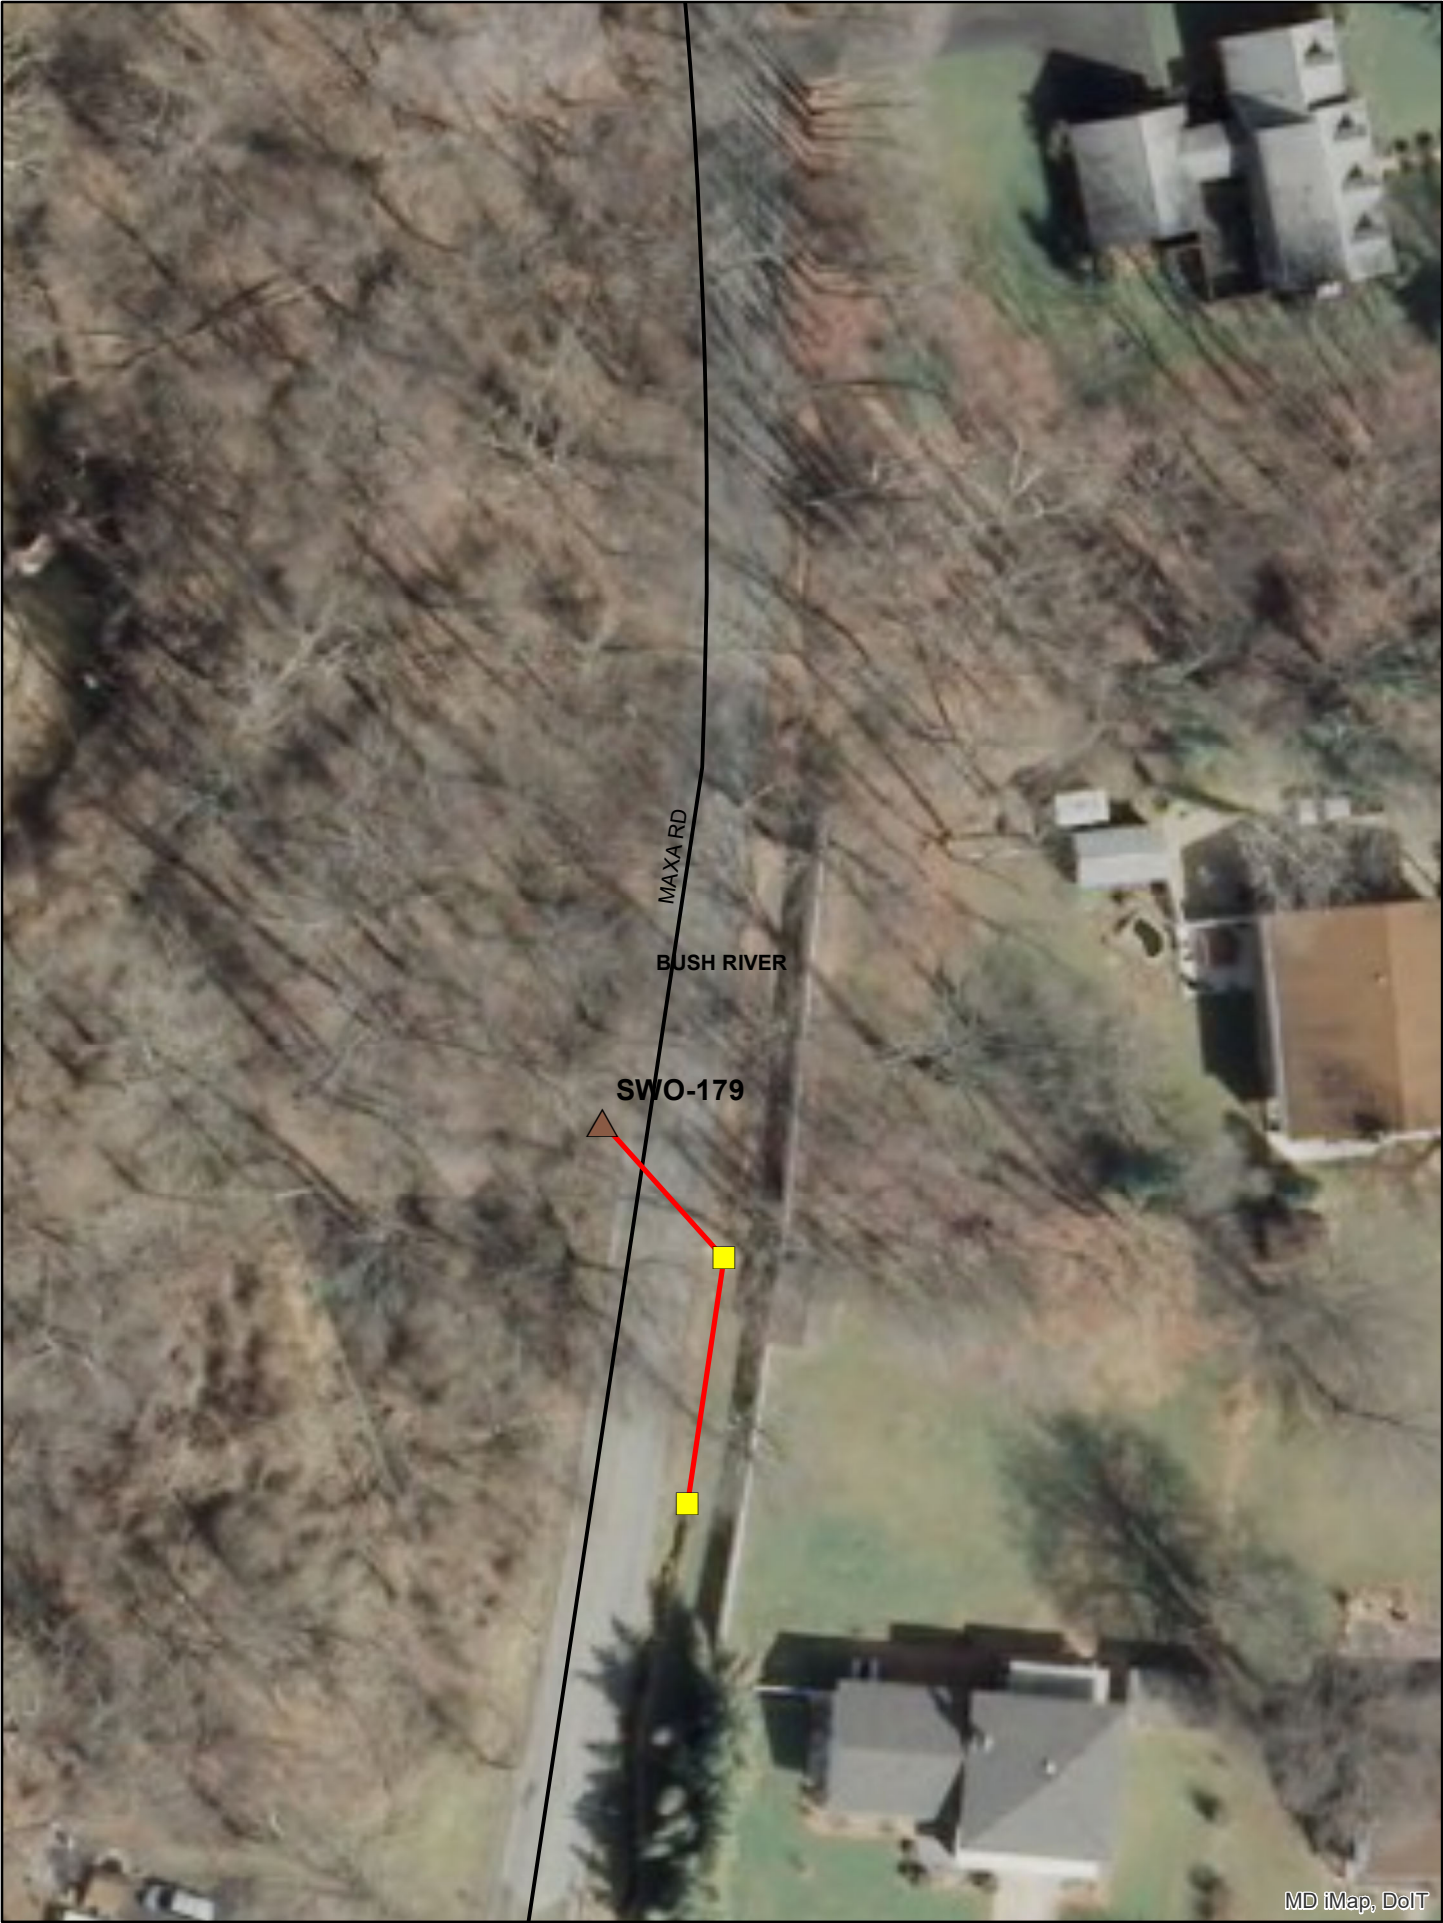
2018-4 SWO-179

☒ Flow ☐ Soap ☐ Cloudy  
☐ Staining ☐ Floatables (toilet paper, etc) ☐ Algae  
☐ Oil / Oil Sheen ☐ Dead Fish ☐ Precip w/in 72 hrs  
☐ Antifreeze ☐ Yard Waste ☐ Other: \_\_\_\_\_

Issue: Dry Weather Flow

Determination: No Evidence of Illicit Discharge; No Further Action Required.

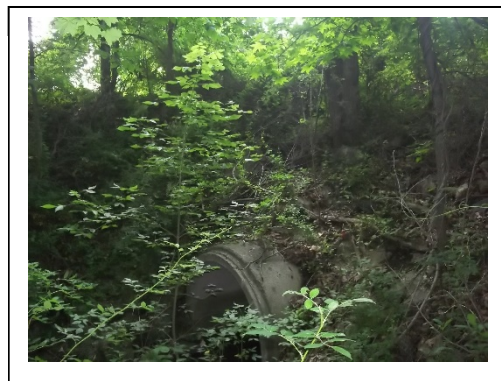
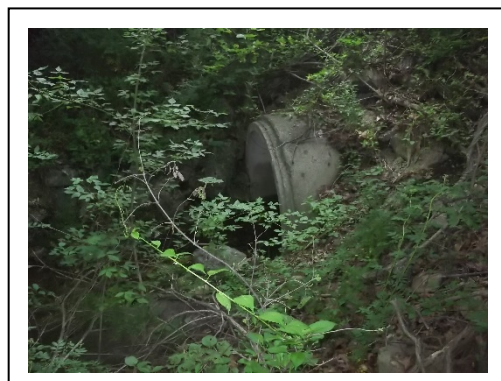
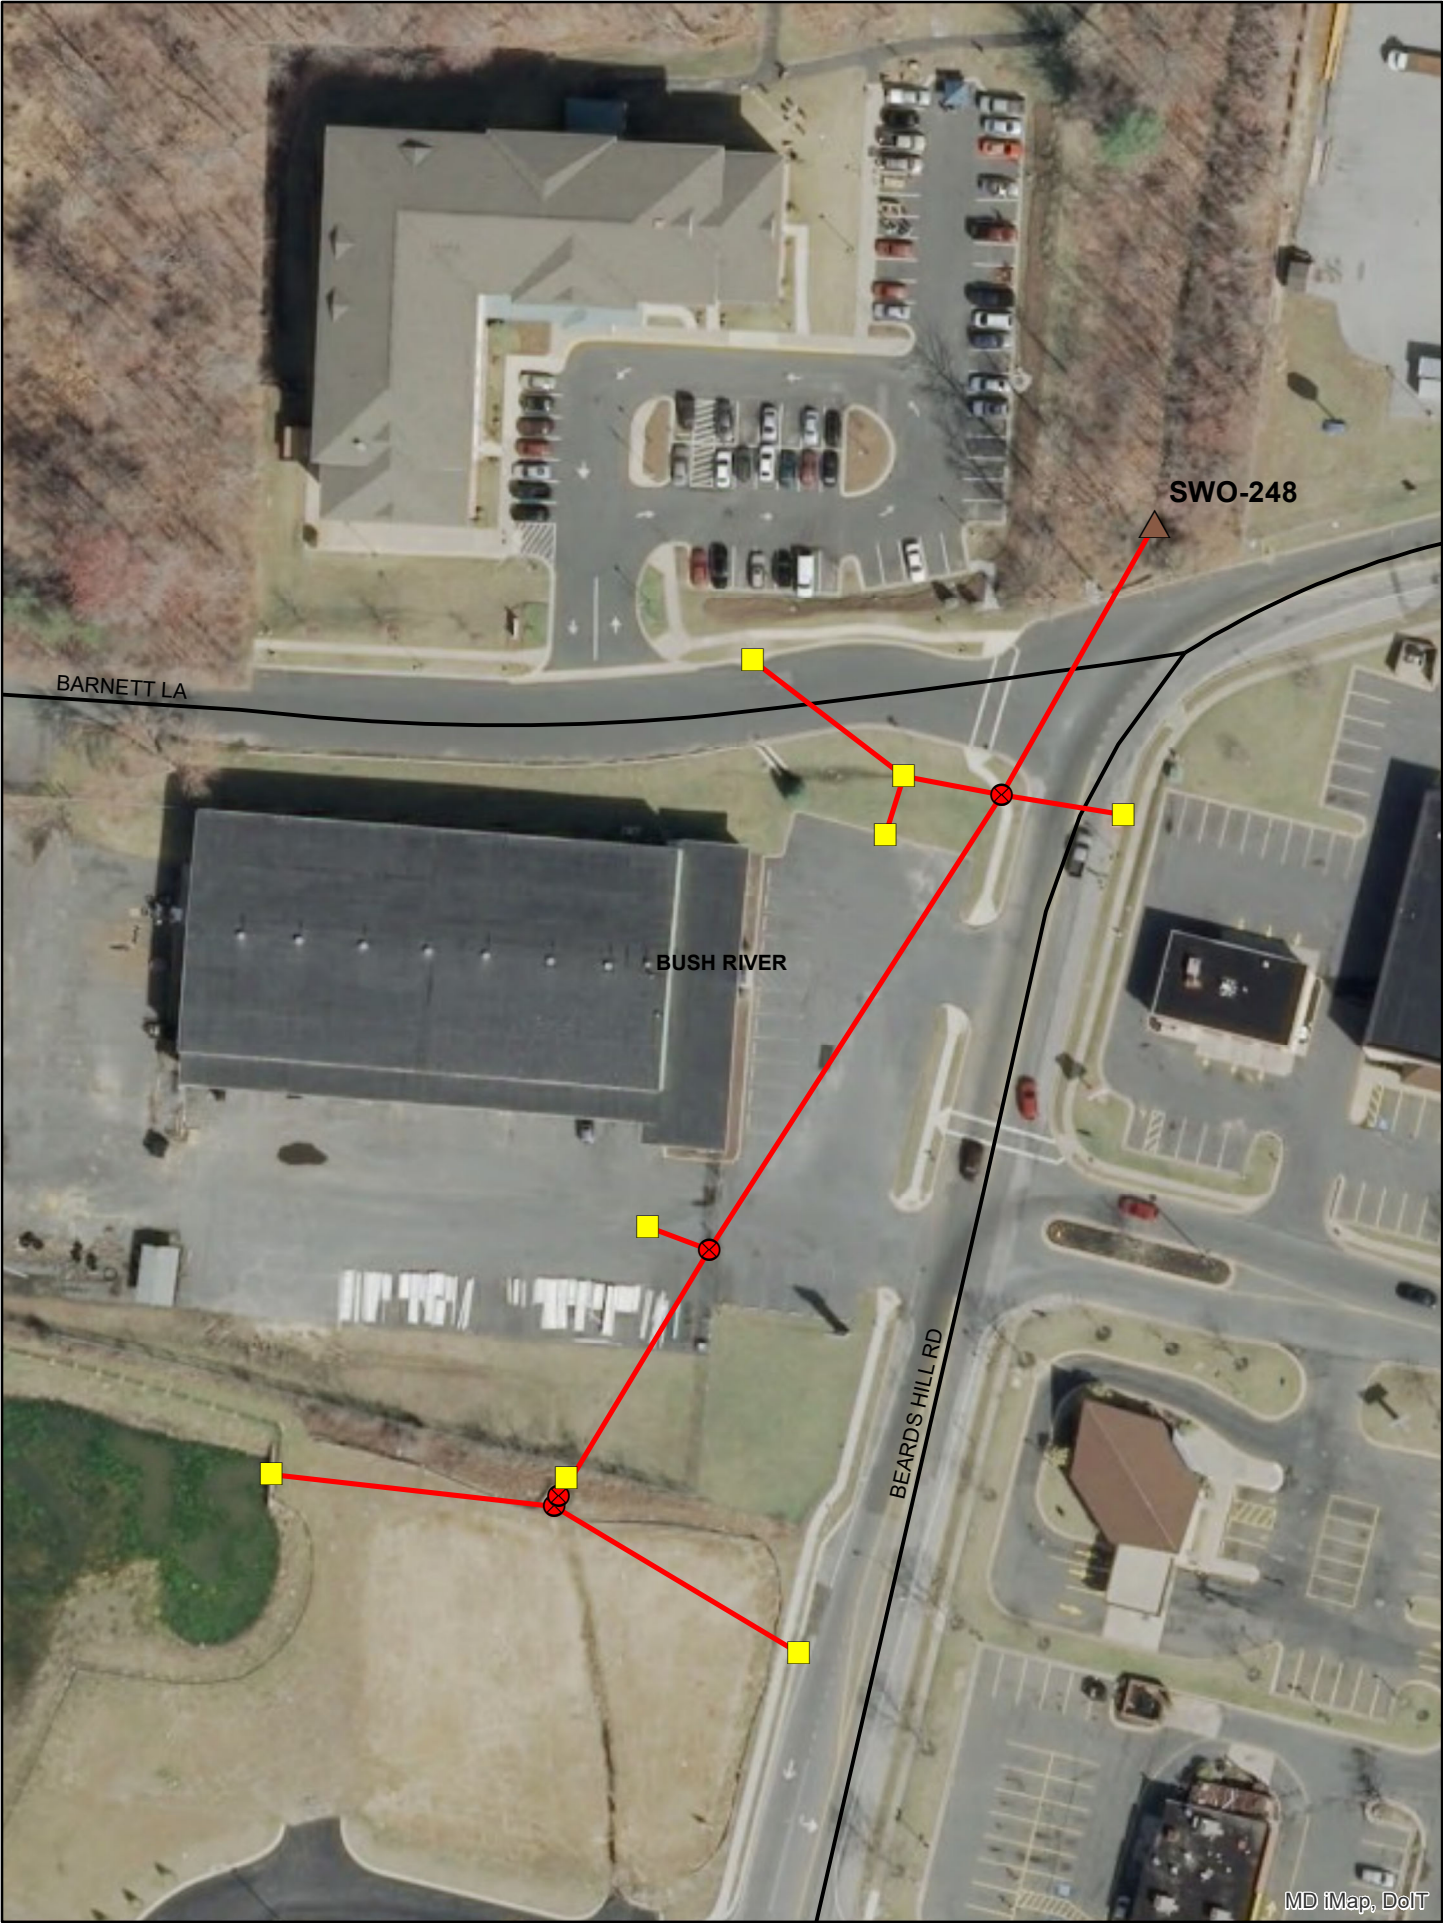
2018-5 SWO-248

☒ Flow ☐ Soap ☐ Cloudy  
☐ Staining ☐ Floatables (toilet paper, etc) ☐ Algae  
☐ Oil / Oil Sheen ☐ Dead Fish ☐ Precip w/in 72 hrs  
☐ Antifreeze ☐ Yard Waste ☐ Other: \_\_\_\_\_

Issue: Dry Weather Flow

Determination: No Evidence of Illicit Discharge; No Further Action Required.

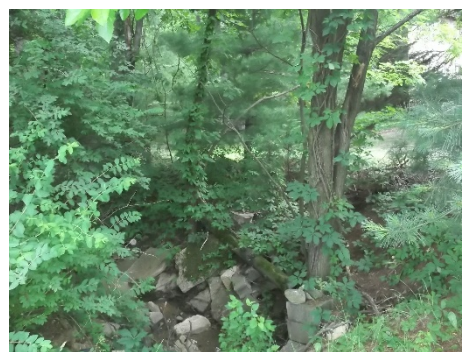
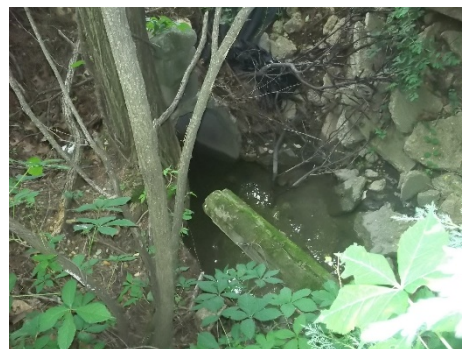
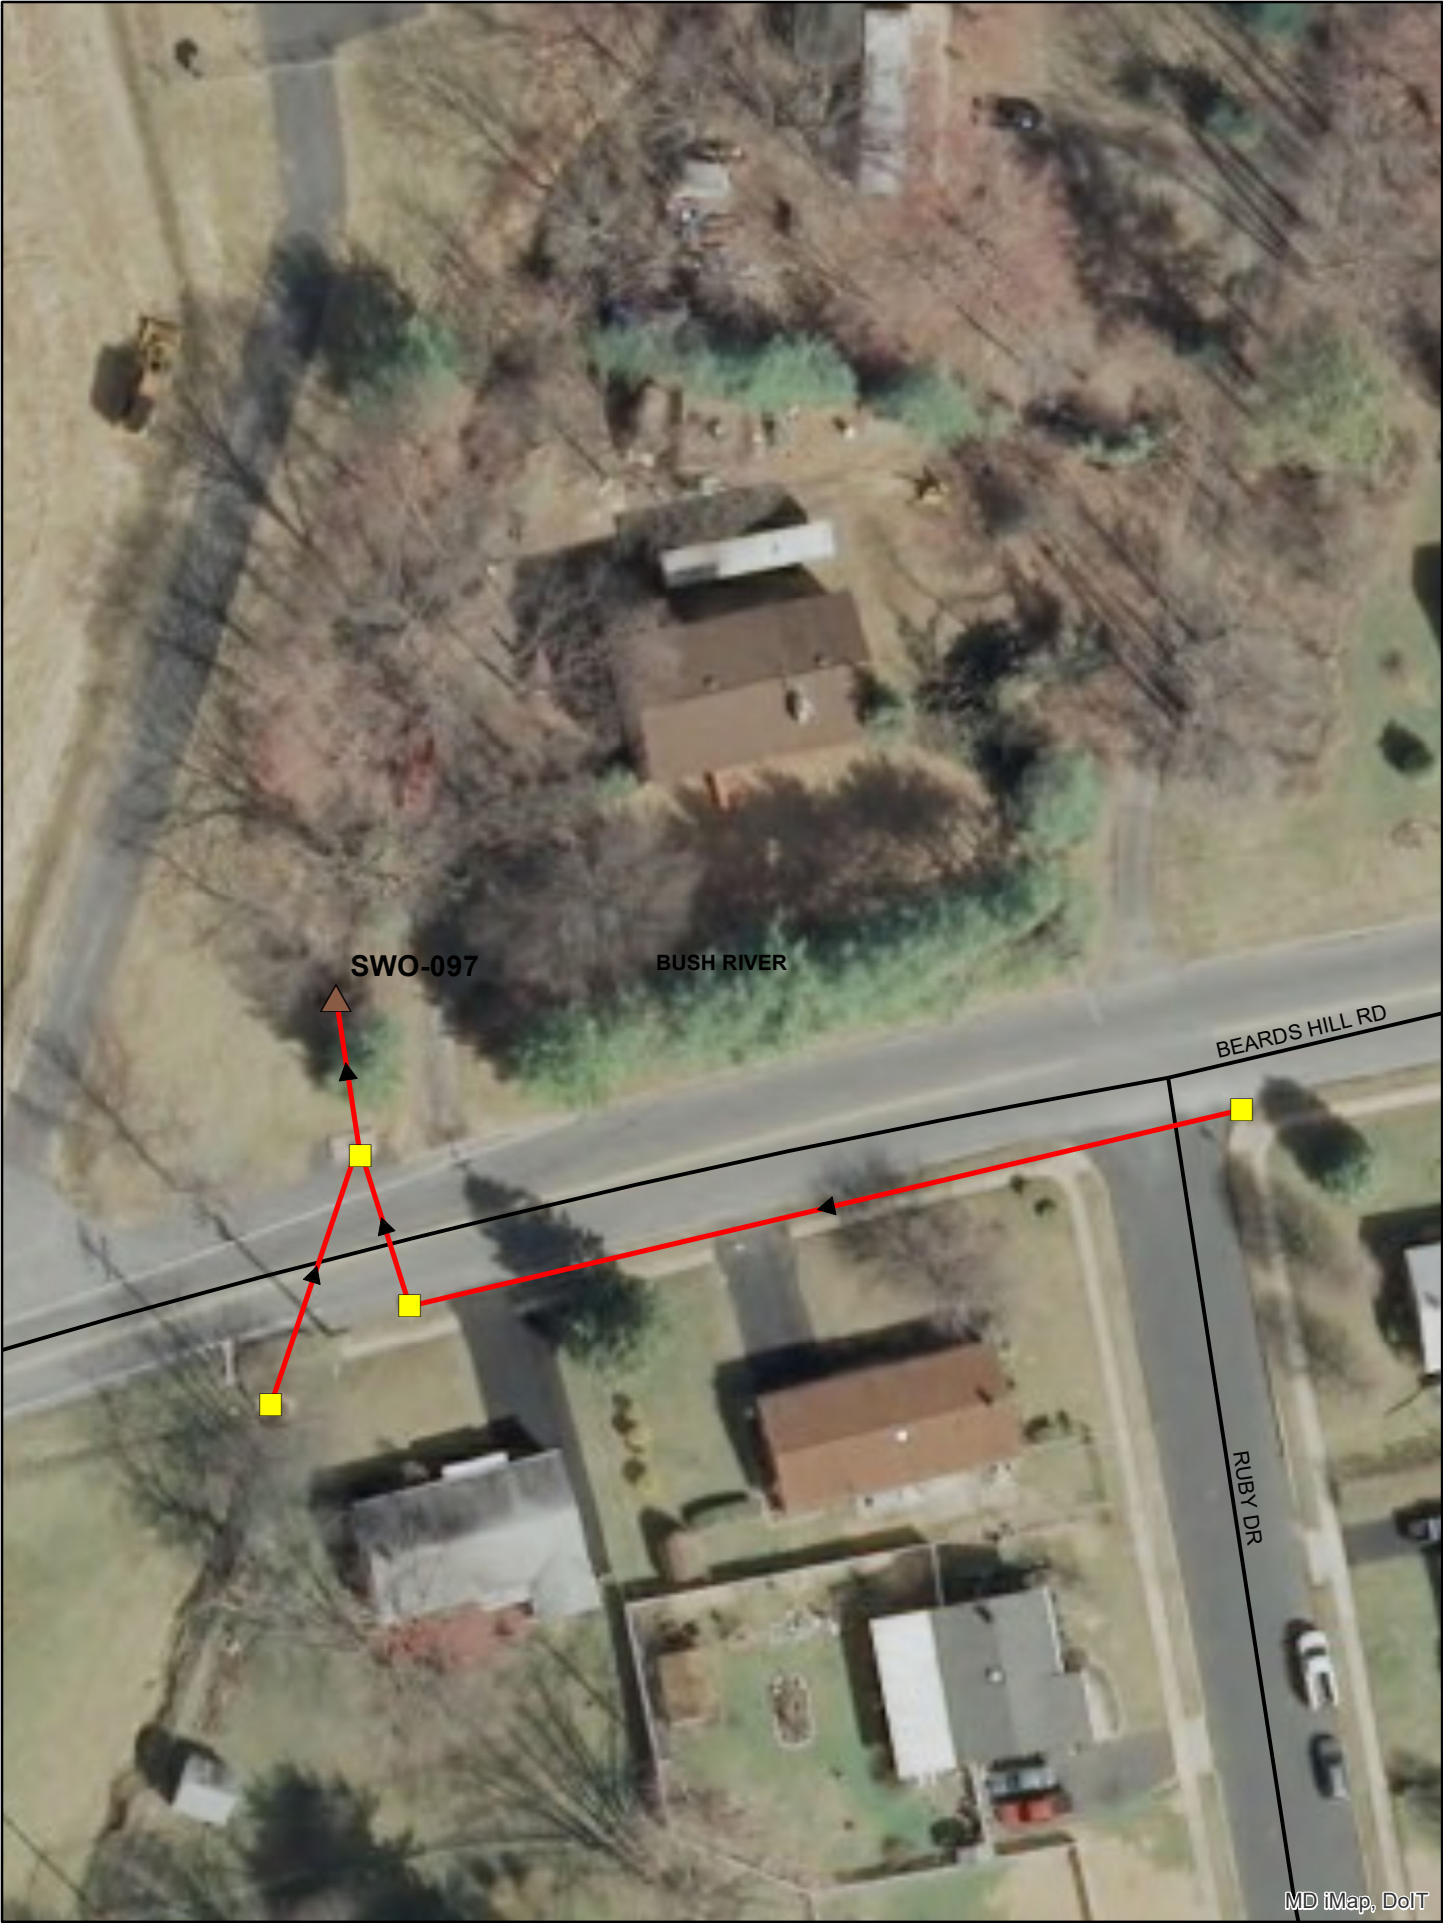
2018-6 SWO-097

☒ Flow ☐ Soap ☐ Cloudy  
☐ Staining ☐ Floatables (toilet paper, etc) ☐ Algae  
☐ Oil / Oil Sheen ☐ Dead Fish ☐ Precip w/in 72 hrs  
☐ Antifreeze ☐ Yard Waste ☐ Other: \_\_\_\_\_

Issue: Dry Weather Flow

Determination: No Evidence of Illicit Discharge; No Further Action Required.
