## **CITY OF ABERDEEN**

### **NATIONAL POLLUTANT DISCHARGE ELIMINATION SYSTEM**

## **FISCAL YEAR 2018 ANNUAL REPORT**

KCI TECHNOLOGIES, INC.

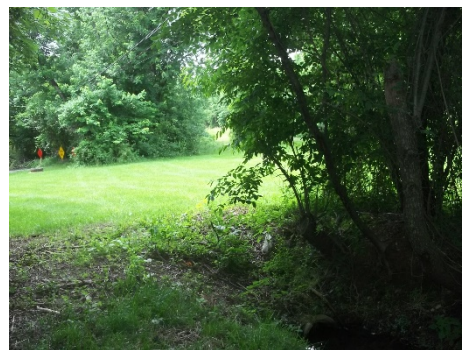
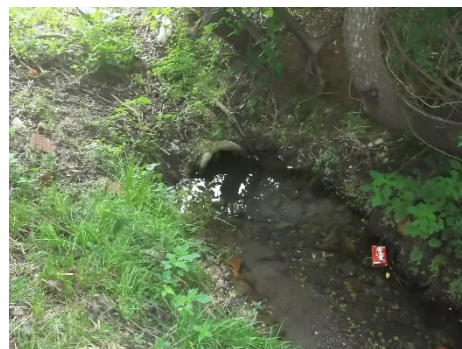
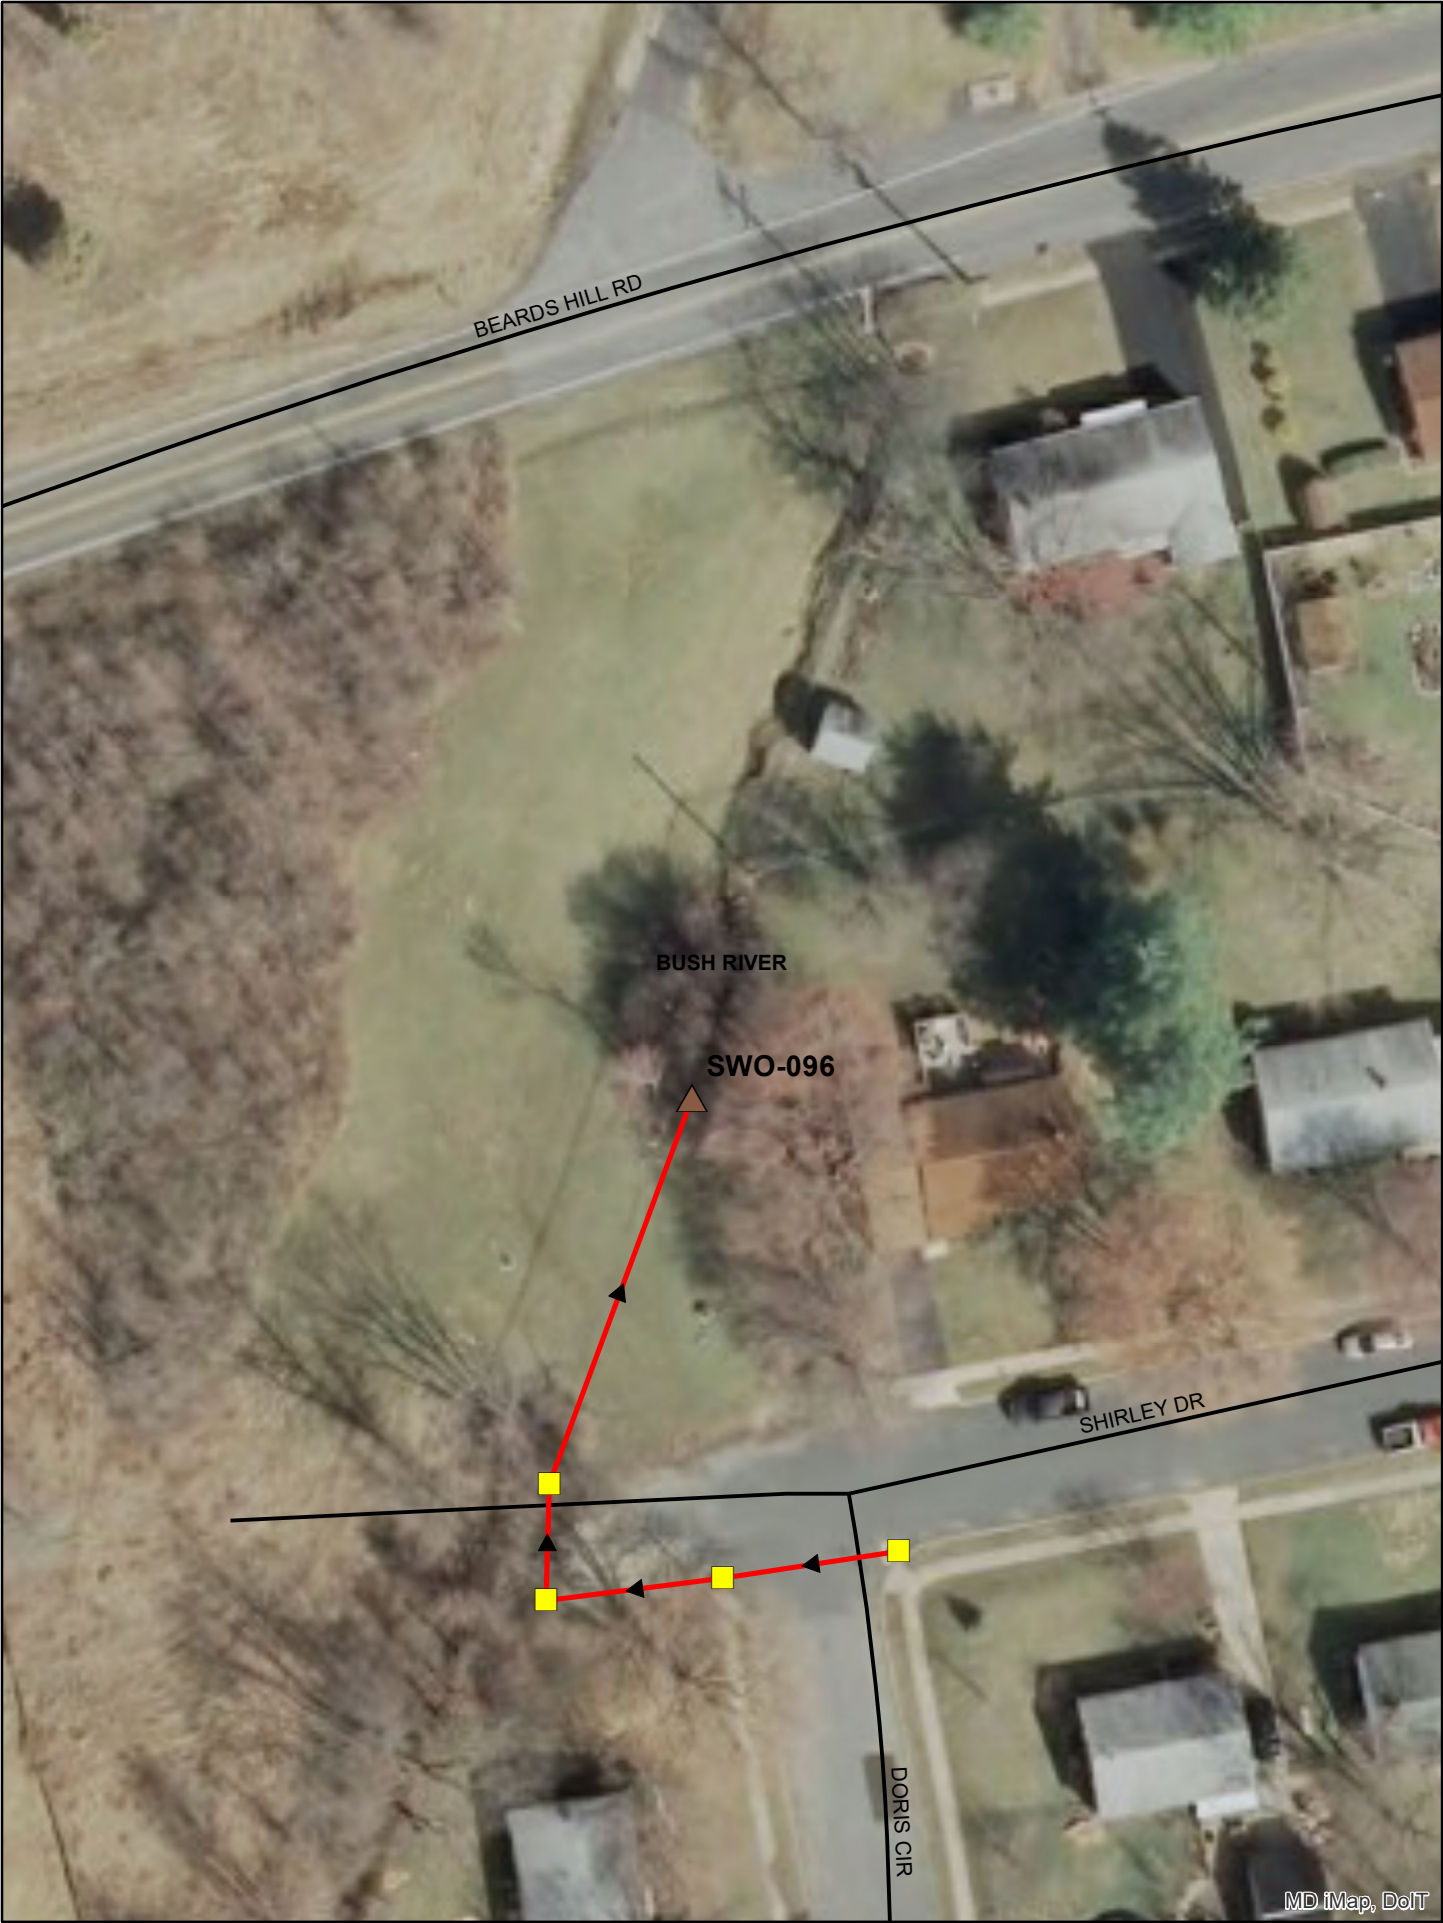
2018-7 SWO-096

☒ Flow ☐ Soap ☐ Cloudy  
☐ Staining ☐ Floatables (toilet paper, etc) ☐ Algae  
☐ Oil / Oil Sheen ☐ Dead Fish ☐ Precip w/in 72 hrs  
☐ Antifreeze ☐ Yard Waste ☐ Other: \_\_\_\_\_

Issue: Dry Weather Flow

Determination: No Evidence of Illicit Discharge; No Further Action Required.
