LEIDOS FIELD AT RIPKEN STADIUM

Assessment Report | July 8, 2022

EXECUTIVE SUMMARY

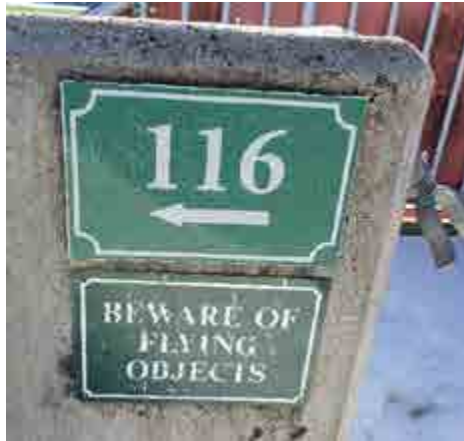
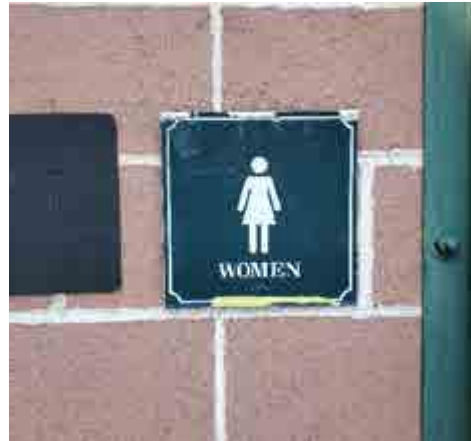
SG-1 Wayfinding and Room ID Signage

1. Wayfinding and Room ID Signage: Based on its expected lifespan and to maintain a current aesthetic, it is anticipated that the wayfinding and room ID signage are due for replacement (See Photo SG-1). **SG-1** Replace all interior and exterior wayfinding, and room identification signage on all levels of the ballpark.

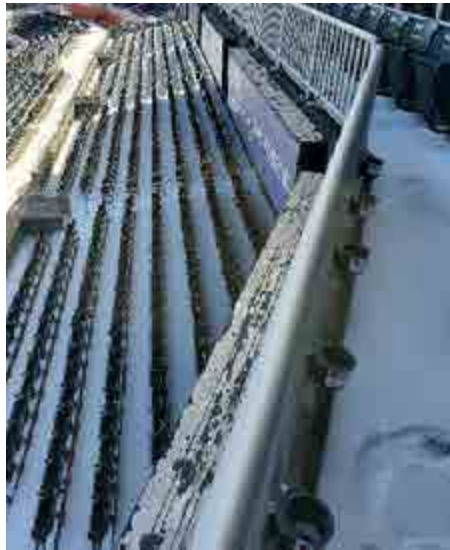
SG-2 Suite/Club Fascia Signage

2. Suite / Club Fascia Ad Signs: The backlit suite / club level fascia signage is beginning to show signs of wear and tear due to its age and UV exposure (See Photo SG-2). **SG-2** Repaint aluminum cabinets of signage.

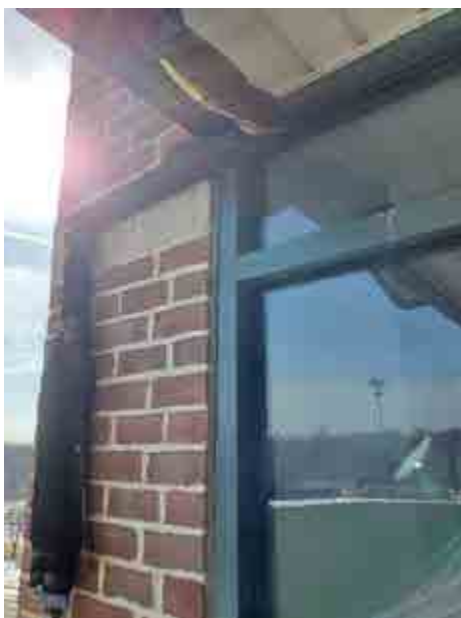
AM-2 Insulation on fire sprinkler drains

1. Door Hardware: Door hardware issues observed throughout suite and concourse level. **AM-1** Replace all damaged / failed door hardware.
2. Insulation on fire sprinkler drain downs: Existing insulation is badly damaged. **AM-2** Replace insulation in fire sprinkler drain downs at exposed ends of Suite/Club level.

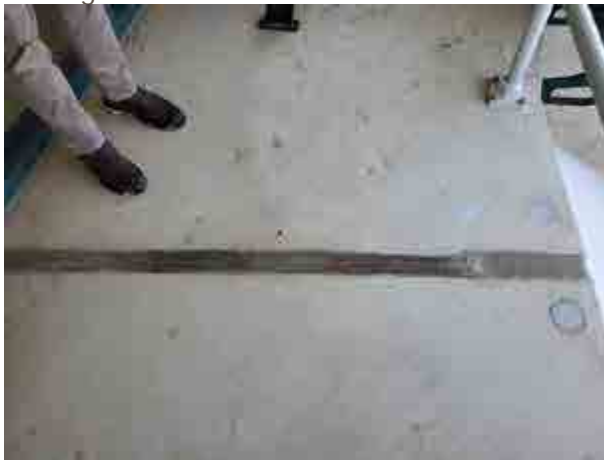
ASB-3 Expansion joints at Suite/Club level

- a. Aisle Nosings: Exterior aisle stairs do not currently have anti-slip nosings installed. **ASB-1** Add anti-slip nosings at each aisle step throughout seating bowl (Lower Bowl and Suite Level).
- b. Aisle Nosings: **ASB-2** Replace step nosings at end of service life.
- c. Expansion Joints: **ASB-3** Replace soft expansion joints at Suite/Club level seating tiers in two locations.

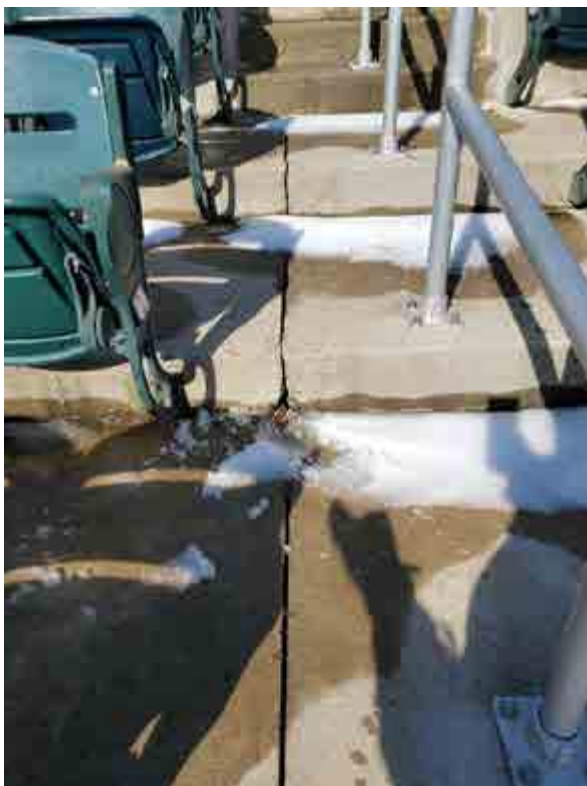
ASB-4 CIP control joints

- d. Control Joint Sealant: **ASB-4** Add soft sealant at control joints in cast in place concrete lower seating bowl.

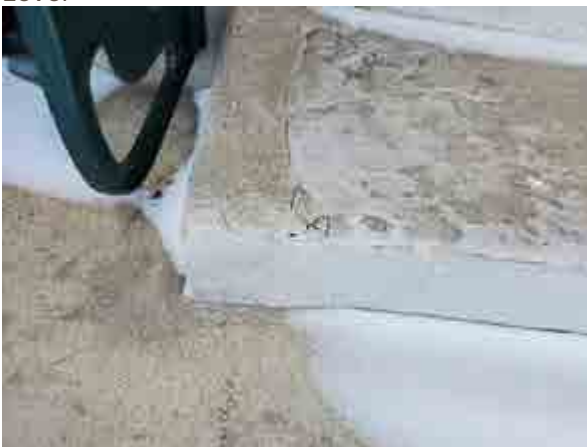
ASB-5 Suite/Club Level aisle steps

- e. Concrete Patch / Repair: **ASB-5** Patch/repair aisle steps on Suite/Club Level

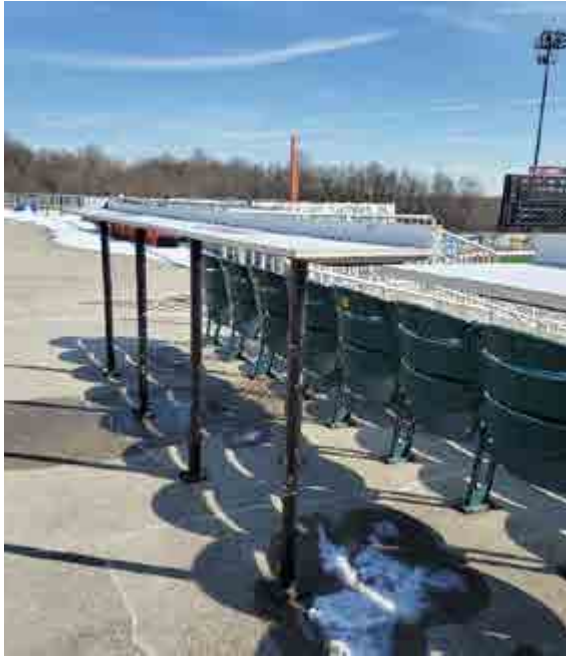
ASB-9 Concourse drink rails

- i. Concourse Drink Rails: **ASB-9** Repaint steel drink rail bases and replace painted wood tops. *Note: We recommend tops be replaced with more durable material, better suited for constant outdoor exposure such as stainless steel, quartz or even Trex decking.*

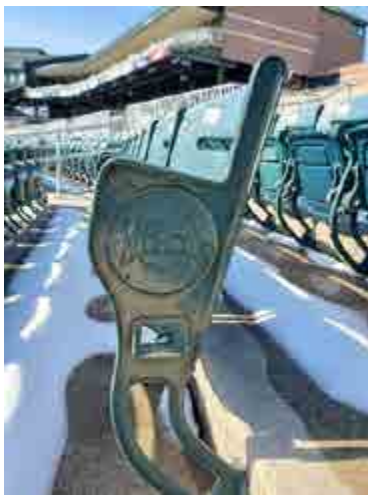
ASB-10 Seating Row Letters

- a. Seating Row Letters: Many locations of missing seat row letters, some instances replaced with temporary sticker. **ASB-10** Replace all aluminum row numbers throughout seating bowl (Lower bowl and Suite Level).

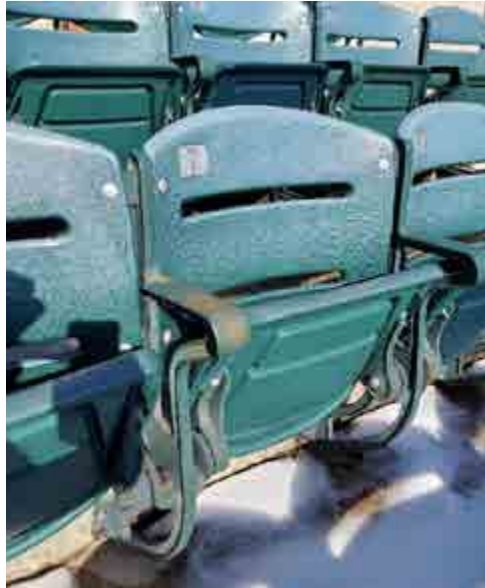
The majority of stadium seats are original. The seats are near the end of their service life and are requiring more and more maintenance annually. Broken seat pans and backs were noted throughout the seating bowl and have reportedly been a constant maintenance headache over the past few years. The paint on the cast iron stanchions is badly faded or has failed and is beginning to rust.

Repainting is not an option because of the factory finish. The end row stanchions are missing the row letters in many instances. And the plastic cupholders all need replaced.

- d. Cupholders: Cupholders are fading due to UV light exposure, some have been broken off due to heavy use. **ASB-13** Replace faded and missing cupholders.
- e. Seating Replacement: The majority of stadium seats are original and near the end of their service life. Broken seat pans and backs were noted throughout the bowl and have reportedly been a constant maintenance issue over the past few years. The paint on the cast iron stanchions is badly faded or has failed and is beginning to rust. Repainting is not an option because of the factory finish. **ASB-14** Replace all seats including stanchions and all components.

ASB-14 Rusted seat stanchions

The original seating manufacturer is no longer in business, so replacement parts are difficult to source. Full replacement of all seats (and cupholders) is recommended in the near-term.

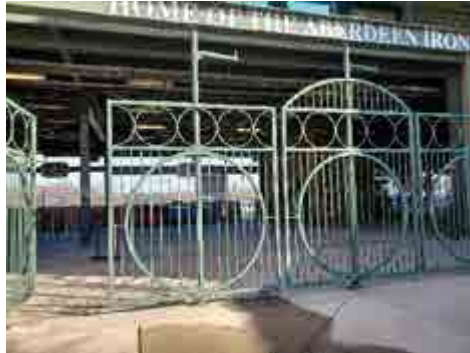
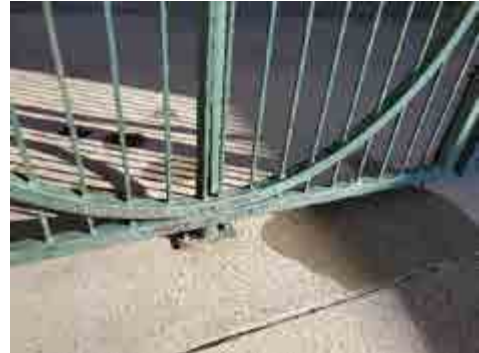
ASE-2 Entry Gates

2. Entry Gates: Paint on entry gates is failing and starting to rust. **ASE-2:** Clean/repaint custom steel entry gates behind home plate.

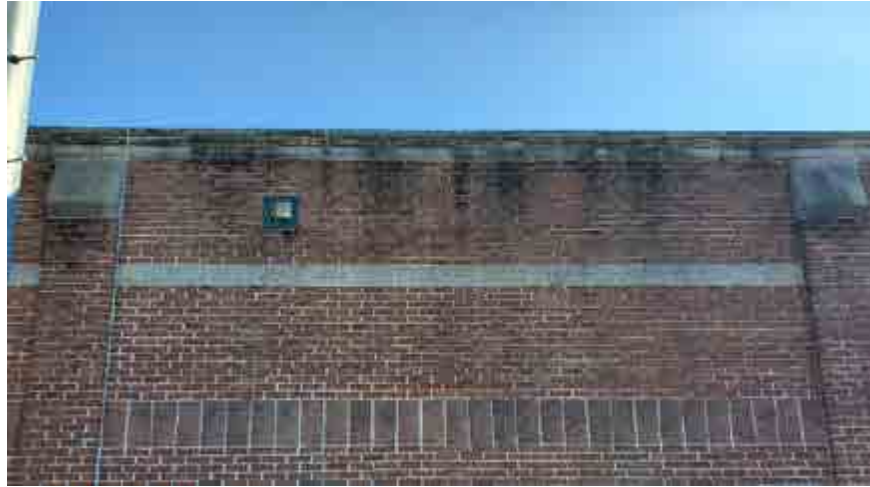
ASE-7 Masonry Parapet Caps

6. Masonry Walls: See note above regarding moisture infiltration. Horizontal mortar joints failing on various locations along the façade. **ASE-6** Repoint some areas of masonry walls where mortar has deteriorated.
7. Masonry Parapet Caps: **ASE-7** Clean masonry parapet caps and repoint joints between blocks to help mitigate moisture infiltration issues.

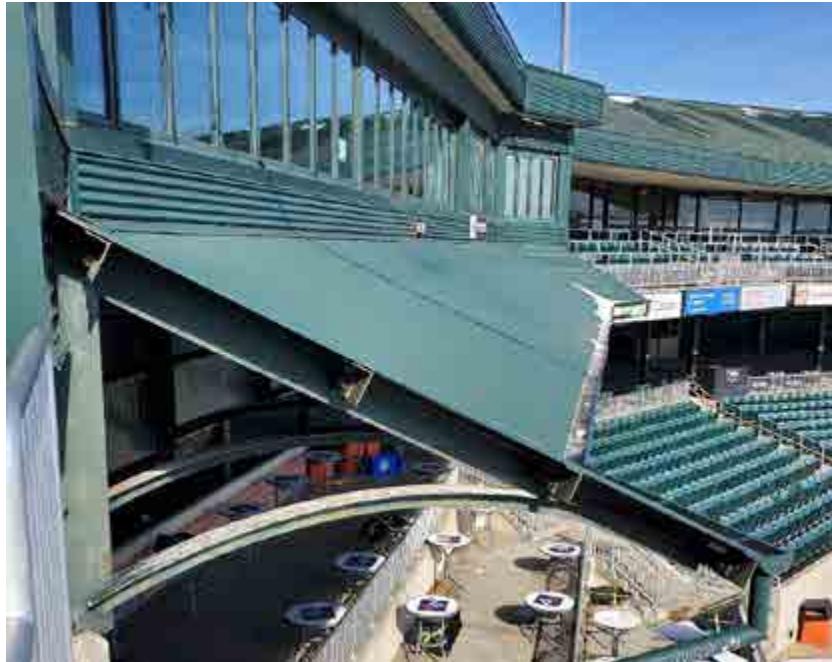
ASR-3 Leaf Screen

- a. Membrane Roofs: Membrane roofs are original and approximately 20 years old. **ASR-1** Replace all EPDM membrane roofs. This assumes +/- 25-year lifespan.
- b. Metal Roof Gutters: **ASR-2** Repair damaged and/or loose roof gutters on corrugated metal canopies at Ticket Office and Admin. Offices to maintain positive slope toward drain leaders.
- c. Leaf Screens at Roof Gutters: **ASR-3** Add rigid leaf screens to gutters of corrugated metal canopy over Home Plate Club seating area to keep foul balls out.

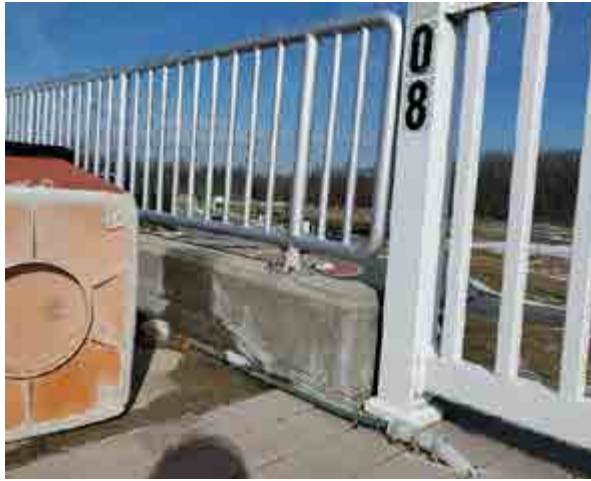
ASCE-1 Concrete Repair

- a. Concrete Repair: **ASCE-1** Repair cracked concrete curb around perimeter of the LF party/kid's play zone area

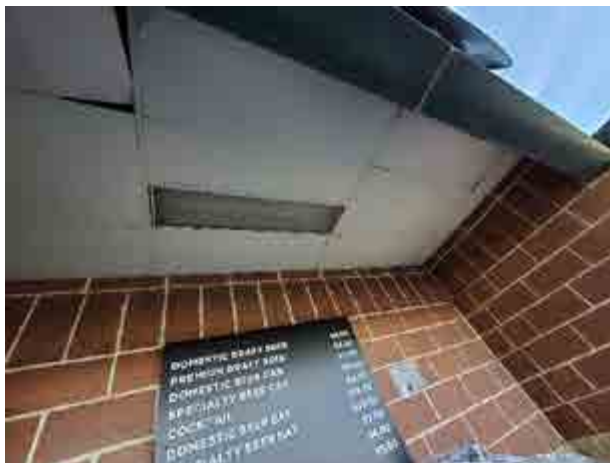
ASCE-2 Alcove Ceilings

- b. Alcove Ceilings: **ASCE-2** Replace 2x4 suspended ceiling in "portable" alcoves around perimeter of concourse with plaster or exterior grade ceilings.

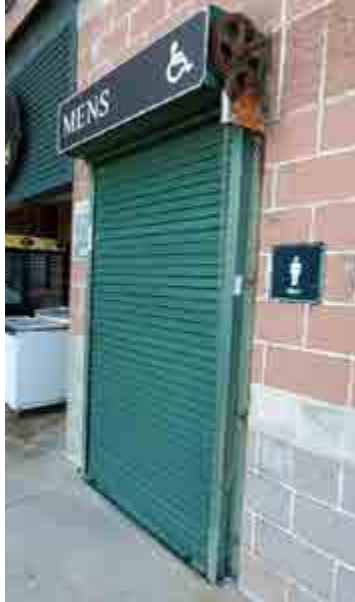
ASCE-3 Overhead Doors

- c. Overhead Doors: **ASCE-3** Repaint exposed steel supports and sheet metal enclosures for overhead doors at entries to public restrooms and add sheet metal caps to protect exposed gear mechanism.

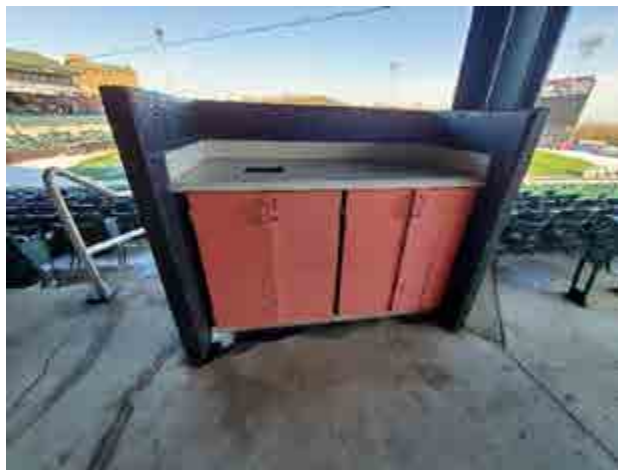
ASCE-4 Condiment stations

- d. Condiment Stations: Condiment station doors and hardware have failed and no longer close. **ASCE-4** Replace condiment station millwork within CMU enclosure.

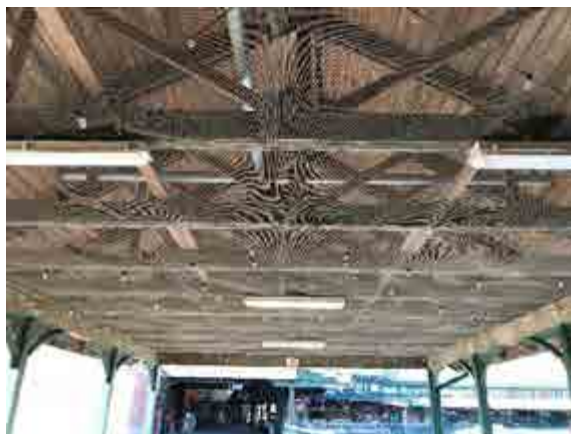
ASCE-7 Bird Netting

- a. Exterior CMU Wall: Several cracks were observed in the exterior face of the CMU wall. **ASCE-6** Seal cracks in wall.
- b. Bird Netting: The existing overhead bird netting in the Good Hops area is damaged with large holes visible. **ASCE-7** Replace bird netting.

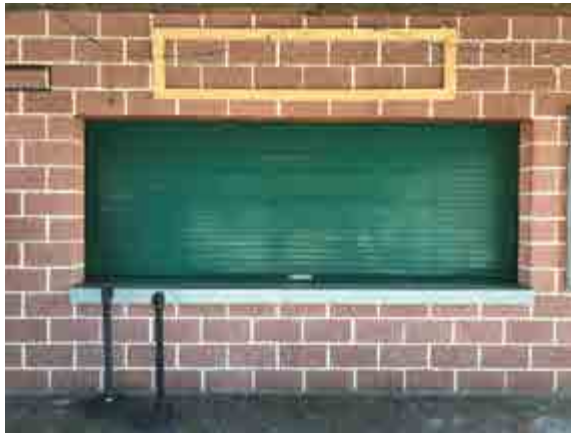
- c. **ASCE-8** Not Used
- d. Steel Structure: The paint is faded and/or peeling. **ASCE-9** Prepare, prime, and paint the steel structure.
- e. Overhead Door: The overhead door is beginning to show signs of wear and tear. **ASCE-10** Replace overhead coiling door in-kind.

ASCE-10 Overhead Door a concession counter

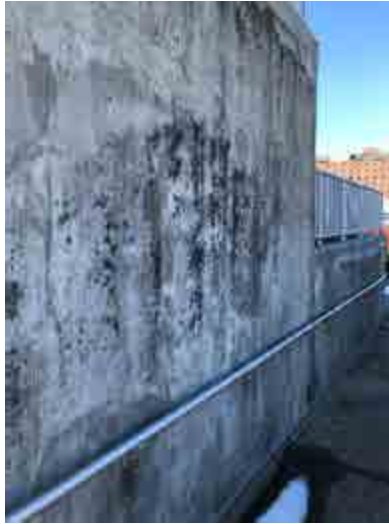
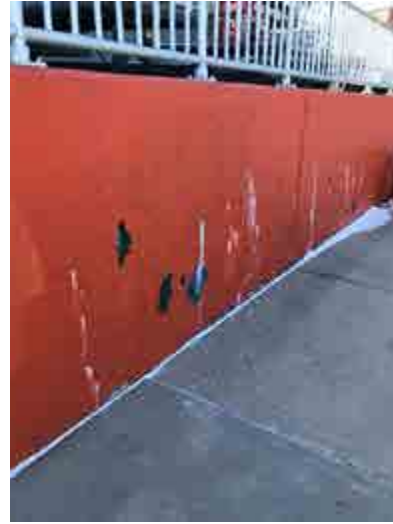
ASCE-12 Concrete Walls

- f. Metal Roof Soffit: **ASCE-11** Anticipated replacement of metal roof soffit at end of life expectancy.
- g. Concrete Walls: Signs of significant moisture infiltration are visible on the concrete retaining walls at the seating areas around Good Hops. **ASCE-12** Further investigate the cause of this water infiltration. For estimating purposes, assume the following: Apply traffic coating to entire area around Good Hops; Remove paint from affected vertical concrete surfaces; Patch concrete wall where damaged; Apply a breathable concrete sealer or paint to all vertical concrete faces around Good Hops.

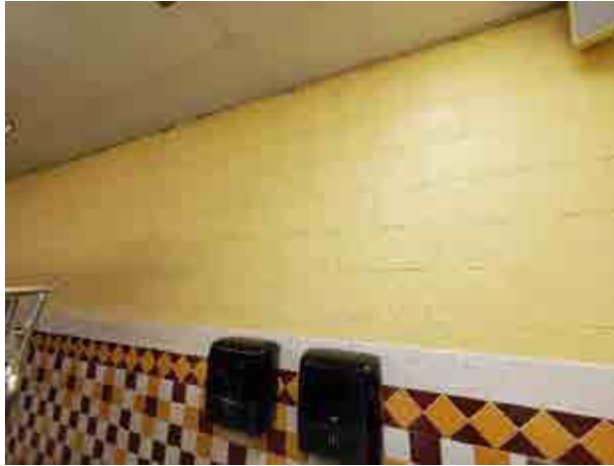
ASCI-6 *Paint Walls*

- a. Paint Walls: Walls exhibited signs of moisture migration through the wall. **ASCI-6** Repaint all walls with epoxy paint.

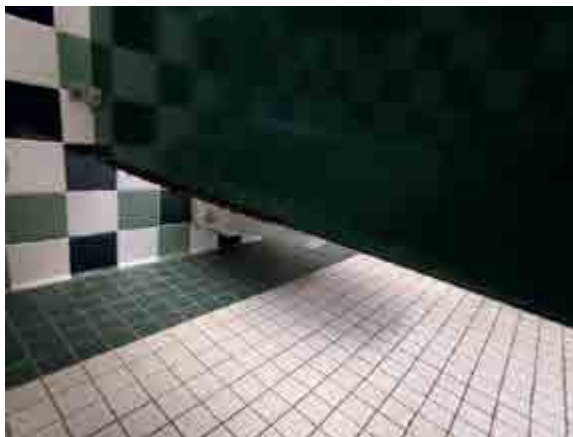
- b. Ceiling Tiles: **ASCI-7** Replace 2x4 suspended ACT ceiling tiles.
- c. Suspended Ceiling System: **ASCI-8** Replace 2x4 suspended ceiling grid and tiles.
- d. Replace Tile Walls: Walls exhibited signs of widespread water damage
ASCI-9 Demo and replace wall tile as a result of water infiltration through CMU exterior wall
- e. Vanity Counters: **ASCI-10** Replace plastic laminate vanity counters
- f. Toilet Partitions: **ASCI-11** Repair corrosion at bottom of baked enamel toilet partitions (or replace panels).

ASCI-11 Corrosion at *Toilet Partitions*

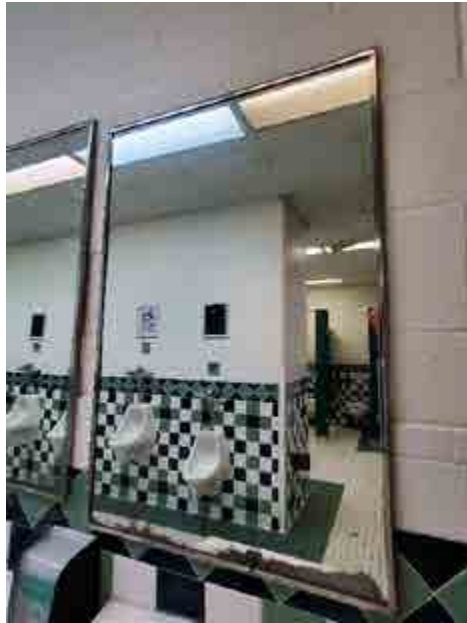
- g. Mirrors: **ASCI-12** Replace individual framed mirrors above lavatories.

ASCI-12 Mirror delamination

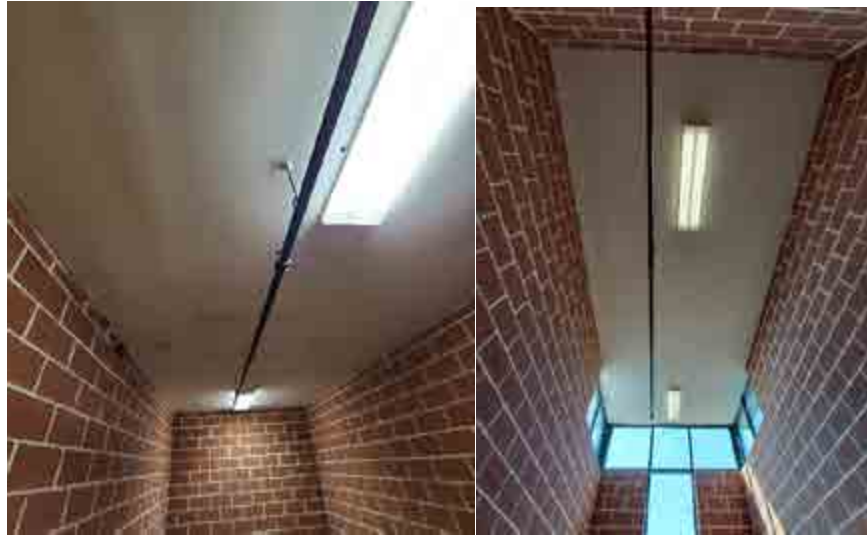
ASCI-14 *GWB Ceilings*

- a. GWB Ceilings: **ASCI-15** Repair water damaged GWB ceilings at stair towers.

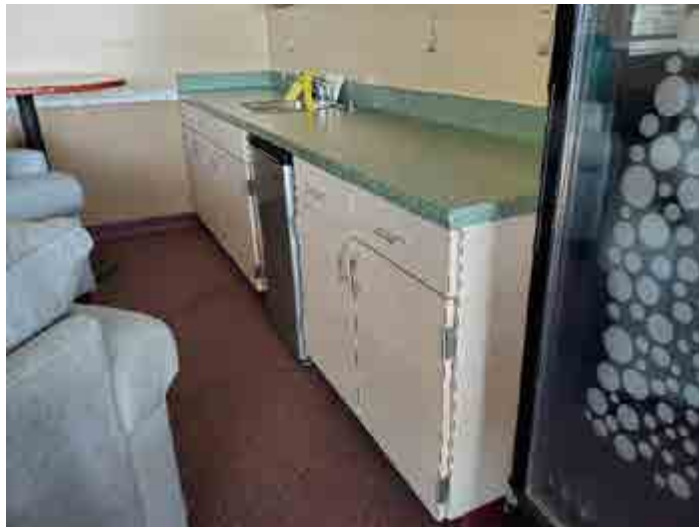
ASCI-17 *Suite Millwork*

- a. Suite Walls: **ASCI-15** Repaint all GWB walls including interior doors.
- b. Suite Toilet Room Walls: **ASCI-16** Replace 4x4 glazed tile walls.
- c. Suite Millwork: **ASCI-17** Replace plastic laminate millwork in-kind.

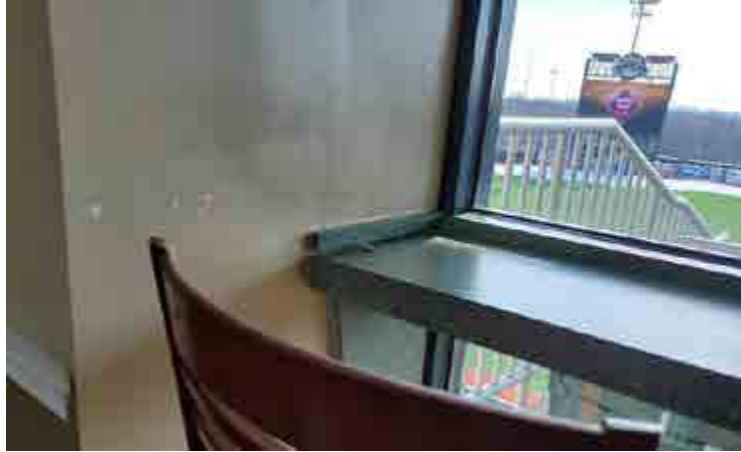
ASCI-18 Suite Drink Rails

- d. Suite Drink Rails: **ASCI-18** Replace plastic laminate drink rails in-kind.

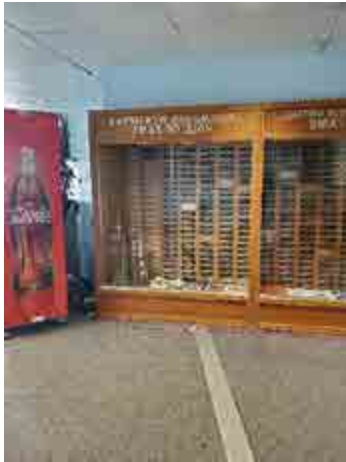
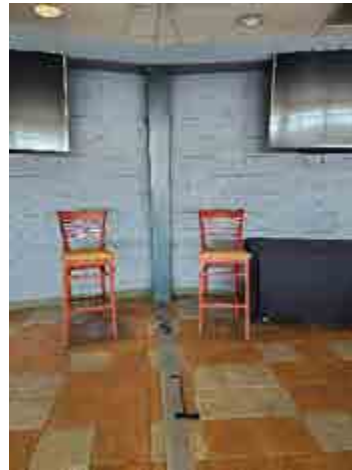
ASCI-32 Expansion joint covers

- a. Club Walls: **ASCI-25** Repaint all GWB walls including interior doors.
- b. Club Ceilings: **ASCI-26 - ASCI-28** Patch damaged GWB soffits and repaint. Replace 2x4 suspended ceiling tiles. Within 10 years, replace ceiling grid and tiles.
- c. Club Floors: **ASCI-29 – ASCI 31** Replace localized areas of 4" h. rubber base where peeling or already removed. Within 5 years replace carpeted areas and rubber base. Within 10 years, replace tiled areas and rubber base.
- d. Club Expansion Joint Covers: **ASCI-32** Replace floor and wall expansion joint covers.

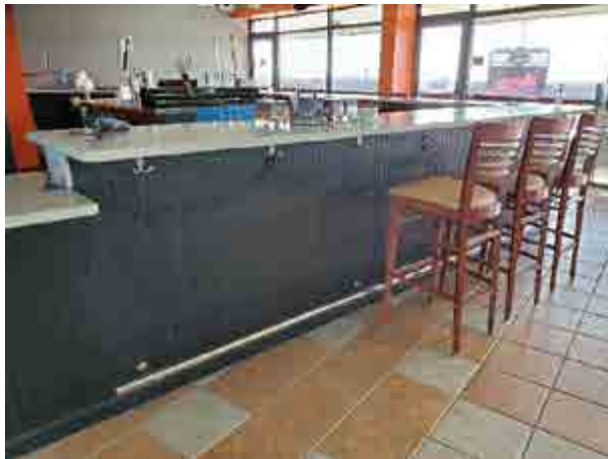
ASCI-33 *Club Concession Counters*

- e. Club Concession Counters: **ASCI-33** Replace quartz concession/bar tops.

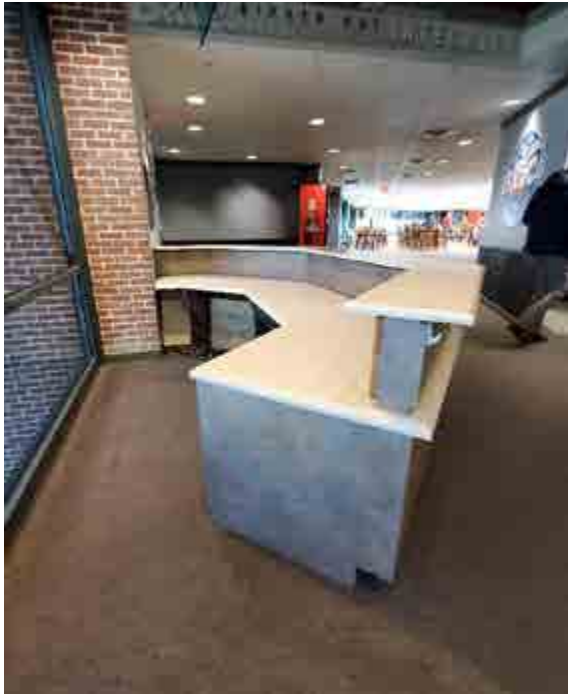
ASCI-35 Club Concierge Millwork

- f. Club Concession Millwork: **ASCI-34** Repair/repaint concession/bar die walls.
g. Club Concierge Millwork: **ASCI-35** Replace concierge station millwork.

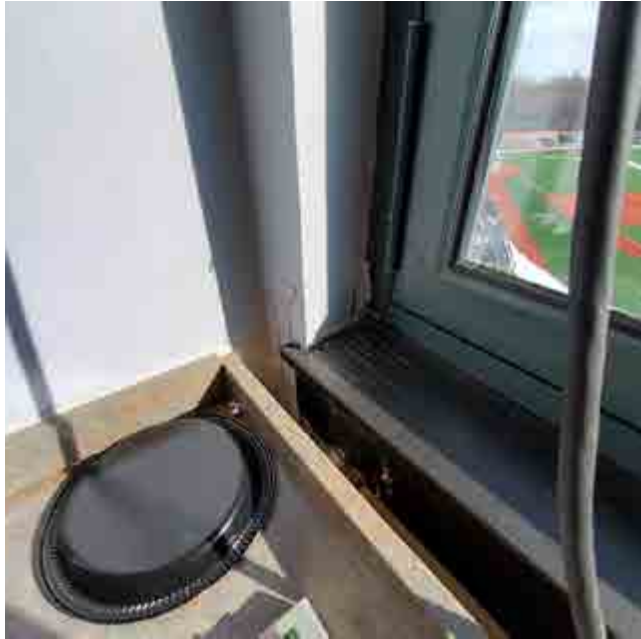
ASCI-43 and 44 Press Box windows sills

- a. Press Box Walls: **ASCI-42** Repaint all GWB walls including toilet rooms and interior rooms.
- b. Press Box Windows: Evidence of moisture infiltration is evident at windows. **ASCI-43 and ASCI-44** Repair window weather seals in TV and Home Radio Booths. Repair painted wood window sills.

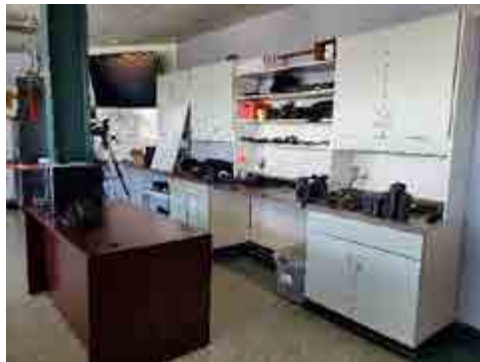
ASCI-48 Press Box millwork

- c. Press Box Ceilings: **ASCI-45 and ASCI-46** Replace 2x4 ceiling tiles within 0-1 year. Replace 2x4 suspended ceiling grid and tiles within 1-5 years.
- d. Press Box Counters: **ASCI-47** Replace plastic laminate work counters (along windows and back counter).
- e. Press Box Millwork: **ASCI-48** Replace plastic laminate upper/lower cabinets at back of Writing Press area and on side wall.

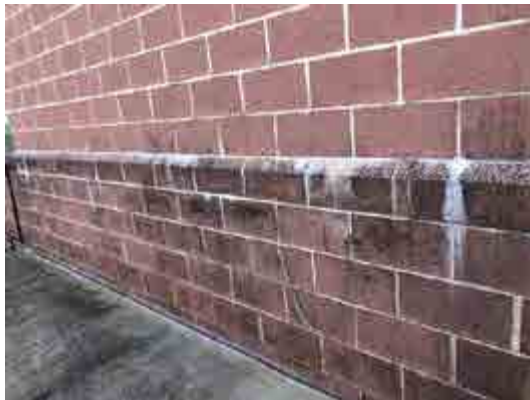
AHCE-1 Exterior CMU Wall Water Table

- a. Exterior CMU Wall Water Table: The exterior CMU wall water table on most exterior facades of the Home Clubhouse is deteriorating to the point where coarse aggregate is exposed. Signs of moisture infiltration such as efflorescence, algae, and an unverified black growth on and/or below this water table course are visible in many locations. In some cases, mortar joints are also missing or damaged at many of these walls. **AHCE-1** Subsurface investigation is recommended in strategic locations to determine the root cause(s) and develop an appropriate fix. For pricing purposes, assume the following fix: Remove a portion of the water table course and install stainless steel flashing and cast stone cap. Repair/install through-wall flashing, seal penetrations, reset coping in a bed of mortar raked back at edges for backer rod and sealant. Sealant to be installed in vertical joints with weeps at 24" o.c.

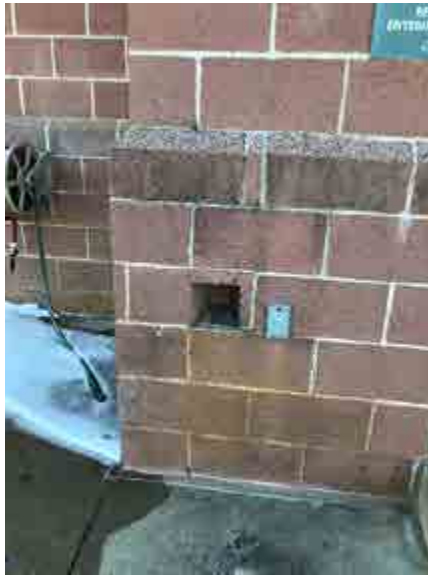
AHCE-3 Masonry Infill

- b. Masonry Joints: Mortar is damaged and/or missing in several brick joints around the exterior of the building. **AHCE-2** Spot re-point damaged/missing masonry joints.
- c. Masonry Infill: A portion of one CMU is missing on the exterior façade. **AHCE-3** Infill missing portion of CMU to match existing.

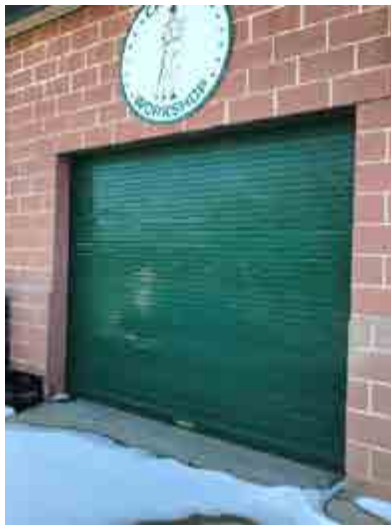
AHCE-5 Overhead Coiling Door

- d. Gutters and Downspouts: The gutters and downspouts are nearing the end of their life expectancy. **AHCE-4** Replace the gutters and downspouts in-kind.
- e. Overhead Coiling Door: Overhead coiling door shows signs of damage. **AHCE-5** Replace overhead coiling door in-kind.

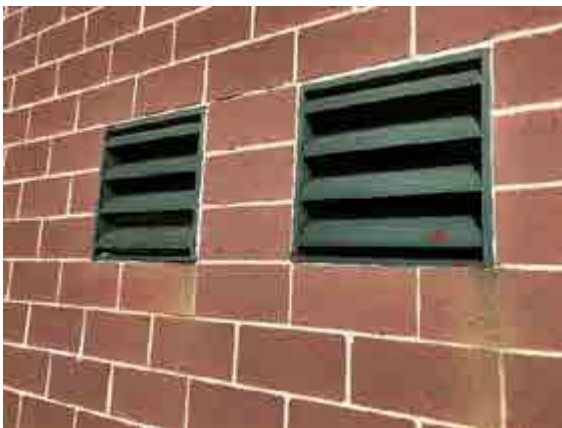
AHCE-6 Exterior Louvers

- f. Exterior Louvers: The paint is faded. **AHCE-6** Repaint exterior louvers.

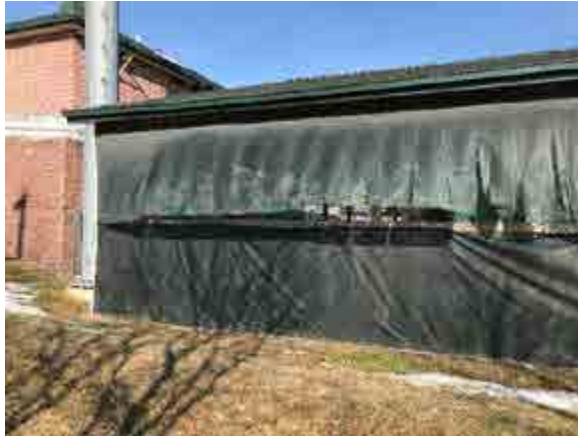
AHCE-10 Windscreen

- b. Wind screen: Wind screen material is damaged. **AHCE-10** Replace wind screen material in-kind.

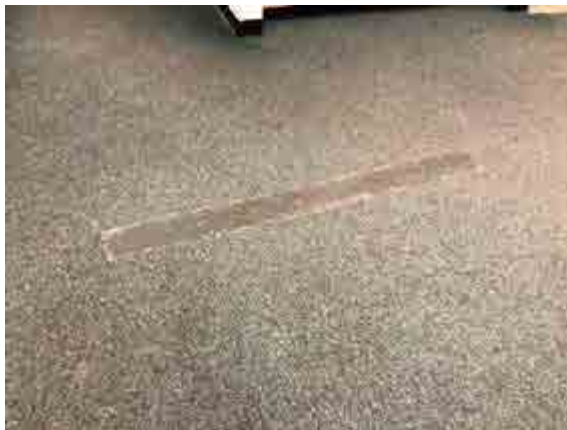
AHCI-1 Carpeting

- a. Carpeting: Carpet shows significant signs of wear and tear and is ready for replacement. **AHCI-1** Replace all carpeting within clubhouse with new carpet tile.

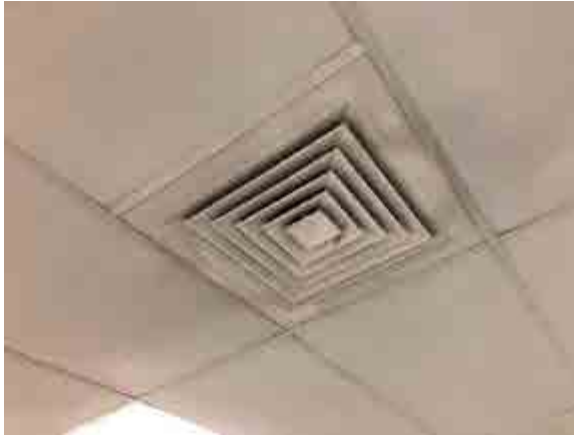
AHCI-5 Ceiling Tile and Grid

- b. Carpeting: **AHCI-2** Replace carpeting at anticipated end of life expectancy.
- c. Wall Base: Rubber base is delaminating in some places. **AHCI-3** Replace rubber wall base in kind during carpeting replacement.
- d. Wall Base: **AHCI-4** Replace rubber wall base at anticipated end of life expectancy.
- e. Ceiling Tile and Grid: Ceiling tile and grid are showing signs of wear and tear and is ready for replacement. **AHCI-5** Replace all ceiling tile and grids within clubhouse in-kind.

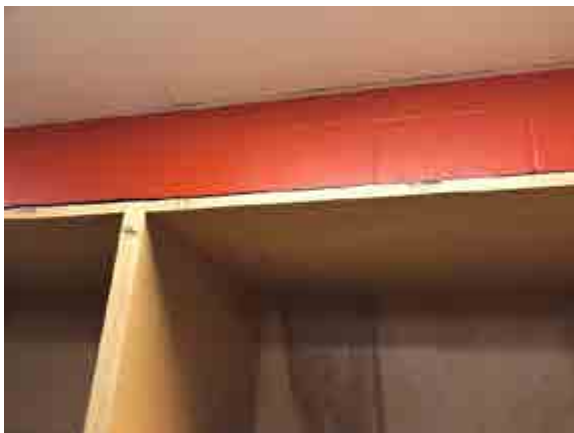
AHCI-12 Lockers

- a. Lockers: Lockers are showing signs of wear and tear such as dents. **AHCI-12** Replace all lockers in-kind.

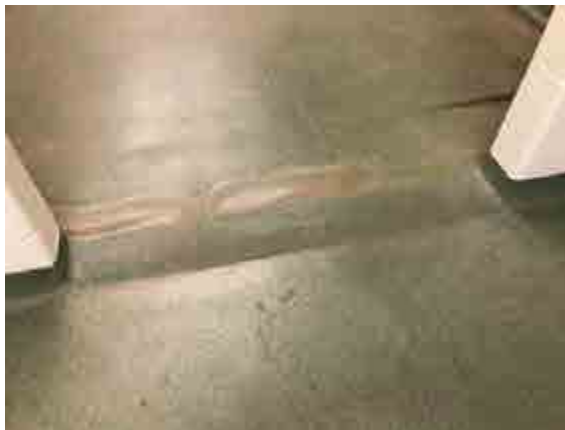
AHCI-19 Epoxy Flooring

- a. Epoxy Flooring: Existing epoxy flooring was observed to be failing in several locations. **AHCI-19** Remove all remaining epoxy flooring and replace flooring, base, and drain grates.

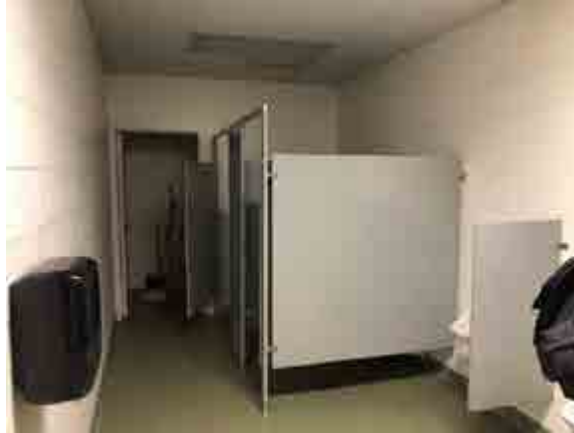
AHCI-25 Toilet Partitions

- f. Toilet Partitions: Toilet partitions are showing signs of wear and tear. **AHCI-25** Replace toilet partitions in-kind.

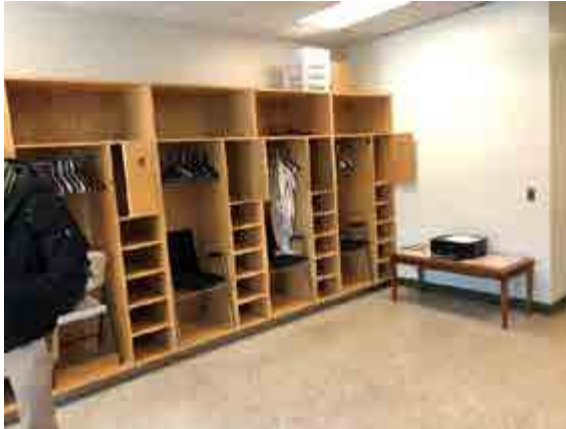
AHCI-34 Lockers

- a. Lockers: Lockers: Lockers are showing signs of wear and tear such as dents and water damage. **AHCI-34** Replace all lockers in-kind.

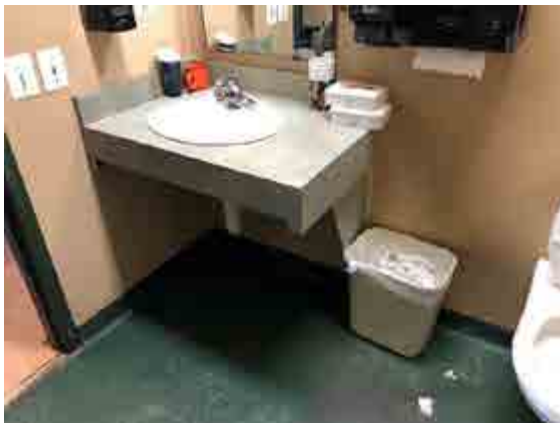
AHCI-38 to AHCI-39 Countertops and Sinks/Faucets

- b. Epoxy Flooring: Existing epoxy flooring was observed to be failing in several locations. **AHCI-35** Remove all remaining epoxy flooring and replace flooring, base, and drain grates.
- c. Tile walls and floors: Tile walls and floors show signs of wear and tear. **AHCI-36 to AHCI-37**. Replace tile floor, wall, base, and drain grates.
- d. Countertops and Sinks/Faucets: Laminate countertops are showing signs of wear and tear. **AHCI-38 to AHCI-39** Replace with solid surface countertops, integral backsplash, undermount sinks, faucets, and new countertop brackets.

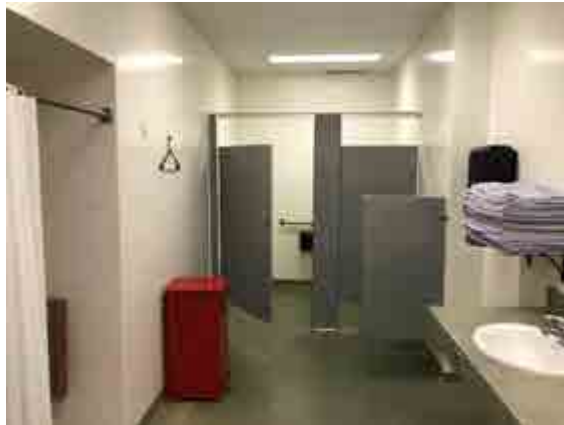
AHCI-43 Toilet Partitions

- e. Toilet Room Accessories: Toilet room accessories are nearing the end of their life expectancy. **AHCI-40** Replace all toilet room accessories (i.e. soap dispensers, etc.) in-kind.
- f. Urinal Screens: Urinal screens are showing signs of wear and tear. **AHCI-41** Replace urinal screens in-kind.
- g. Mirrors: The mirrors are showing signs of wear and tear. **AHCI-42** Replace all mirrors in-kind.
- h. Toilet Partitions: Toilet partitions are showing signs of wear and tear. **AHCI-43** Replace toilet partitions in-kind.

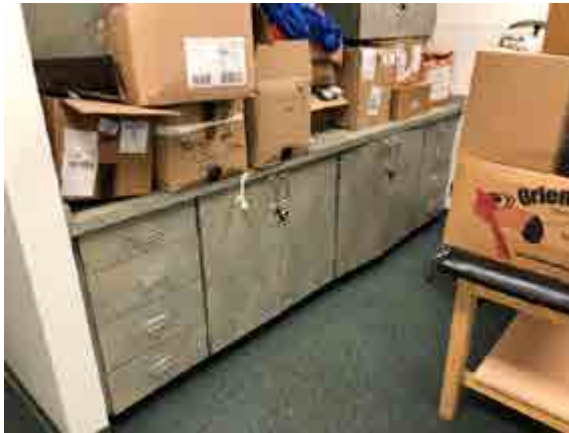
AHCI-44 to AHCI-45 Cabinets and Countertops

- a. Cabinets and Countertops: Cabinets and Countertops are showing signs of wear and tear. **AHCI-44 to AHCI-45** Replace cabinets and countertops in-kind.

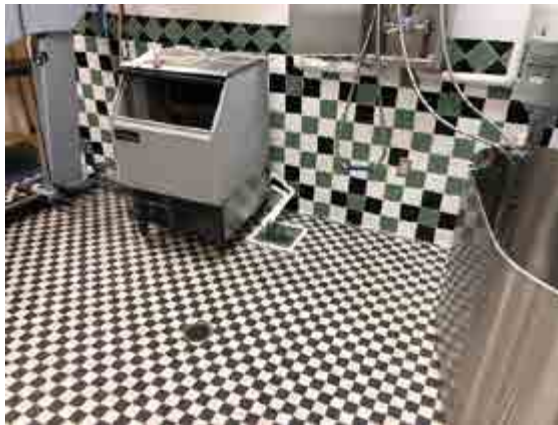
AHCI-47 Ice Machine

- b. **AHCI-46** Not Used
- c. Ice Machine: Ice machine is nearing the end of its life expectancy.
AHCI-47 Replace in-kind.

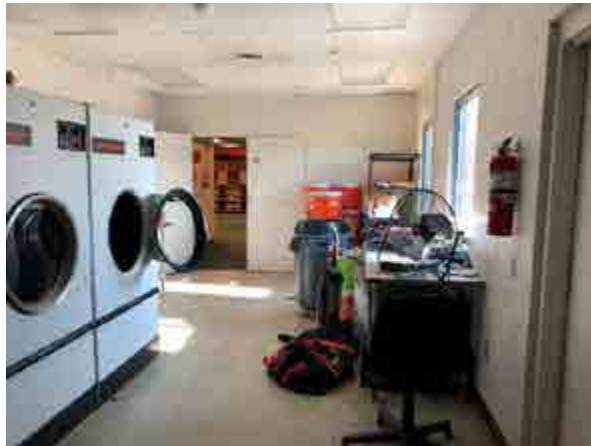
AHCI-50 LVT Flooring

- a. LVT Flooring: LVT flooring is heavily damaged throughout. **AHCI-50** Replace in-kind.

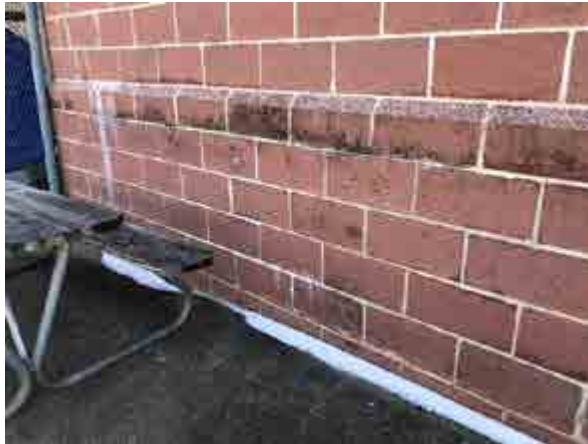
AVCE-1 Exterior CMU Wall Water Table

- a. Exterior CMU Wall Water Table: The exterior CMU wall water table on most exterior facades of the Visiting Clubhouse is deteriorating to the point where coarse aggregate is exposed. Signs of moisture infiltration such as efflorescence, algae, and an unverified black growth on and/or below this water table course are visible in many locations. In some cases, mortar joints are also missing or damaged at many of these walls. **AVCE-1** Subsurface investigation is recommended in strategic locations to determine the root cause(s) and develop an appropriate fix. For pricing purposes, assume the following fix: Remove a portion of the water table course and install stainless steel flashing and cast stone cap. Repair/install through-wall flashing, seal penetrations, reset coping in a bed of mortar raked back at edges for backer rod and sealant. Sealant to be installed in vertical joints with weeps at 24" o.c.

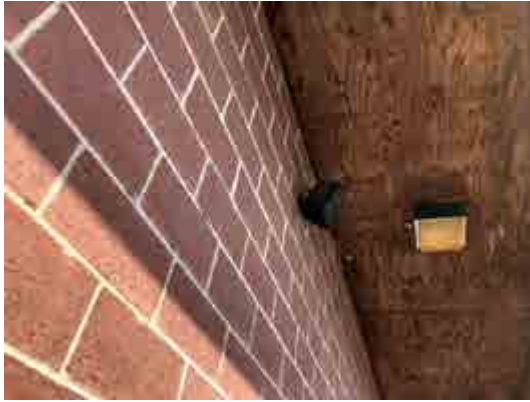
AVCE-3 Plywood Ceiling

- b. Masonry Joints: Mortar is damaged and/or missing in several brick joints around the exterior of the building. **AVCE-2** Spot re-point damaged/missing masonry joints.
- c. Plywood Ceiling: Plywood ceiling shows signs of deterioration. **AVCE-3** Remove plywood ceiling and replace with suitable exterior grade ceiling material.

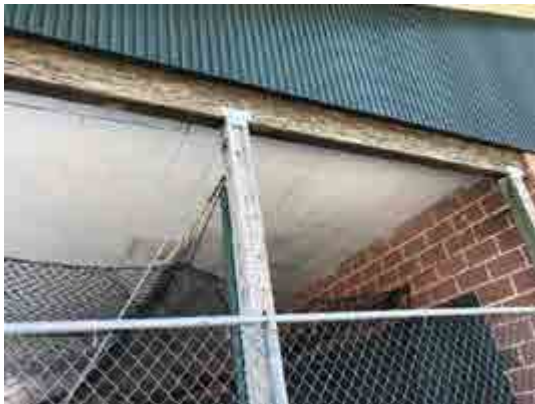
AVCE-8 Plywood Ceiling

- a. Plywood Ceiling: Plywood ceiling shows signs of deterioration. **AVCE-8** Remove plywood ceiling and replace with suitable exterior grade ceiling material.

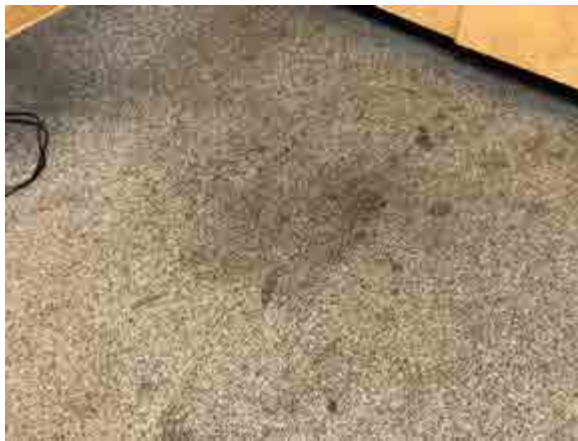
AVCI-1 Carpeting

- a. Carpeting: Carpet shows significant signs of wear and tear and is ready for replacement. **AVCI-1** Replace all carpeting within clubhouse with new carpet tile.

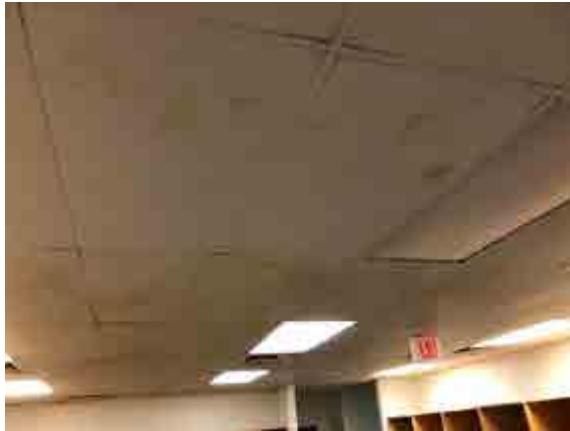
AVCI-5 Ceiling Tile and Grid

- b. Carpeting: **AVCI-2** Replace carpeting at anticipated end of life expectancy.
- c. Wall Base: Rubber base is delaminating in some places. **AVCI-3** Replace rubber wall base in kind during carpeting replacement.
- d. Wall Base: **AVCI-4** Replace rubber wall base at anticipated end of life expectancy.
- e. Ceiling Tile and Grid: Ceiling tile and grid are showing signs of wear and tear and is ready for replacement. **AVCI-5** Replace all ceiling tile and grids within clubhouse in-kind.

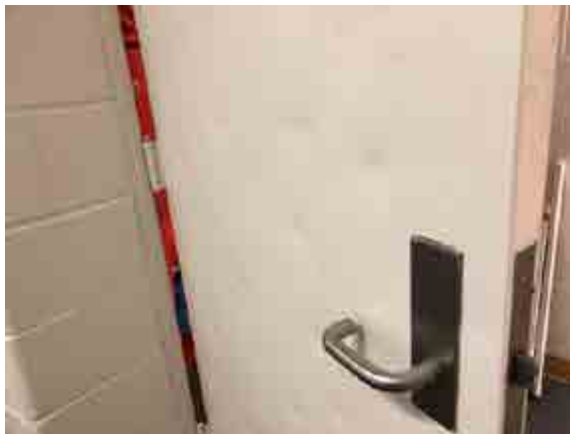
AVCI-8 to AVCI-11 Doors, Frames, and Hardware

- f. Wall Paint: Walls are showing signs of needing to be repainted in the coming years. **AVCI-6** Prep and paint all walls in clubhouse.
- g. Wall Paint: **AVCI-7** Repaint walls at anticipated end of life expectancy.
- h. Doors, Frames, and Hardware.: Doors, frames, and hardware are showing signs of damage. **AVCI-8 to AVCI-11** Replace all doors in clubhouse in-kind.

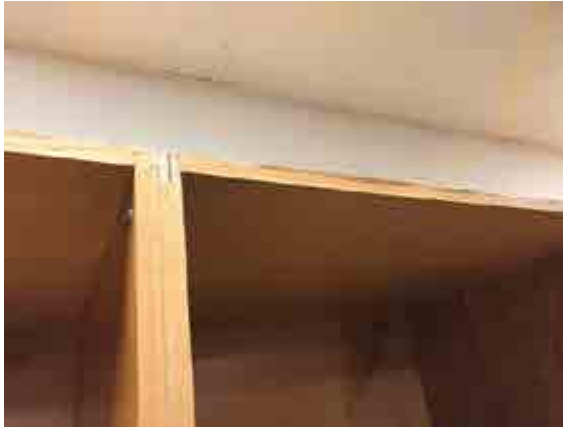
AVCI-12 Lockers

- a. Lockers: Lockers are showing signs of wear and tear such as dents and water damage. **AVCI-12** Replace all lockers in-kind.

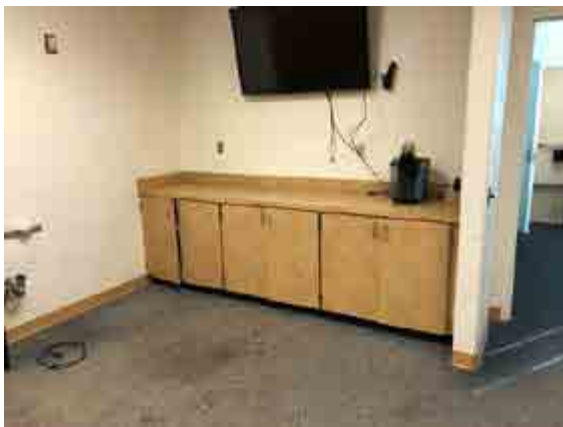
AVCI-13 Cabinets and AVCI-14 Countertops

- b. Cabinets: Cabinets are in poor condition and do not close properly. **AVCI-13** Replace cabinets in-kind.
- c. Countertops: Countertop is in poor condition. **AVCI-14** Replace countertops in-kind.

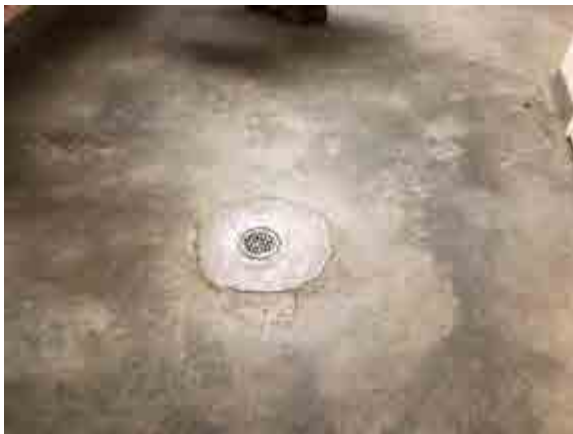
AVCI-16 Epoxy Flooring

- a. Epoxy Flooring: Existing epoxy flooring was observed to be failing in several locations. **AVCI-16** Remove all remaining epoxy flooring and replace flooring, base, and drain grates.

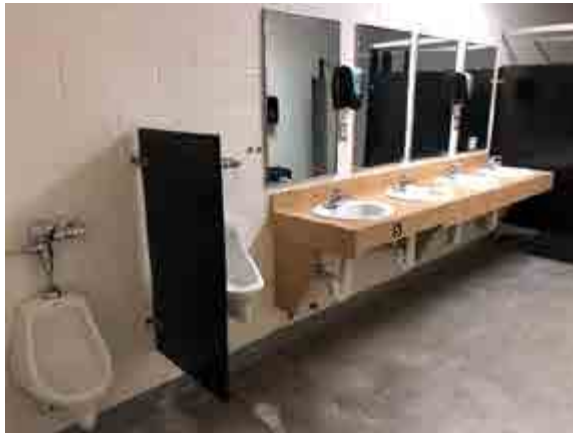
AVCI-17 Urinal Screens

- b. Urinal Screens: Urinal screens are showing signs of wear and tear. **AVCI-17** Replace urinal screens in-kind.

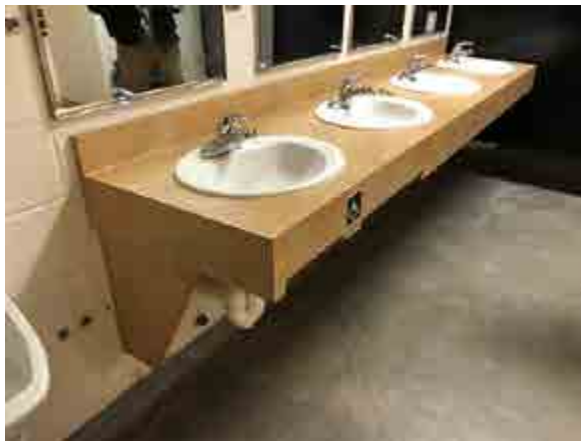
AVCI-18 to AVCI-19 Countertops and Sinks/Faucets

- c. Countertops and Sinks/Faucets: Laminate countertops are showing signs of wear and tear. **AVCI-18 to AVCI-19** Replace with solid surface countertops, integral backsplash, undermount sinks, faucets, and new countertop brackets.

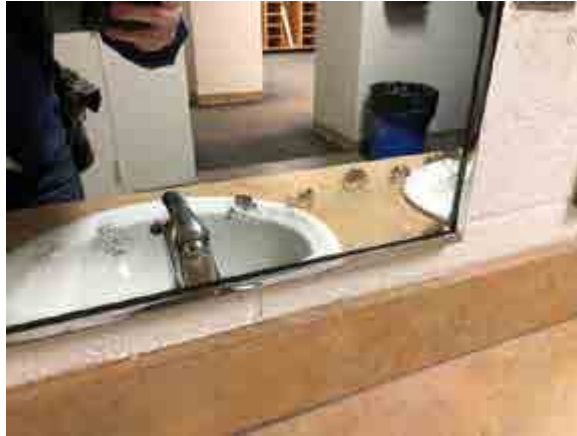
AVCI-21 Mirrors

- d. Toilet Room Accessories: Toilet room accessories are nearing the end of their life expectancy. **AVCI-20** Replace all toilet room accessories (i.e. soap dispensers, etc.) in-kind.
- e. Mirrors: The mirrors are showing signs of wear and tear. **AVCI-21** Replace all mirrors in-kind.

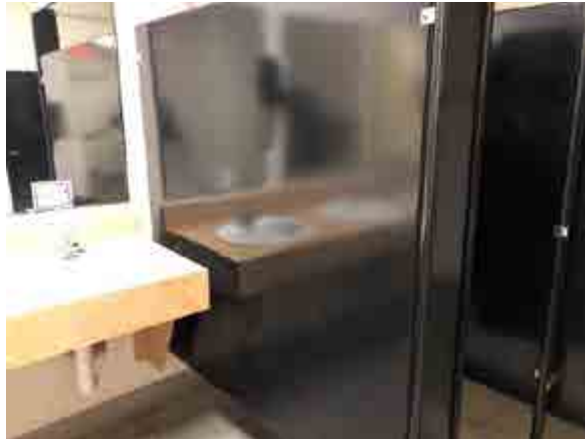
AVCI-22 Toilet Partitions

- f. Toilet Partitions: Toilet partitions are showing signs of wear and tear.
AVCI-22 Replace toilet partitions in-kind.

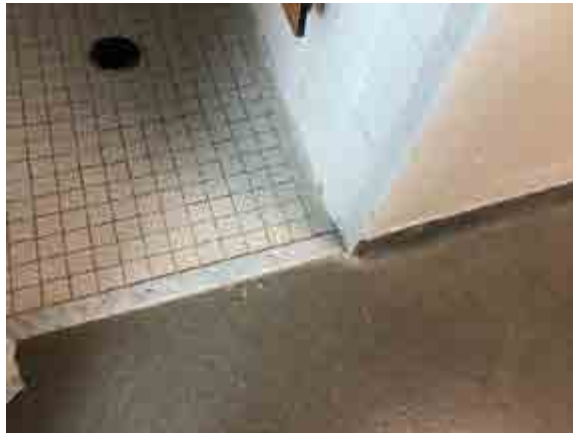
AVCI-25 to AVCI-26 Tile Walls and Floors

- a. **AVCI-23** Not Used
- b. Epoxy Flooring: Existing epoxy flooring was observed to be failing in several locations. **AVCI-24** Remove all remaining epoxy flooring and replace flooring, base, and drain grates.
- c. Tile walls and floors: Tile walls and floors show signs of wear and tear. **AVCI-25 to AVCI-26.** Replace tile floor, wall, base, and drain grates.

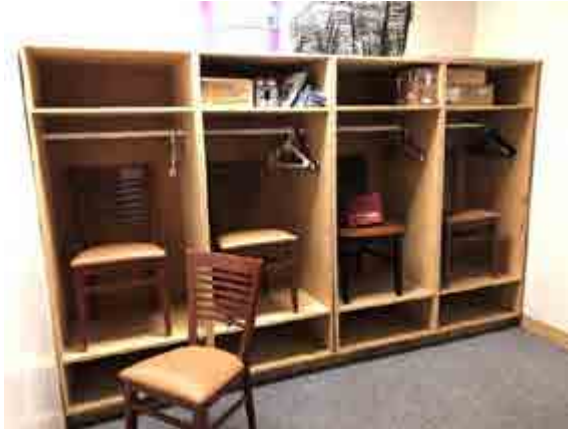
AVCI-31 Lockers

- a. Lockers: Lockers: Lockers are showing signs of wear and tear such as dents and water damage. **AVCI-31** Replace all lockers in-kind.

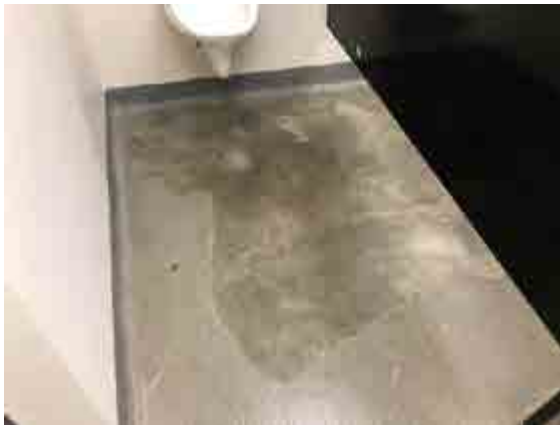
AVCI-32 Epoxy Flooring

- b. Epoxy Flooring: Existing epoxy flooring was observed to be failing in several locations. **AVCI-32** Remove all remaining epoxy flooring and replace flooring, base, and drain grates.
