LEIDOS FIELD AT RIPKEN STADIUM

Assessment Report | July 8, 2022

EXECUTIVE SUMMARY

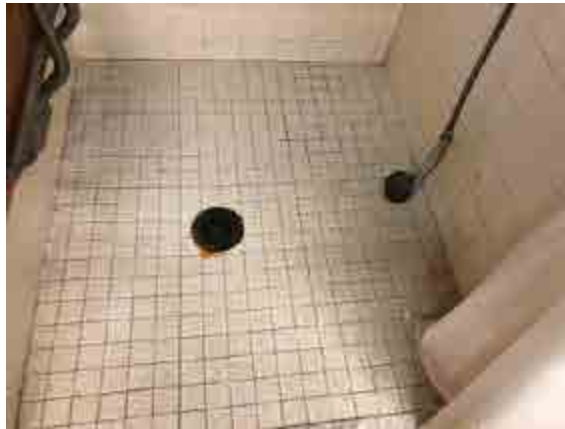
AVCI-34 Tile Walls and Floors

- c. Tile walls and floors: Tile walls and floors show signs of wear and tear. **AVCI-33 to AVCI-34.** Replace tile floor, wall, base, and drain grates.

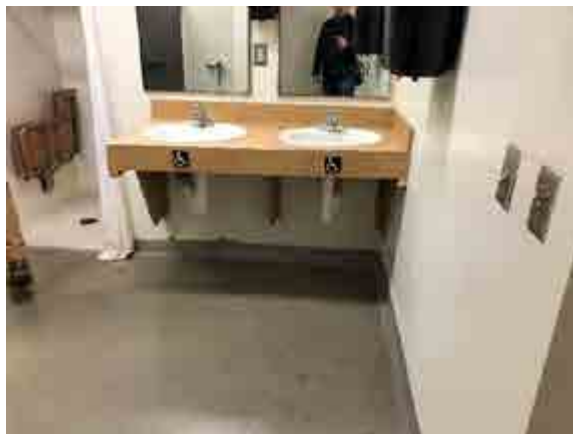
AVCI-35 TO AVCI-36 Countertops and Sinks/Faucets

- d. Countertops and Sinks/Faucets: Laminate countertops are showing signs of wear and tear. **AVCI-35 to AVCI-36** Replace with solid surface countertops, integral backsplash, undermount sinks, faucets, and new countertop brackets.

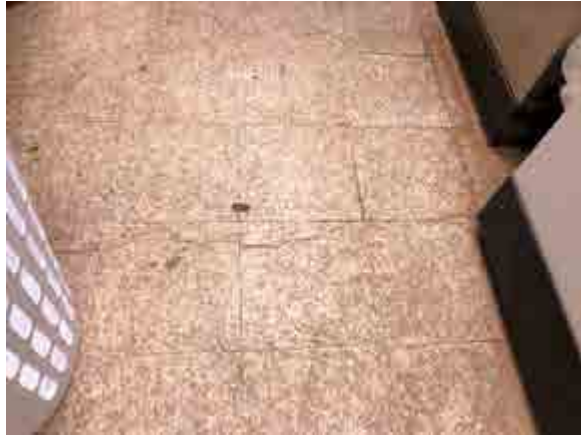
AVCI-46 VCT Flooring

- a. VCT Flooring: VCT flooring is significantly damaged. **AVCI-46** Replace in-kind.

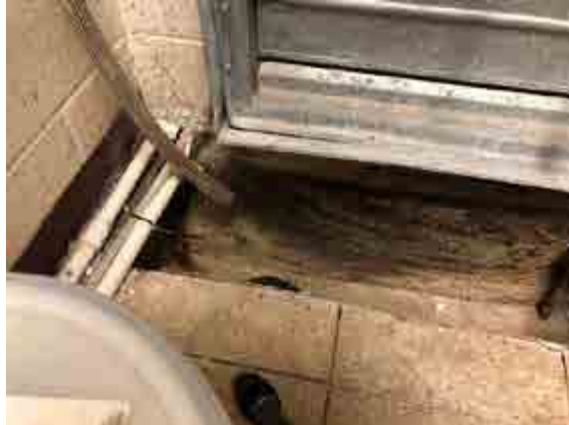
AVCI-47 Trench Drain

- b. Trench Drain: Trench drain is damaged and has rotting wood. **AVCI-47** Replace with stainless steel trench drain.

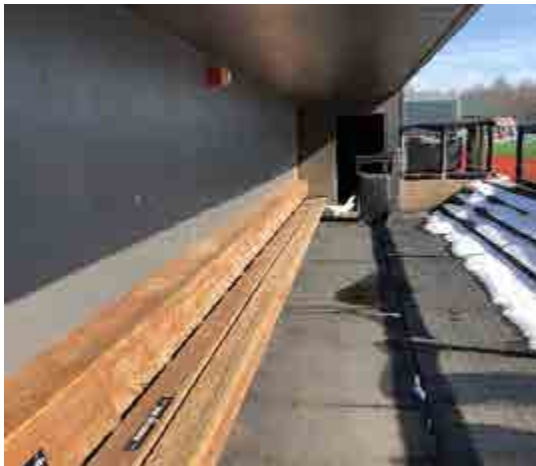
APF-1 Dugout Rubber Flooring

- a. Flooring: Rubber flooring in dugout is showing signs of wear and tear. **APF-1** Replace rubber flooring on walking surfaces and steps.

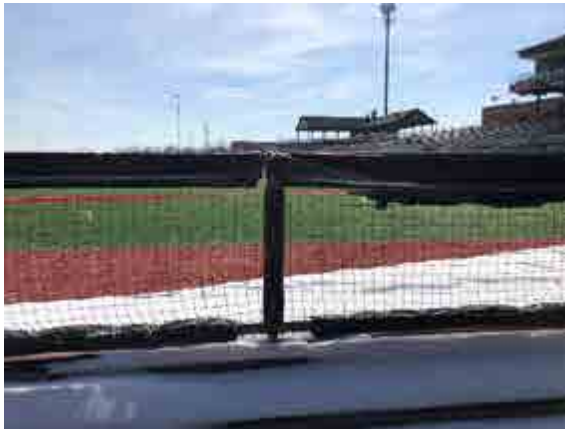
AFP-8 Dugout Protective Netting

- b. Flooring: **APF-2** Anticipated replacement of rubber flooring on walking surfaces and steps at end of lifespan.
- c. Wood Bench: **APF-3** Replace wood bench seat and back only; structure was observed to be in good condition.
- d. Wood Bench: **APF-4** Anticipated replacement of dugout bench end of lifespan.
- e. Walls and Ceilings: **APF-5** Prep and paint all surfaces of dugout and dugout restroom that are currently painted.
- f. Walls and Ceilings: **APF-6** Prep and paint all surfaces of dugout and dugout restroom at the anticipated end of paint lifespan.
- g. Dugout Protective Netting: Shows signs of wear and tear. **APF-7** Replace.
- h. Dugout Protective Netting: **APF-8** Anticipated replacement of dugout protective netting at end of lifespan.

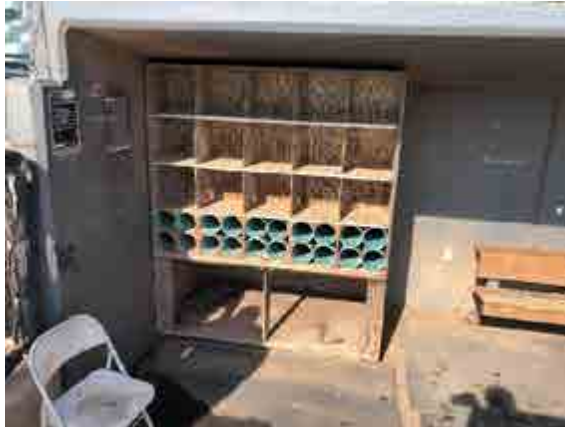
APF-9 Wooden Helmet and Bat Rack

- i. Helmet and Bat Racks: Wood is rotting, and trim is damaged. **APF-9** Replace helmet and bat racks in-kind.

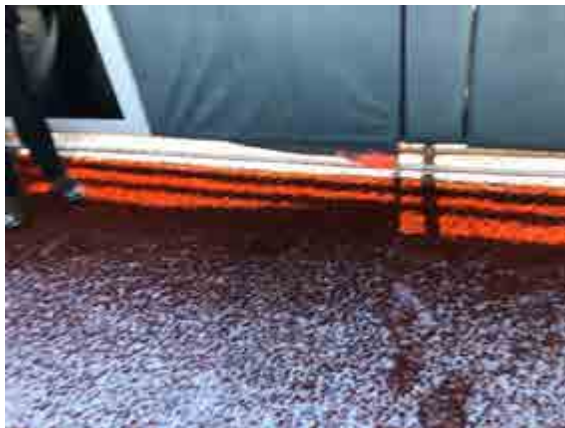
APF-15 Outfield Wall Padding

- a. Outfield Wall Plywood: Wood was observed to be rotting in places. **APF-12** Replace with exterior grade plywood.
- b. Outfield Wall Plywood: **APF-13** Replace all outfield wall padding at end of life expectancy.
- c. Outfield Wall Chainlink Fencing: **APF-14** Replace damaged, unconnected metal rails along chainlink fencing.
- d. Outfield Wall Padding: Outfield wall padding was observed to be failing at multiple locations. **APF-15** Replace outfield wall padding.

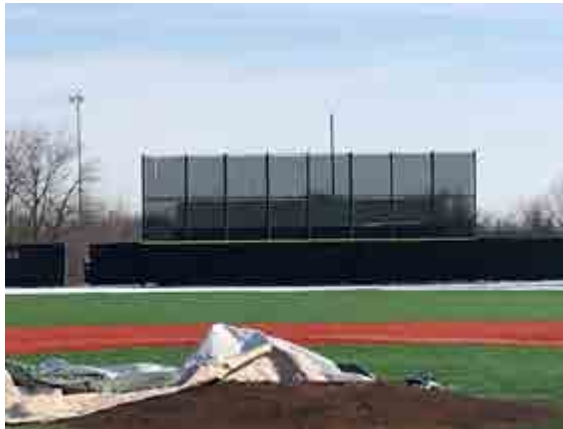
APF-17 Batter's Eye

- a. Windscreen: **APF-17** Replace windscreen on batter's eye (2 layers of windscreen) at end of life expectancy.

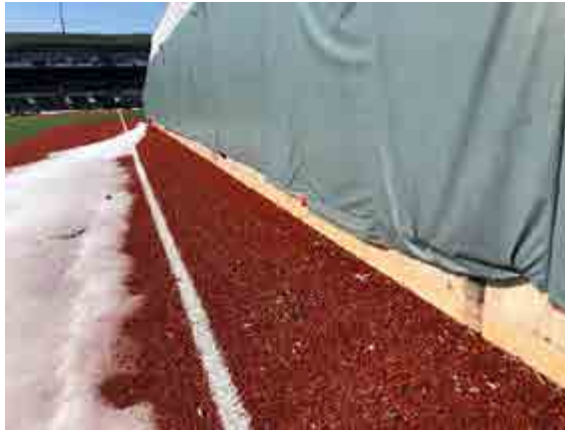
APF-18 Field Wall Padding

- a. **Field Wall Padding:** Wall padding is coming off and/or damaged in some locations. **APF-18** Replace all wall padding; Chainlink fence only gets padding on posts and rails.

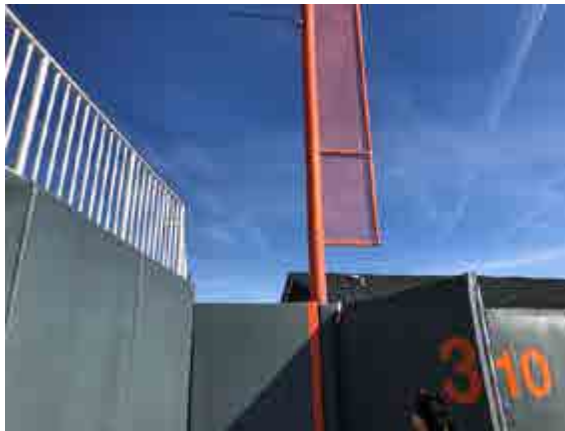
APF-21 Foul Poles

- b. **Protective Field Wall Netting: APF-19** Replace protective netting above field wall padding in-kind at end of remaining life expectancy. Cables assumed to remain.
- c. **Field Access Gates: APF-20** Replace field access gates at end of remaining life expectancy.
- d. **Foul Poles: APF-21** Paint Foul Poles.

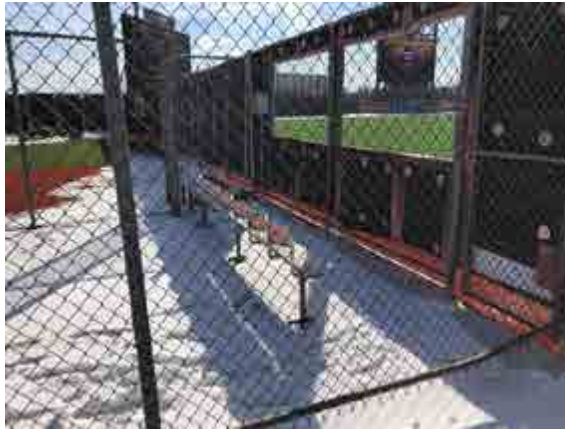
APF-23 Metal Bench at Bullpen

- a. **Metal Bench: APF-23** Replace Metal Bench.

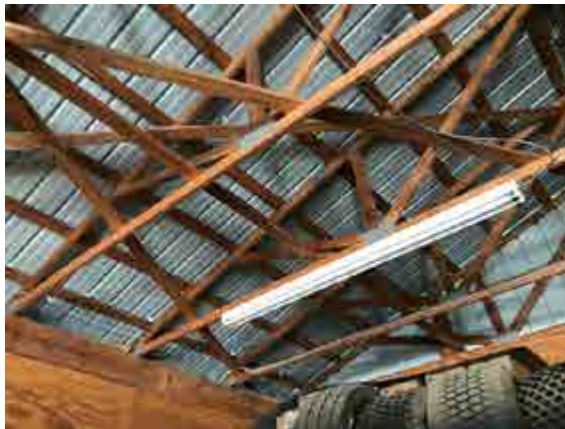
AMB-1 Metal Roof

- a. Right Field Maintenance Building
 - i. Metal Roofing: Numerous visible holes where observed in roof.
AMB-1 Replace all metal roofing.

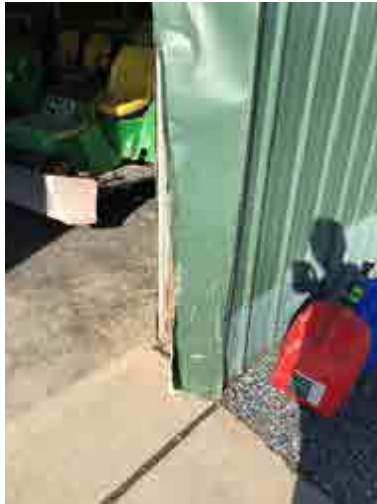
AMB-2 Metal Panel

- ii. Metal Panels: Exterior metal wall panels are damaged in several locations along the loading sides of the building. **AMB-2**
Replace all metal panels.

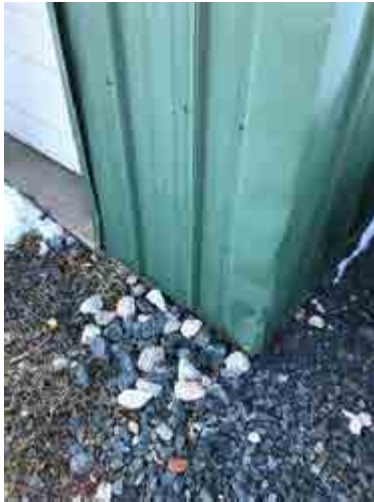
AMB- 5 Metal Panel

- iii. Overhead Doors: Overhead doors are damaged. **AMB-3**
Replace in kind.
- b. Center Field Maintenance Building
 - i. Metal Roofing: **AMB-4** Replace all metal roofing.
 - ii. Metal Panels: Exterior metal wall panels are damaged in several locations along the loading sides of the building. **AMB-5**
Replace all metal panels.

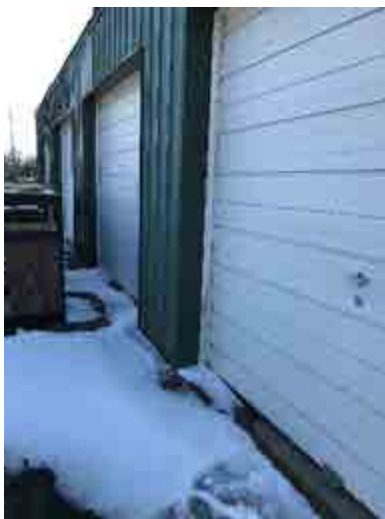
AMB-6 Overhead Doors

- iii. Overhead Doors: Overhead doors are damaged. **AMB-6**
Replace in kind.

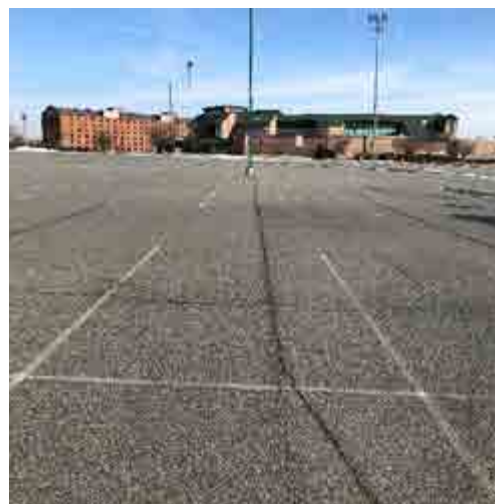
C-1 thru C-4 Seal all cracks and open pavement joints, including the joints between concrete curbs and bituminous pavements, with rubberized joint sealer. Complete spot repairs as necessary to remove ponding, depressions, longitudinal and traverse cracking greater than 1/2" in width.

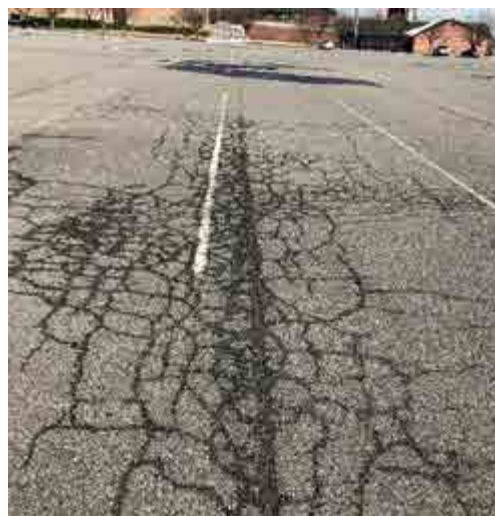
C-1 thru C-4 Apply a bituminous surface sealer at all reflective cracking / water-borne pavement markings. The reflective cracking is prevalent throughout all the parking lots and Roads A, B, C, & D. Reflective cracking could be caused by a poor subbase and/or ponding water.

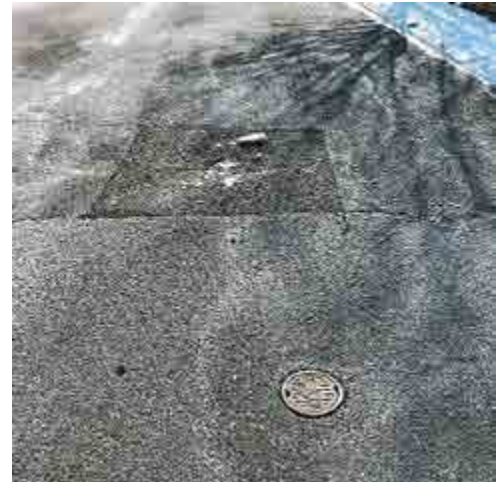
C-1 thru C-4 Throughout the site, there are inlets and valve covers that are uneven and preventing positive drainage. Continued ponding at these locations will accelerate pavement distress and ultimately localized pavement failure. The recommended course of action is to remove the distressed pavement with sound material, making neat clean edges and vertical surfaces, and replace with a bituminous wearing course paving mixture, flush with the top of the surface. This may require adjusting the structures to assure positive drainage.

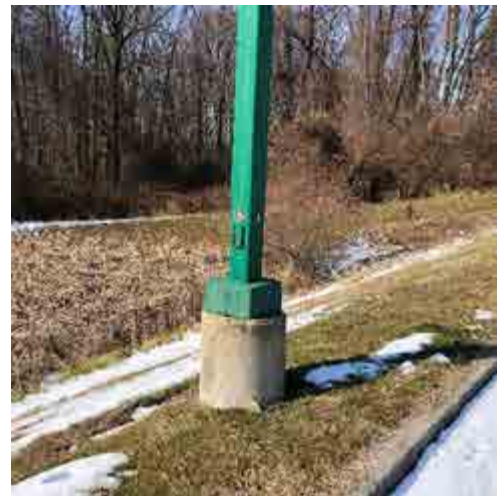
C-5 and C-6 Both the parking lot and pedestrian scale light pole foundations are in good shape. The light poles (30) should be cleaned, rust removed, and painted every 5-7 years. Light poles should be replaced in 15-20 years. Light pole foundations should be inspected on a yearly basis.

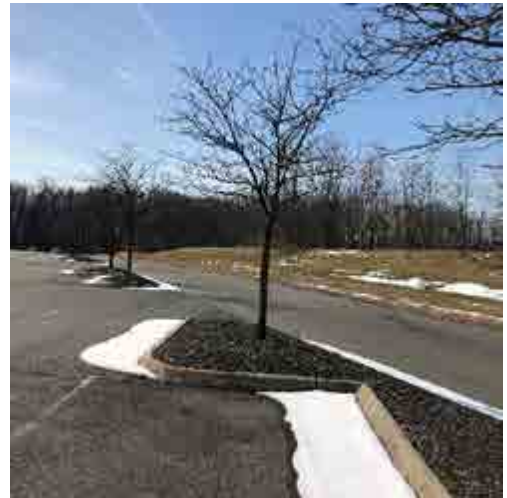
EXTRUDED CONCRETE CURB DAMAGE

- C-7** Extruded concrete curb is utilized around all of the landscape islands within the existing Parking Lots 1 and 2. At several locations, cracking has occurred at these landscape islands and should be replaced to avoid further deterioration.

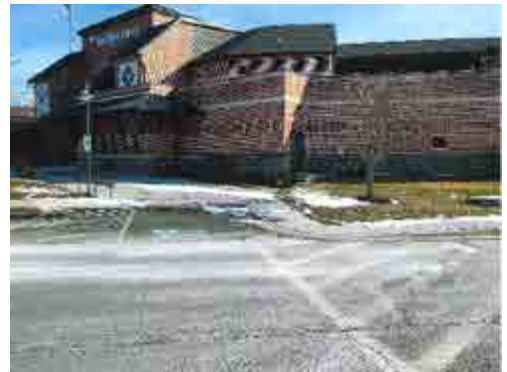
CONCRETE PARKING WHEEL STOPS

- C-8** Concrete parking wheel stops are utilized at several locations. The wheel stop at the handicapped parking space at the northwest corner of the stadium should be replaced in kind.

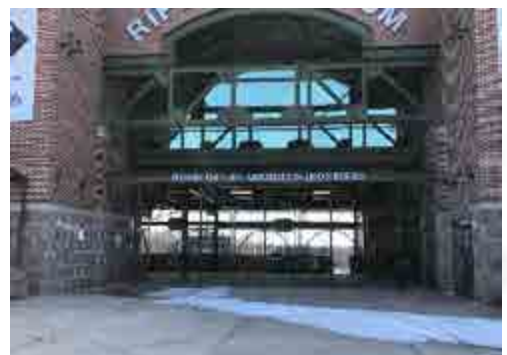
CONCRETE SIDEWALK

- C-9** The concrete sidewalk along the outside of the stadium is in excellent condition with some minor cracking at several locations and some construction joints which need to be sealed with a rubberized joint sealer.

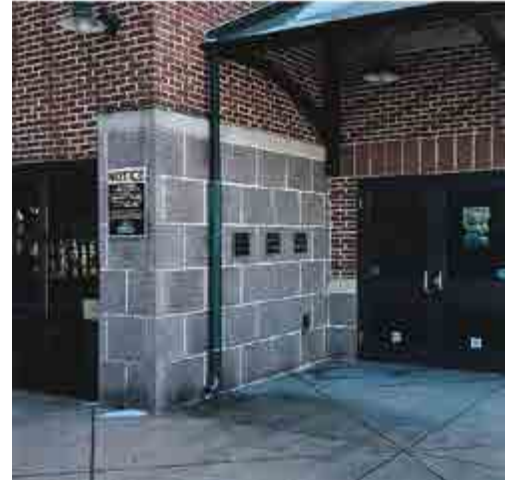
- C-10** The downspouts located at the Stadium's main entrance (ADA) area are in excellent condition. The only concern with these downspouts is that they outlet across the concrete sidewalk which is heavily traveled during events. Consideration should be given to having these downspouts outletting at another location or piped under the sidewalk.

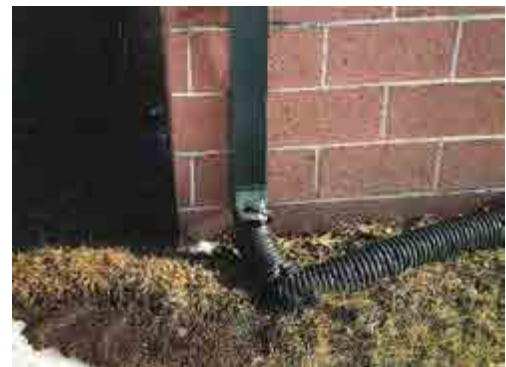
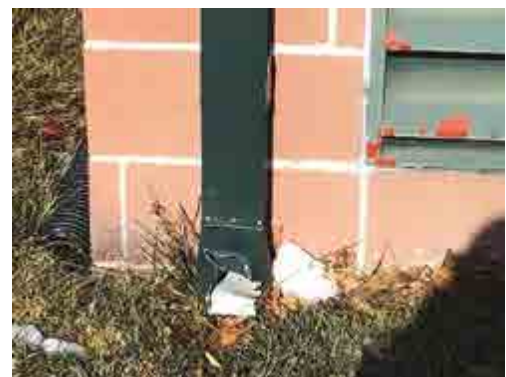
- C-10** The downspouts at other locations around the building need some maintenance. The throat opening of the downspout at these locations have been damaged to the point where it may be restricting flow, and in some cases, reconnected to the flex drainage pipe.

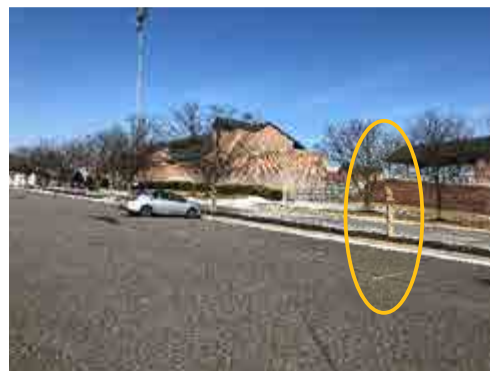
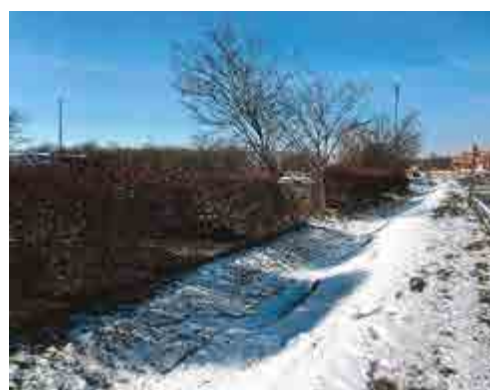
LANDSCAPE AT BUILDING AND PARKING LOT ISLANDS

C-11 and C-12 The landscape material and planting beds contiguous to the building and at the parking lot islands have been well-maintained. Trees and bushes have been seasonally pruned and cut back. There is one tree that was recently cut off 4' up (highlighted in the adjacent photo) and should be replaced.

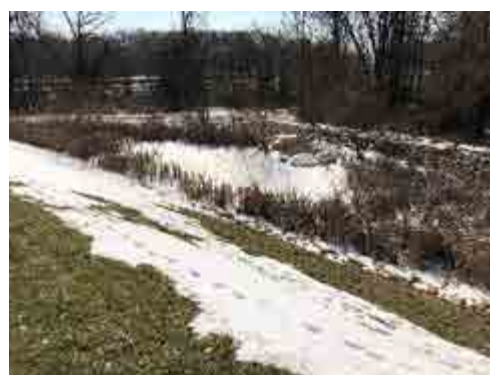
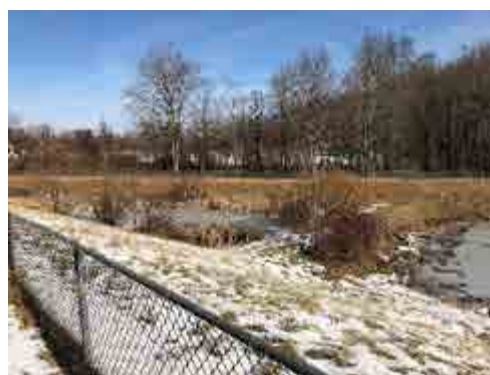
STORMWATER MANAGEMENT FACILITIES

C-13 There are numerous stormwater management water quality / quantity facilities throughout the site that are being well-maintained. These facilities are located on the west and south edge of the existing parking lots and at the southeast corner of the service drive. The only follow up maintenance would be to remove the trees that have grown up within the stormwater management facility. Cut the trees down to ground level, do not remove the root system, which could destabilize that area.

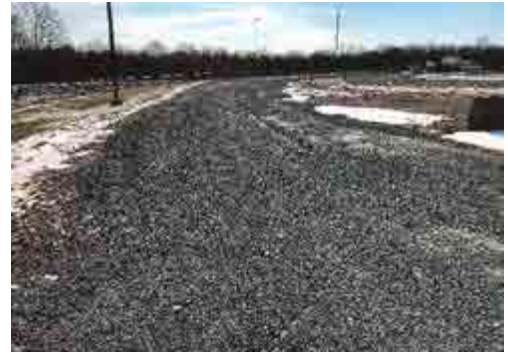
BACK OF HOUSE GRAVEL SERVICE DRIVE

- C-14** The service drive located in the rear of the Stadium receives runoff from the playing fields and the service area yard. This continuously washes out portions of the gravel service road. The runoff ultimately flows into the stormwater management facility. The recommendation would be to pave the entire length of service road, 620 LF \pm . The pavement section should be a minimum 8" CR-6 stone, 2" bituminous base with 1" surface course.

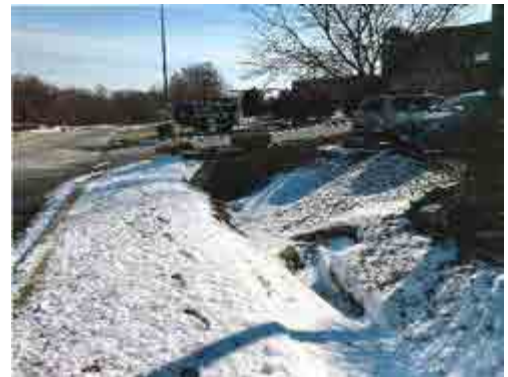
DRAINAGE DITCH REPAIR

- C-15** The drainage ditch at the main entrance off of Long Drive is experiencing some erosion. This is mainly due to the runoff coming from Parking Lot 1. To correct this problem, it is suggested to place several gabion cages in the area.

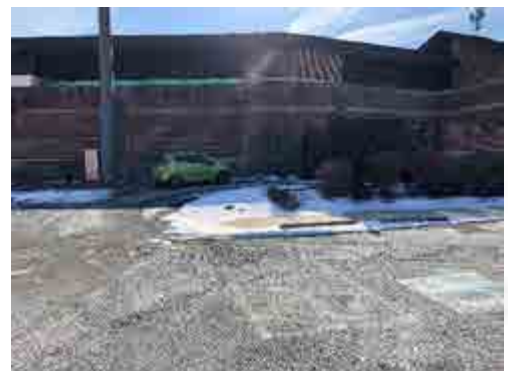
PARKING LOT STRIPING

- C-16** The striping in all four lots needs to be redone; in particular, the handicapped parking spaces show the worst wear. This can be done when the parking paving is totally milled and resurfaced, in 2-3 years. In the interim, all the handicapped spaces should be restriped now, in accordance with Maryland ADA striping/marketing specifications.

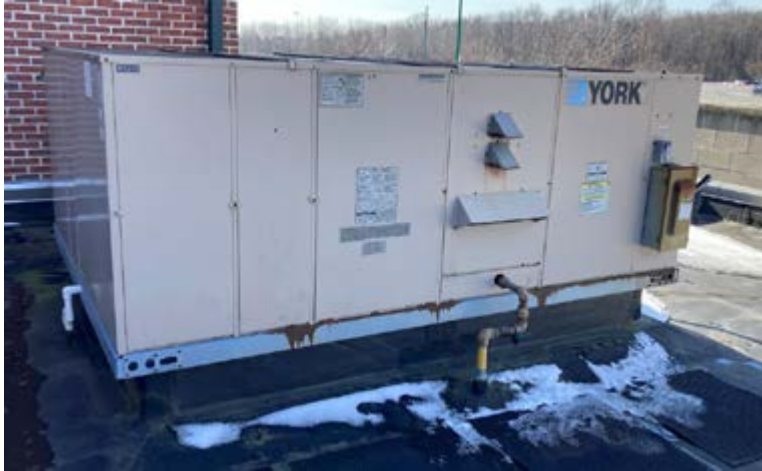
(13) Rooftop Air Handling Unit (RTU-1)

The administration area is served by RTU-1 (5,800 CFM, 15 TONs cooling, 240 MBH heating) which provides conditioned air as well as ventilation air. The unit is provided with DX cooling and gas-fired heating. The supply air duct work is externally insulated. The return air system is an uninsulated ductwork return system. There is a single thermostat located in the administrative area that controls the RTU.

REPLACEMENT (YEARS)	ITEM	DESCRIPTION	QUANTITY	UNIT	RATE	GENERAL CONDITIONS	AMOUNT	REMARKS	0-1	0-5	5-10	10-15	15-20	
0-5	H-1a	RTU-1 serving office and administration area	1	EA	\$ 45,000.00	\$ 6,750.00	\$	63,000.00 5,800 cfm total supply with 1,100 cfm of OA. 15 Tons of DX cooling and 240 MBH of gas-fired heating. Unit is in poor condition		\$	63,000.00			
15-20	H-1b	Replace RTU-1, again at end of service life	1	EA	\$ 45,000.00	\$ 6,750.00	\$	63,000.00 5,800 cfm total supply with 1,100 cfm of OA. 15 Tons of DX cooling and 240 MBH of gas-fired heating. Unit is in poor condition				\$	63,000.00	
15-20	H-2	RTU-2 serving store and adjacent vendor pantry area	1	EA	\$ 45,000.00	\$ 6,750.00	\$	63,000.00 5,800 cfm total supply with 1,100 cfm of OA. 15 Tons of DX cooling and 240 MBH of gas-fired heating. Unit is in poor condition and has been installed recently					\$	
0-5	H-3a	RTU-3 serving north concessions	1	EA	\$ 36,000.00	\$ 5,400.00	\$	50,400.00 Dedicated outdoor air system 3,900 cfm total supply. 15 Tons of DX cooling and 390 MBH of gas-fired heating. Unit is in poor condition		\$	50,400.00

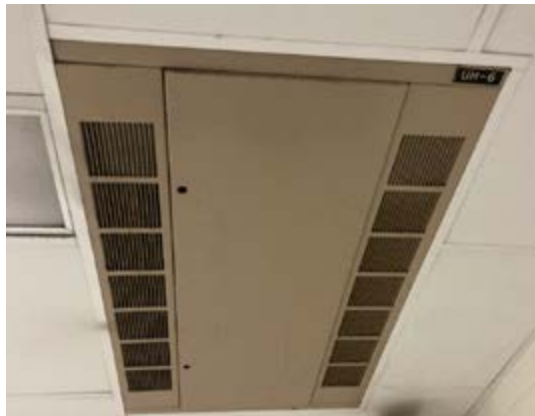
(16) Typical Gang Restroom Electric Unit Heater (UH-6)

0-5	H-18	UH-6 Unit heater serving large concourse	4	EA	\$ 2,400.00	\$ 1,440.00	\$	13,440.00 Manually operated electric wall mounted unit heater 200 cfm supply, 8 KW of heating, 480V/3PH. Units are in poor condition		\$	13,440.00			
0-5	H-19	EF-2 exhaust fan serving home and visitor club	2	EA	\$ 2,400.00	\$ 720.00	\$	6,720.00 In-line fans, 2000 cfm - 2700 cfm exhaust, 1 HP motors. Units are in fair condition		\$	6,720.00			
0-5	H-20	EF-3, EF-5, EF-16, EF-20 exhaust fan serving large concourse restrooms, south concessions, club level concessions, north concessions, club level concessions, north concessions	6	EA	\$ 3,400.00	\$ 3,060.00	\$	28,560.00 Roof mounted upblast fans, 2750 cfm - 3600 cfm exhaust, 3/4 - 1-1/2 HP motors. Units are in fair to poor condition		\$	28,560.00			
0-5	H-21	EF-4, EF-15 exhaust fan serving south and north concessions, club level concessions	3	EA	\$ 4,000.00	\$ 1,800.00	\$	16,800.00 Roof mounted exhaust fans, 4000 cfm - 4500 cfm exhaust, 2 - 3 HP motors. Units are in poor condition		\$	16,800.00

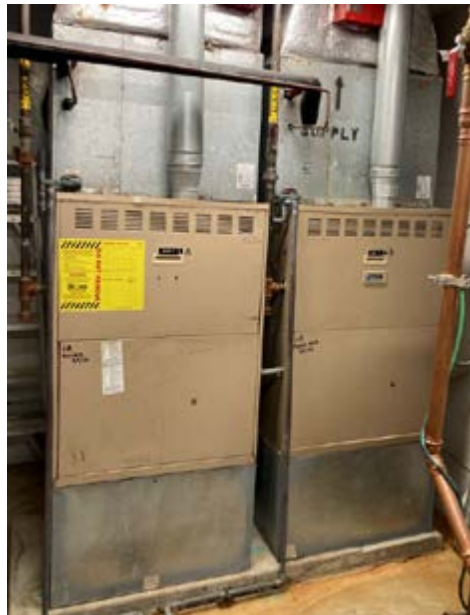
(21) Home Clubhouse Split Systems (AH-1A & AH-1B)

The facility staff reported that the two indoor evaporators failed in August 2021 and are awaiting replacement parts. The units are past their useful service life and should be replaced. Due to the difficulty in replacing the units in-kind, we recommend replacement with similar capacity units that are self-contained outdoor units mounted on-grade adjacent to the mechanical room where the current condensing units are located. Duct the supply and return air ductwork through the mechanical room wall and connect to the existing building ductwork mains.

H-7, H-8: Replace split systems serving the Home Clubhouse

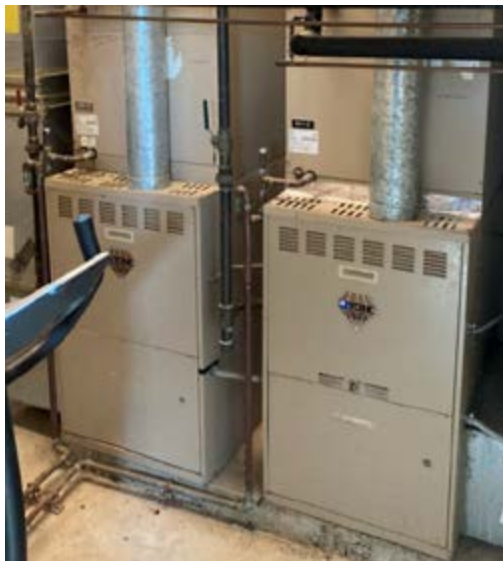
(25) Visitor Clubhouse Split Systems (AH-2A & AH-2B)

0-5	H-10	AH-2A split system serving visitor clubhouse	1	EA	\$ 21,500.00	\$ 3,225.00	\$	30,100.00 2,000 cfm total supply with 700 cfm of OA. 5 Tons of DX cooling and 122 MBH of gas-fired heating. Unit is in poor condition		\$	30,100.00			
0-5	H-11	AC-1A terminal air conditioning unit serving home clubhouse manager area	1	EA	\$ 21,500.00	\$ 3,225.00	\$	30,100.00 295 cfm total supply. 1.25 Tons of self contained DX cooling, 13.1 MBH of electric heating. Unit is in fair condition		\$	30,100.00			
0-5	H-12	AC-1B terminal air conditioning unit serving umpire area	1	EA	\$ 21,500.00	\$ 3,225.00	\$	30,100.00 295 cfm total supply. 1.25 Tons of self contained DX cooling, 13.1 MBH of electric heating. Unit is in fair condition		\$	30,100.00			
0-5	H-13	AC-1C terminal air conditioning unit serving the area	1	EA	\$ 21,500.00	\$ 3,225.00	\$	30,100.00 295 cfm total supply. 1.25 Tons of self contained DX cooling, 13.1 MBH of electric heating. Unit is in fair condition		\$	30,100.00

- H-9: AH-2A split system serving Visitor Clubhouse
- H-10: AH-2A split system serving Visitor Clubhouse
- H-11: AC-1A terminal air conditioning unit serving Home Clubhouse Manager area

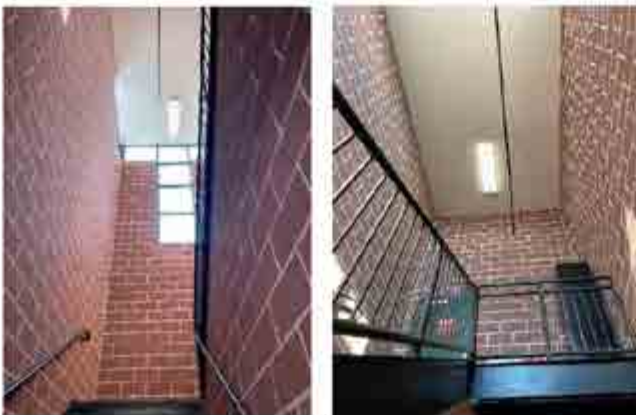
- EL-6 Lighting and Lighting Controls (Stairwells): The stairwells are currently served by mostly fluorescent and metal halide luminaires that require maintenance and replacement lamps often. In addition, the fixtures are located in inconvenient locations for maintenance and do not seem to be positioned in locations where code required light levels would be met. Replacing these with LED fixtures will require far less maintenance and power to provide equal or better light levels. It is recommended that using occupancy sensors within these spaces will provide a more energy efficient approach and help extend the lamp life of the fixtures. When stairwell is unoccupied, occupancy sensors shall trigger lights to go to 50% light output for egress purposes.

Fluorescent/Metal Halide fixtures located in hard-to-reach areas in stairwell

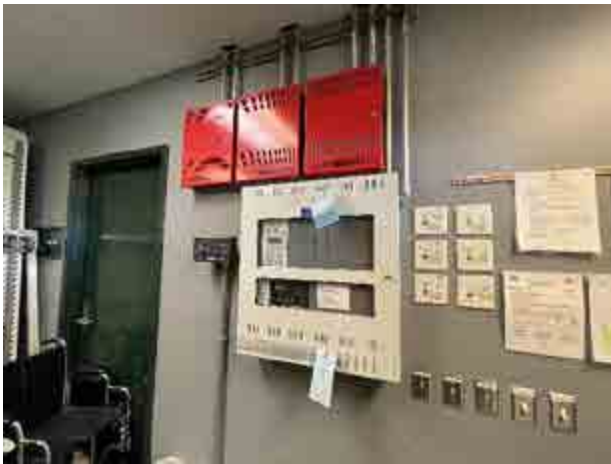
- FA-1 Fire Alarm Control Panel: It was reported that the Fire Alarm Control Panel in the home team side of the building is nearing the end of its life. It is recommended to replace the fire alarm control panel and its components for a fully functioning addressable system. The new Fire Alarm Control Panel shall maintain functionality with the public address/general announcement system.

Existing Fire Alarm Control Panel

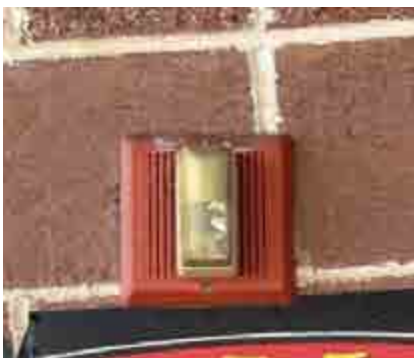
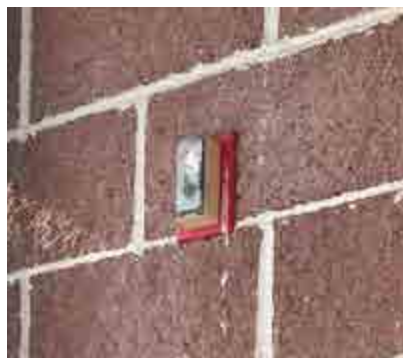
- FA-2 Fire Alarm Outdoor Strobes/Speakers: The fire alarm outdoor speakers throughout the ballpark are significantly corroded and in need of replacement. We recommend replacing all outdoors speakers for the fire alarm system. Replacement of theses devices should include weatherproof requirements to increase long term use of device.

Corroded fire alarm outdoor strobes/speakers

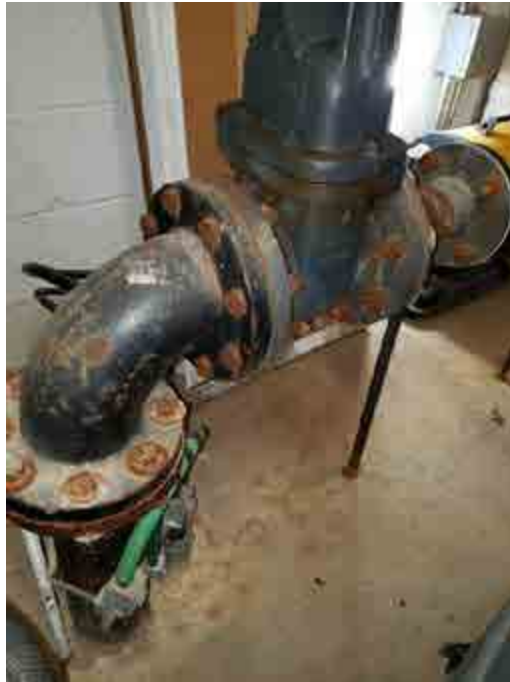
4" Incoming Domestic Water Service

A dedicated 4" domestic water service enters the ballpark in the Main Mechanical Room to a water meter and 3" double check backflow preventer. The BFP appears to be in excellent condition. The copper service piping extending from the backflow preventer has been replaced with Apollo Press type fittings, but new insulation has not been provided on the replaced pipe sections. The 4" domestic cold water supply then extends throughout the ballpark.

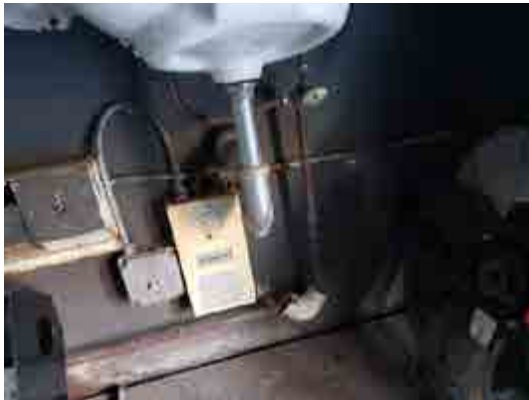
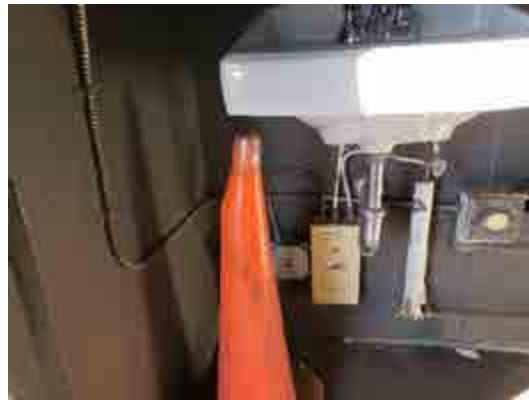
Electric Point of Use water heaters serve each Dugout

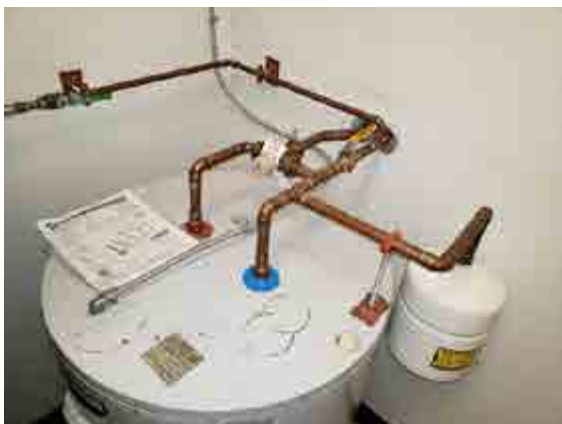
An electric 50-gallon water heater serves the Suite Bar.

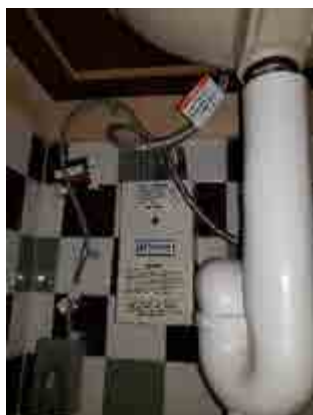
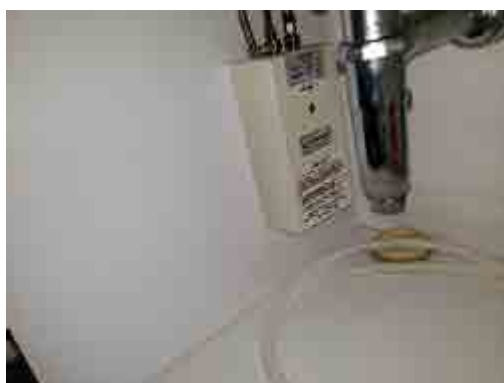
(12) Electric Point of Use water heaters are located below each lavatory and countertop sink to serve the Suites.

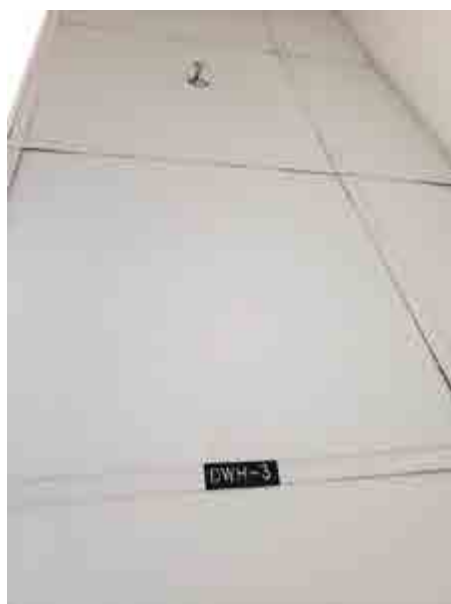
(4) Electric 30-gallon water heaters located above the ceiling serve the Public Toilet Rooms on Levels 1 & 2.

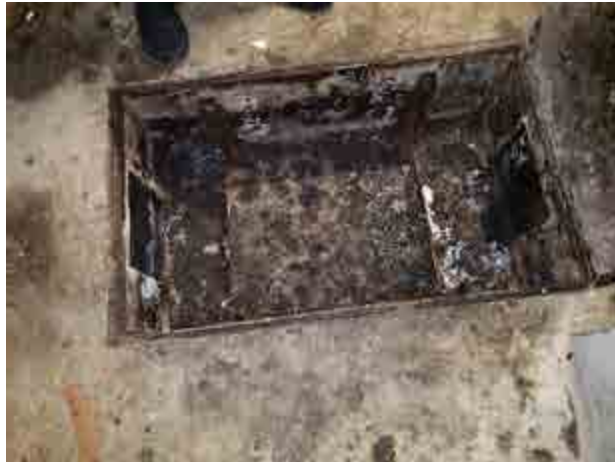
Grease waste serving the Concessions and Buffet appear to be the original 50 GPM 100 LB capacity grease interceptors installed. Two of the interceptors are installed below the stairs accessible through a hatch in in each Concession. The third interceptor serving the Buffet is mounted at the underside of the structure.

50 GPM Grease Interceptor below the stairs to serve each Concession

- Consider utilizing plastic type units in lieu of steel for future grease interceptor replacement.

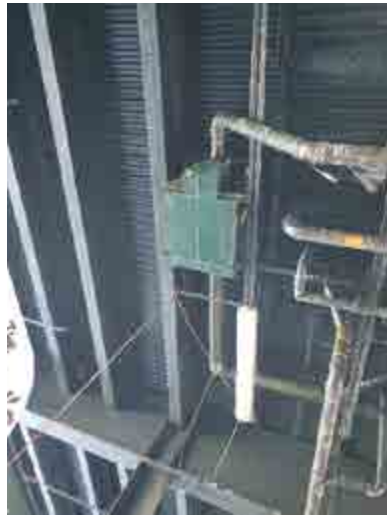
50 GPM Grease Interceptor at underside of structure serving the Buffet Kitchen above.

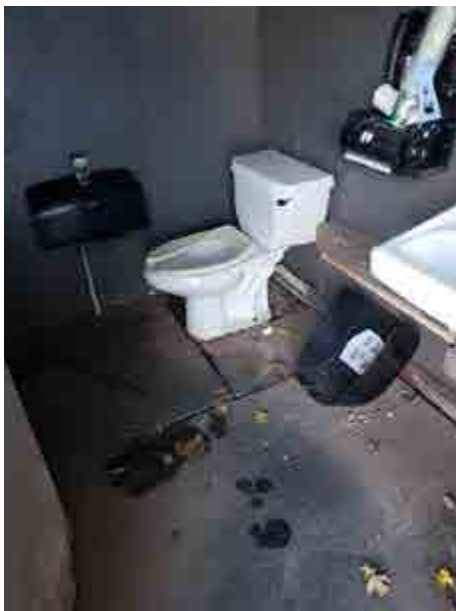
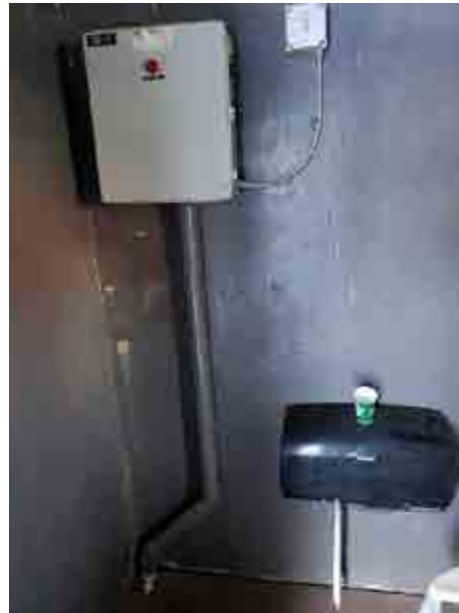
Team Dugout Sewage Ejector Pit and wall mounted Control Panel

- Closely examine the sewage ejector pump in the dugouts to determine if replacement is required.

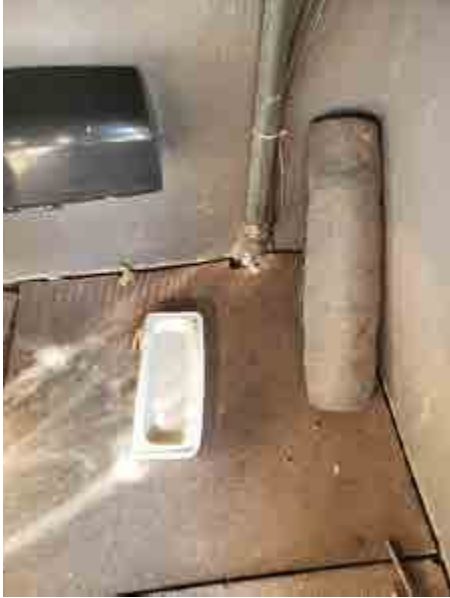
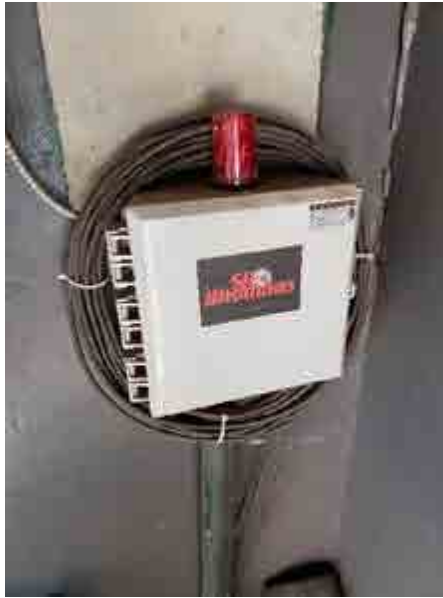
Team Dugout Sewage Ejector Pit and wall mounted Control Panel

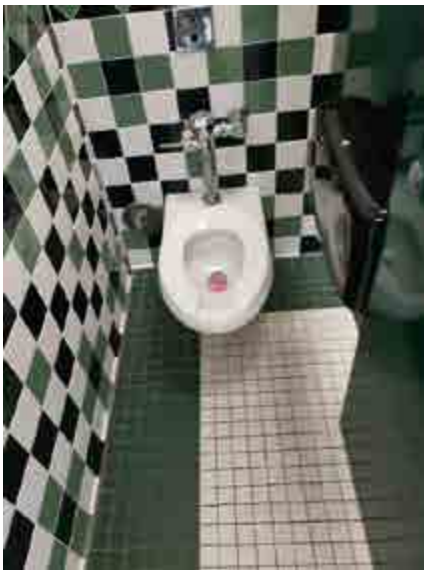
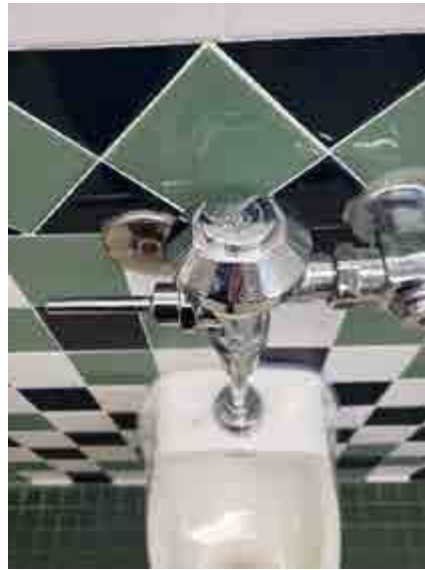
Where hard-wired sensor operated flush valves were once installed in the public toilet rooms, as issues arose, they've been replaced with manual flush valves at both the public water closets and urinals.

Typical hard-wired to manual flush valve replacement at water closets and urinals.

- Replace remaining hard-wired sensor operated flush valves with manual type. (Locations not known)

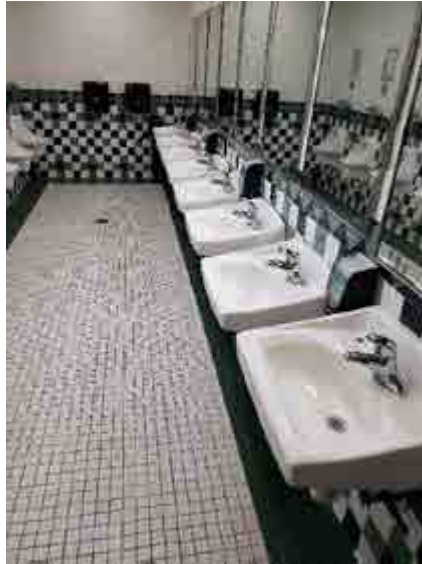
Wall-hung Lavatories and single lever faucets at Men's Public Toilet Rooms

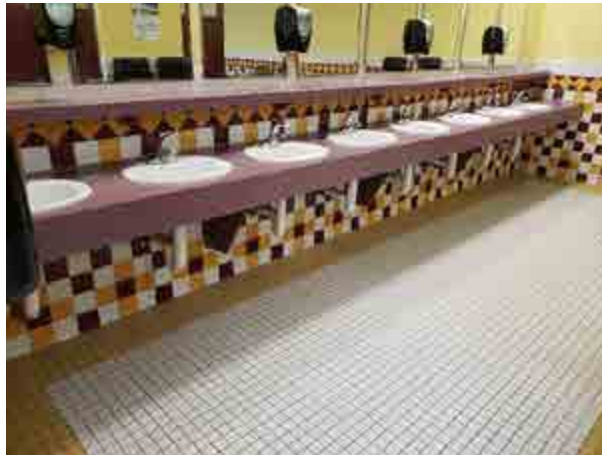
Drop-in Lavatories and single lever faucets at Women's Public Toilet Rooms

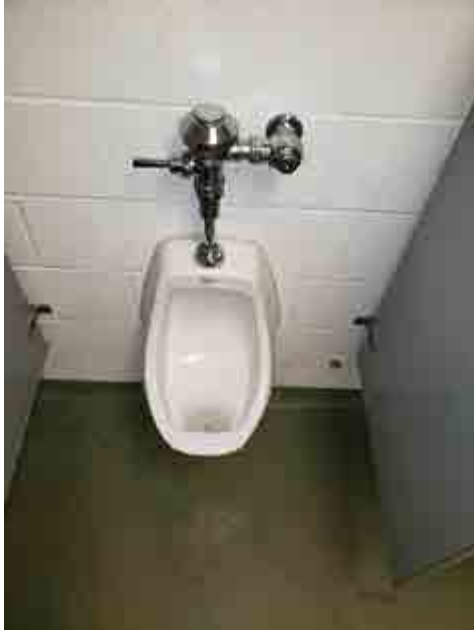
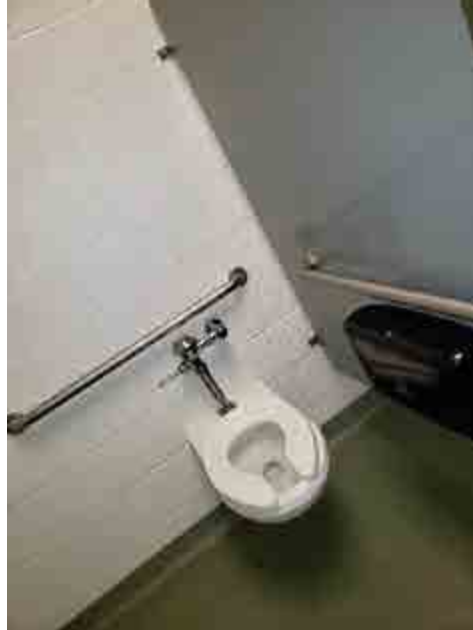
Manual flush valve Urinal and Water Closet at Home Team Clubhouse

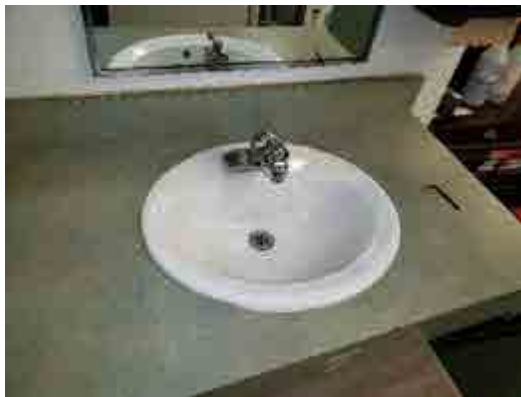
Drop-in Lavatories and single lever faucets at Clubhouse and Office toilet rooms

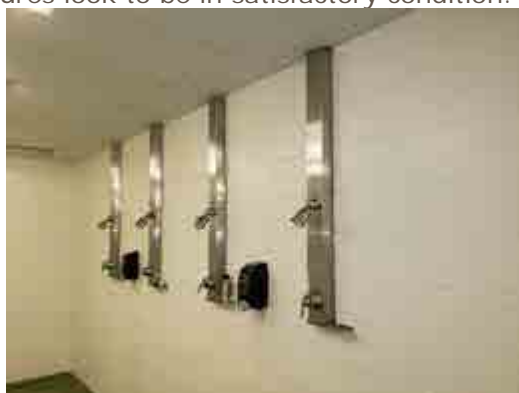
The Clubhouse showers are provided with individual stainless steel panel shower enclosures. These fixtures look to be in satisfactory condition.

Clubhouse Shower enclosure systems

- Replace shower enclosure systems.

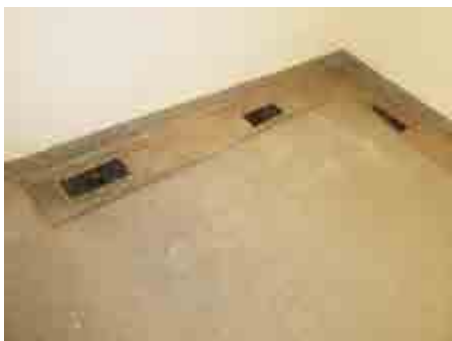
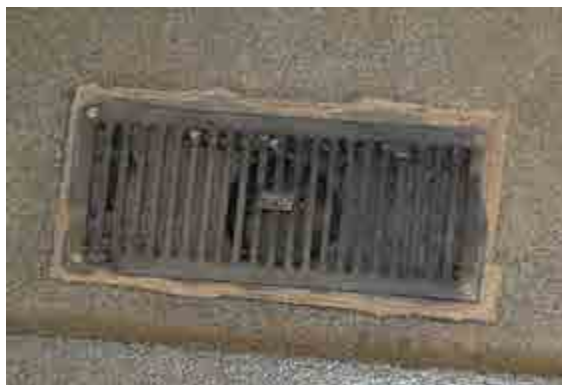
Clubhouse Shower Trough with Trench Drains

- Remove trench drain grate and verify condition of drain body. Replace body and grate as required.

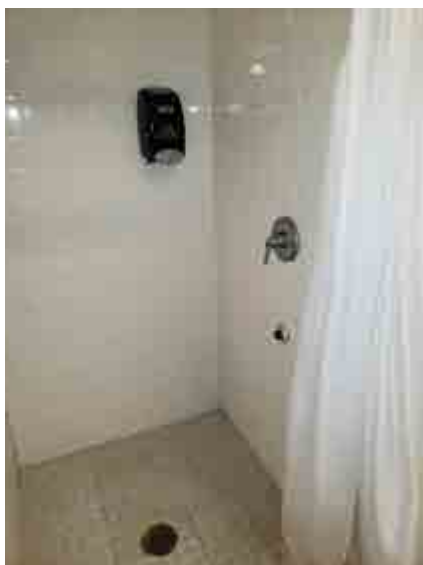
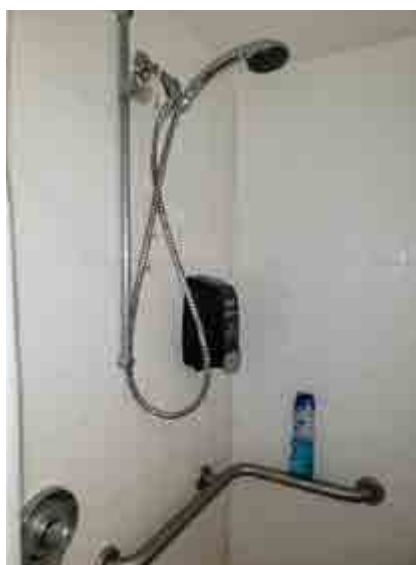
Typical Coaches Showers

- Replace shower controls and head.

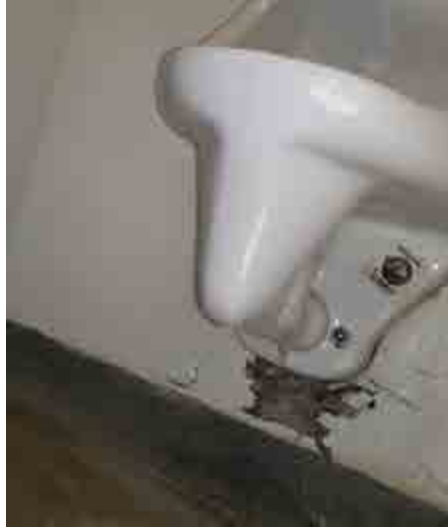
Water damage at Umpire Urinal

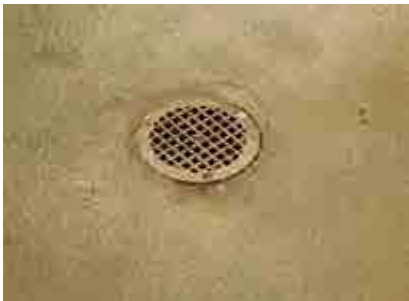
Typical floor drain at shower areas

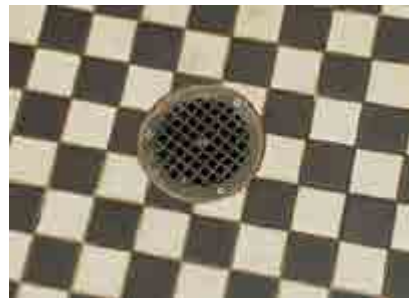
Floor drain at Home Team Training

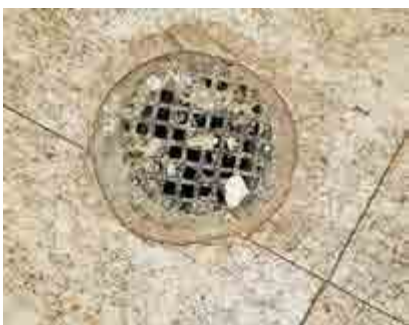
Floor drain at Visiting Laundry

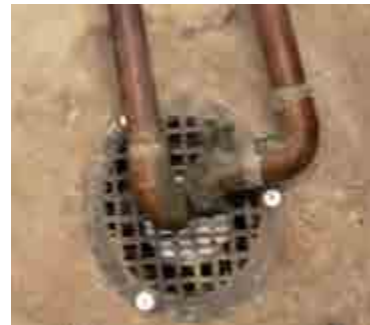
Floor drain at Visiting Mechanical Room

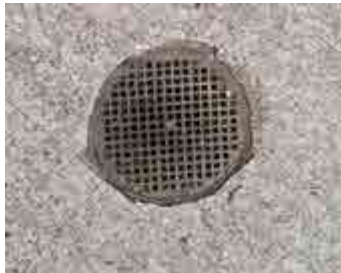
Floor drain at Home Team Laundry

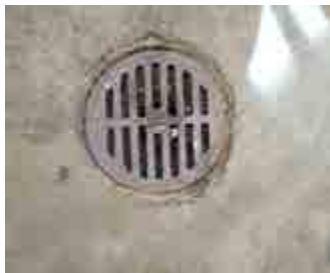
Floor drain at Facilities Workshop

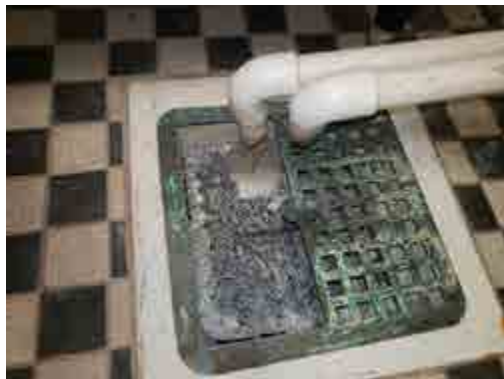
The floor sink receiving the whirlpool discharge at the Home Clubhouse appears to be eroding, possibly due to salt content in the tub.

Compromised Floor sink at Home Team Training Room

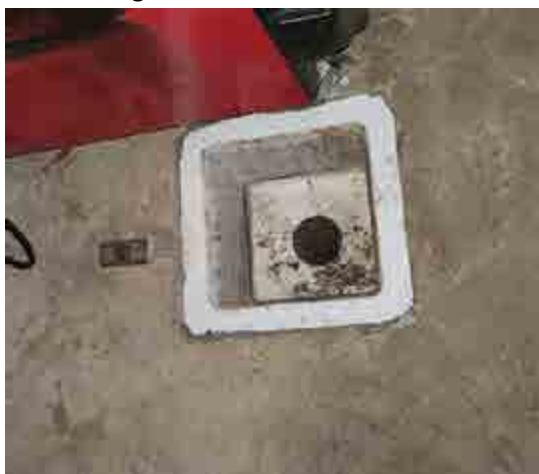
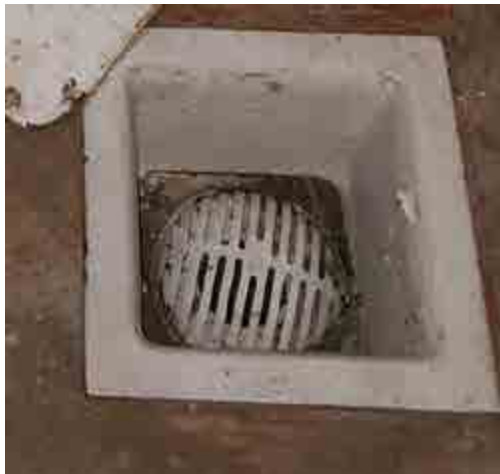
There are several locations where floor sinks do not have a strainer dome or top grate. This can allow foreign substances to enter the sanitary system.

Floor sink missing strainer dome and a floor sink with the dome but no top grate

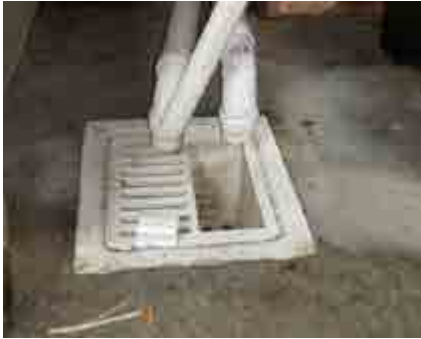
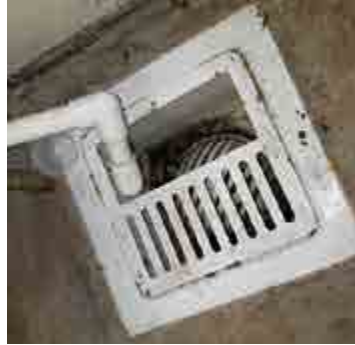
Floor sinks with grates and domes
