LEIDOS FIELD AT RIPKEN STADIUM

Assessment Report | July 8, 2022

EXECUTIVE SUMMARY

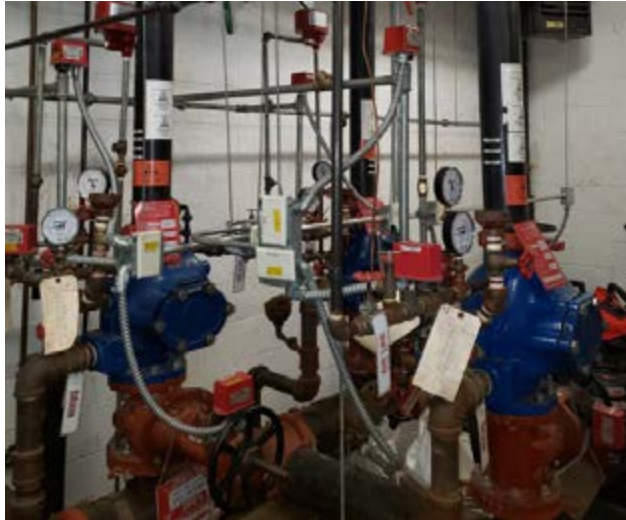
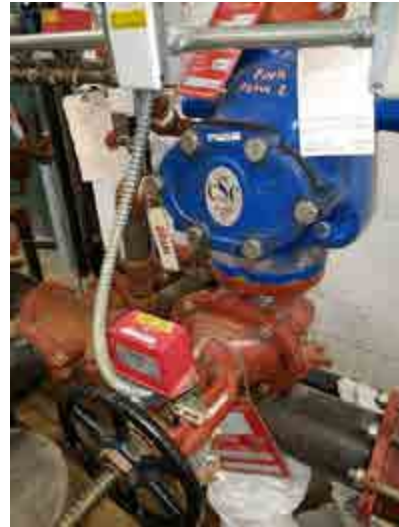
Dry Sprinkler Valve Assemblies

The wet sprinkler supply main extends to Dry Sprinkler Valve assemblies which serve the ballpark's dry sprinkler system. Reportedly, the existing Dry Valve replacement parts have been difficult to acquire.

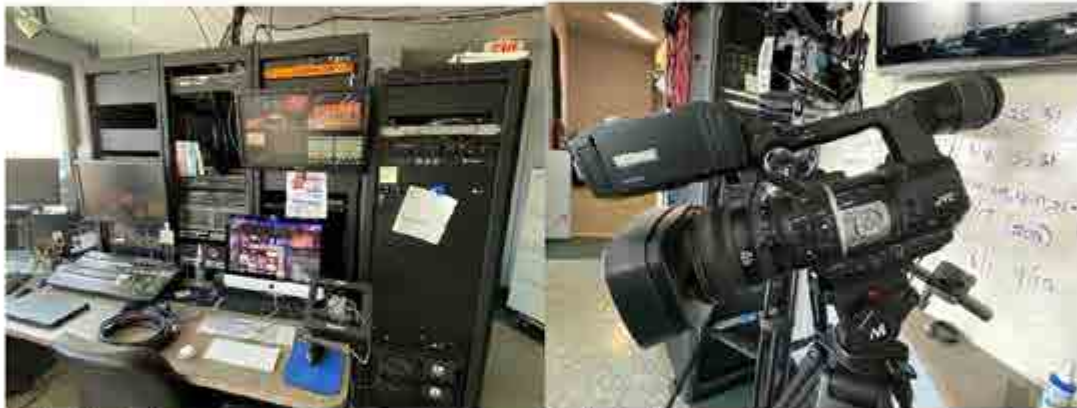
Production Racks

- The four cameras are not the same make/model, so there is color matching deficiencies when switching between cameras.
- Due to the size and type of production switcher, the ability to do two separate productions (one for scoreboard, one for MILB stream) is not possible. In this situation, the stream has to see everything that goes onto the scoreboard or go to a blank screen in order for the stadium to show commercials.

- Cabling and connections for cameras is very worn and corroded.

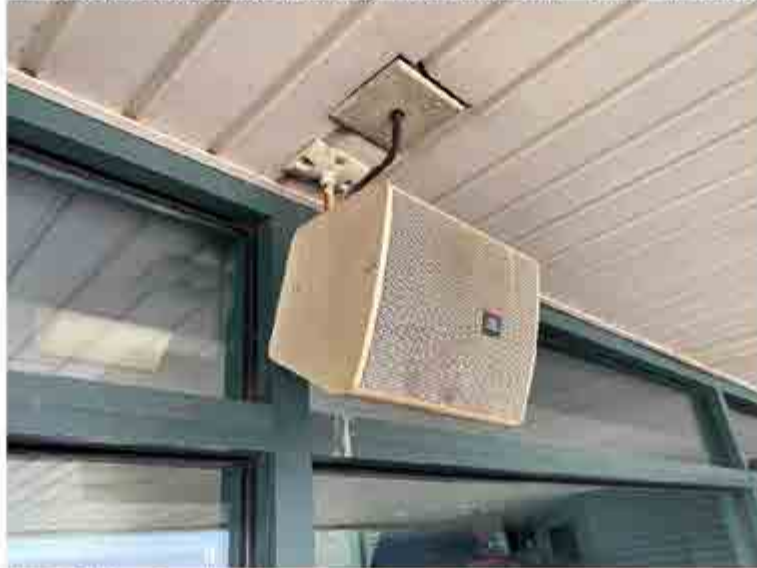
Suite Outdoor Speaker

- Some speakers are showing wear and tear and will need to be monitored.

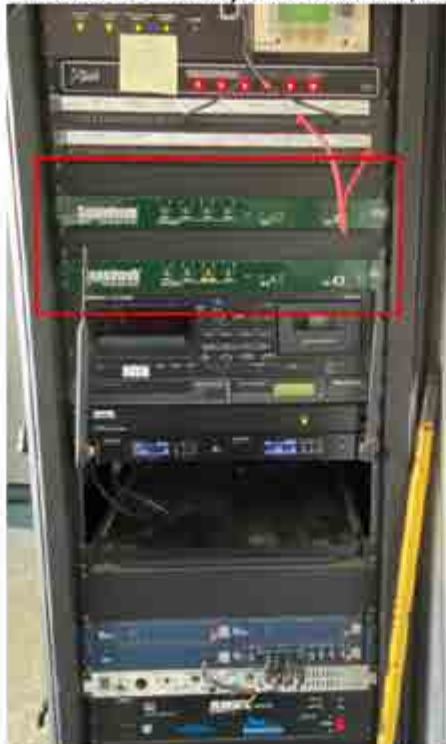
BSS Components

- There is no Assisted Listening System (ALS) for hearing impaired.
- The BSS Digital Signal Processors (DSP) have been out of production for quite some time. If any of those fail, major sections of sound will fail as well.

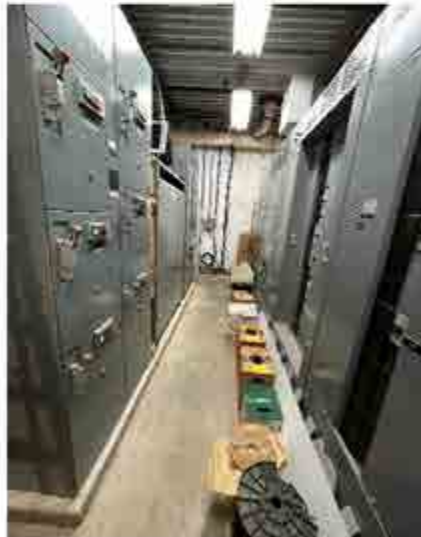
Electrical Switchgear in IT Shared Space

This is a shared space with electrical transformers and panels. A gypsum barrier wall protrudes between the IT portion of the room and fire pump room area. There is no dedicated HVAC system.

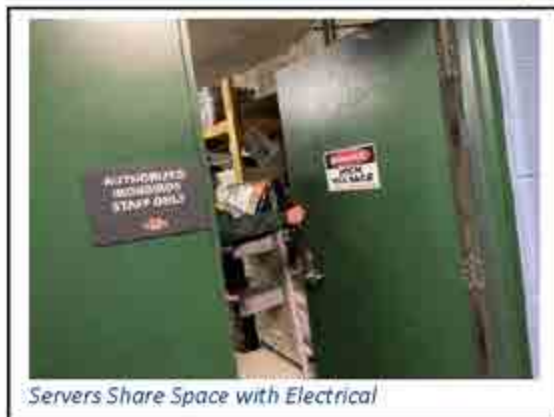
Servers Share Space with Electrical

The North Concourse IT room is the Server Room and contains a wall rack in a Storage room off a corridor on the North Concourse. This is a shared space. There is no dedicated HVAC system.

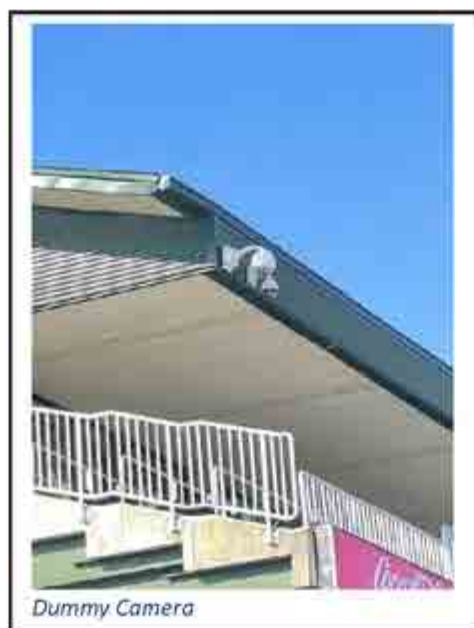
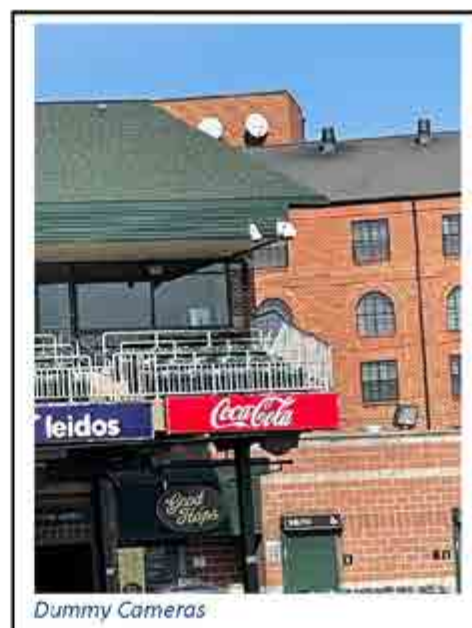
This facility had an analog surveillance system to cover the upper and partial lower bowl. It has fallen into disuse and is no longer operational. Cameras remain in place as psychological deterrent to unwanted activity. There is currently no active video surveillance at the facility.

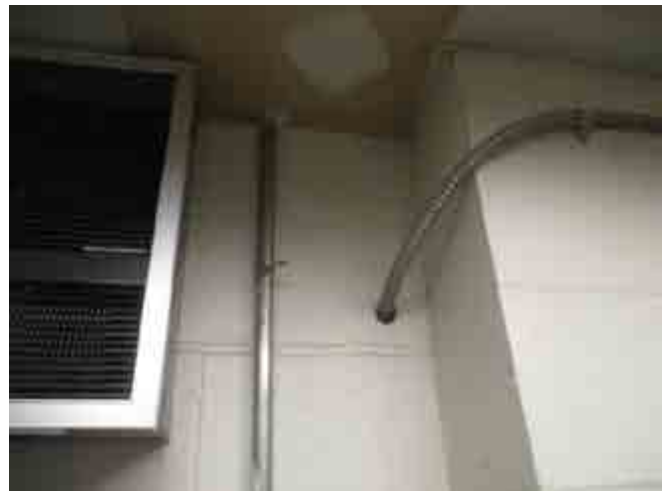
4. Relocate flexible conduit entering elevator #2 machine room

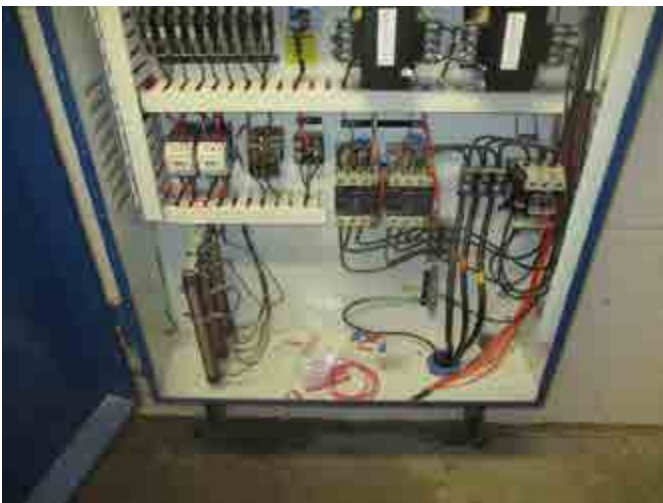
7. Clean out inside of controllers

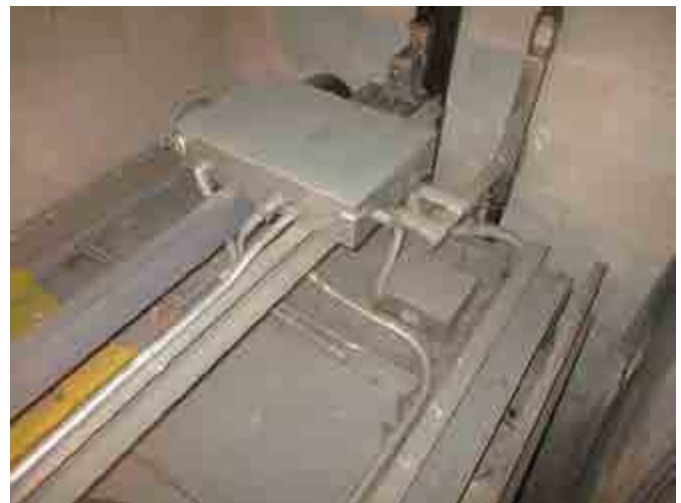
8. Clean cartops

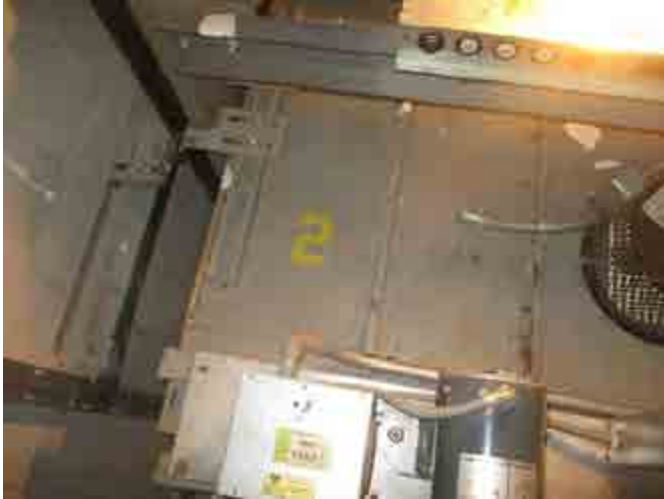
9. Clean cartops

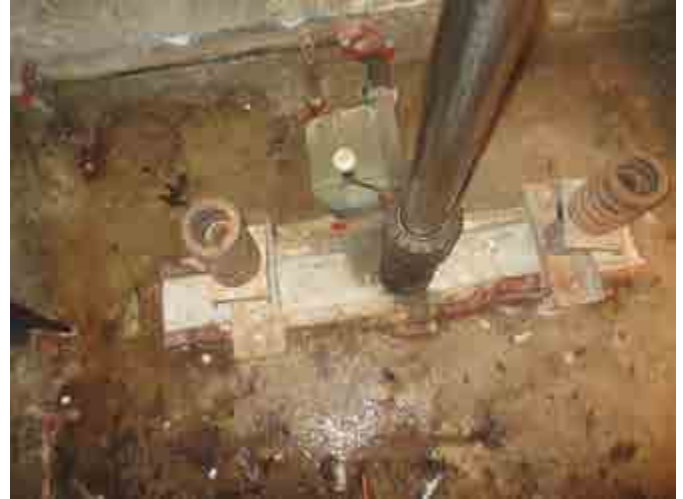
10. Clean pits

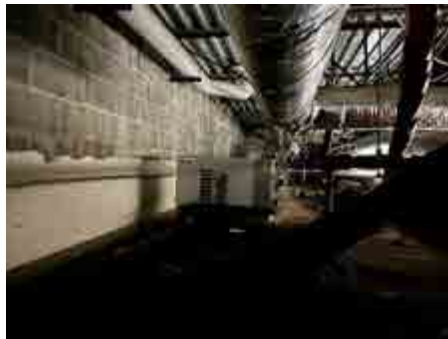
- The air-cooled condensing units for the walk-ins are installed in the plenum above the walk ins and it was reported they have difficulty maintaining temperature inside the boxes on hot summer days. The condensing units were sitting on top of the walk-in boxes themselves and this is not recommended when the condensing units are in excess of 150 lbs. Steps need to be taken right away to mitigate the issue of ineffective cooling of the remote condensing units.

- There are three (3) primary ways to address the issues with the condensing units: 1) introduce additional air movement in the plenum to reject the heat gain from the condensing units; 2) relocate the air-cooled units outdoors where heat rejection is not an issue; or 3) convert the air-cooled units in the plenum to water-cooled units which means tapping into a chilled water loop or purchasing a dedicated chiller. Probably the easiest and cleanest solution would be to take the condensing units outdoors but that means identifying an outdoor location and then finding a route to run liquid and suction refrigeration lines no more than 100 ft. **(FS-3)**

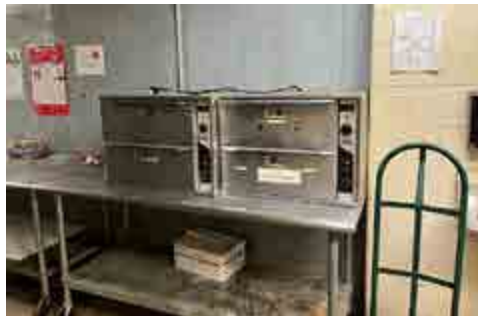
- To continue with the operating model currently in use, support foodservice equipment like stainless steel work tables and bulk heated holding cabinets should be replaced. **(FS-9, FS-10)**

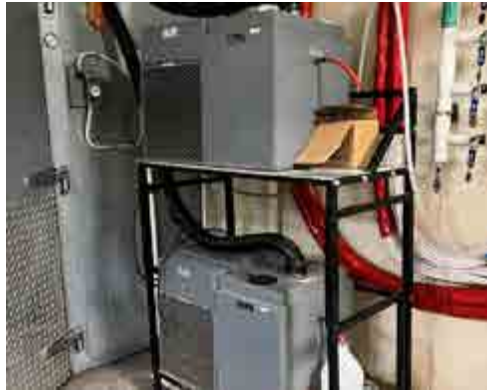
- Immediate support equipment for serving customers such as sandwich slides, heated transfer cabinets and warming drawers used to hold food items are nearing the end of their service life and will soon need to be replaced. **(FS-11)**
- The draft beer system has basically been the same since the ballpark opened with only one (1) reported repair made for a glycol leak. In 2002, Perlick ran the glycol through copper tubing rather than plastic tubing wrapped with metal tape so it is possible the trunk lines are still good, but after 20 years, it is likely the neoprene insulation needs to be replaced which is critical to maintaining proper serving temperature. We recommend the lines be evaluated by a service technician. **(FS-12)**

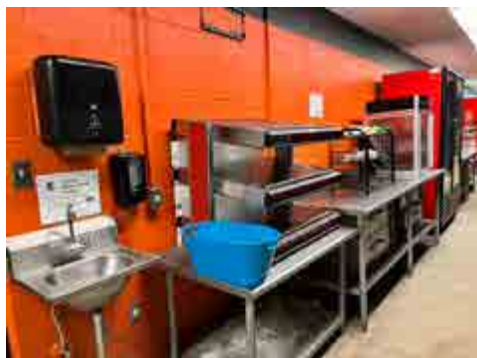
- The rear service line up of foodservice equipment includes a series of open frame stainless steel work tables with galvanized legs and undershelves. The galvanized metal is unsightly and foodservice surfaces made from material in that condition are frowned upon by local health officials. These tables should be replaced with the one modification being that the undershelves and legs be stainless steel as opposed to galvanized. **(FS-14)**

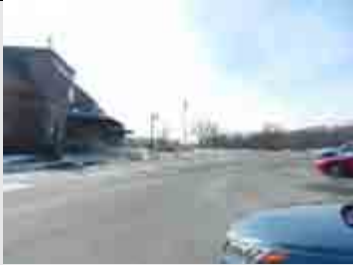
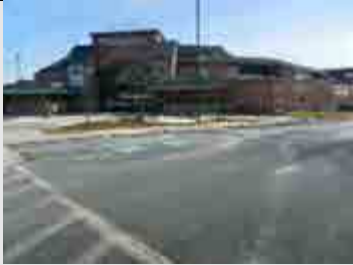
Exterior	4.	1	Accessible Parking Spaces (South)	Slope	Accessible parking spaces have excessive slope.	Parking spaces shall be level with surface with a slope not exceeding 1:48 (2.08%) in all directions.
Exterior	5.	1	Accessible Parking Space (North)	Parking Space	The accessible parking space is less than 96" wide at 93.5". This condition occurs at the northern most parking space.	Car parking spaces shall be 96 inches (2438 mm) minimum.
Exterior	6.	1	Accessible Parking Space (North)	Access Aisle	The access aisle is less than 60" ranging from 58.5" to 59.25". This condition occurs at multiple parking spaces.	All accessible spaces shall have access aisle of 60 inches wide minimum measured centerline to centerline.

Code Reference	Possible Solution	Image #1	Image #2
provided in l of 1,941 accessible per	ADAS 208.2	Determine if additional accessible parking is required. Coordinate with other accessible parking requirements.

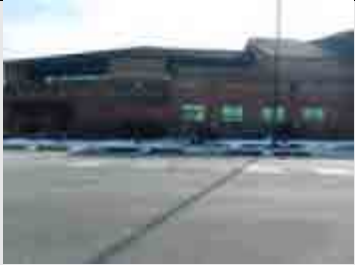
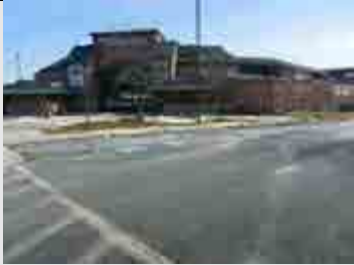
Location	Item #	Priority	Area	Element	Noncompliance Description	Requirement
Exterior	7.	1	Accessible Parking Space	Access Aisle	There is no signage identifying the accessible parking space. This condition occurs at multiple parking spaces.	Parking space identification signs shall be provided in accordance with COMAR 09.12.53.7 and the International Symbol of Accessibility.
Exterior	8.	1	Accessible Parking Space	Van Accessible Parking	There is insufficient number of van accessible parking spaces provided.	COMAR requires one in every four accessible parking spaces, but not less than one, shall be provided. The access aisle 96 inches minimum width and the accessible parking space shall be identified with supplemental "Van Accessible" sign.
Exterior	9.	1	Ramp from Accessible Parking	Slope	The running slope is greater than 1:12 (8.3%) and the cross slope exceeds 1:48 (2.08%) along the ramp from the southern parking area (Key 1).	The running slope of a ramp walking surface shall not exceed 1:12 (8.3%) and the cross slope of a ramp walking surface shall not be steeper than 1:48.

Code Reference	Possible Solution	Image #1	Image #2
be provided in cluding the	ADAS 502.3	Provide signage.

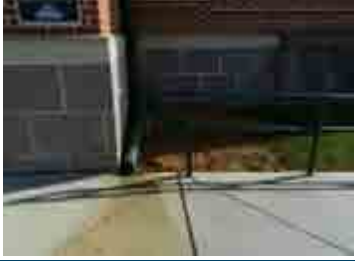
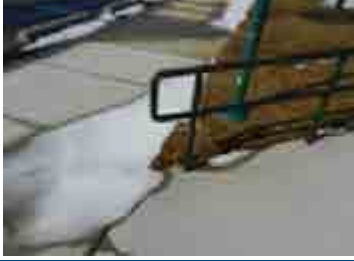
Exterior	10.	1	Ramp from Accessible Parking	Ramp Handrails	The handrails do not extend 12" minimum parallel to the walking surface at the top and bottom landing of the ramp.	Ramp handrails shall extend horizontally along the landing for 12 inches (305 mm) minimum at the top and bottom of ramp runs. Extension shall be to a wall, guard, or the landing surface, or continuous to the handrail of an adjacent ramp.
Exterior	11.	1	Walking Surface	Gaps	There are gaps greater than 1/2" wide and 1/4" deep along the accessible route from the accessible parking to the building entrance. This condition occurs at multiple locations.	Openings in floor or ground surfaces shall not allow the passage of a sphere more than 1/2 inch in diameter.
Exterior	12.	1	Walking Surface	Change in Level	There are vertical changes in level greater than 1/4" not beveled.	Changes in level greater than 1/4" but not more than 1/2" are to be beveled 1:2. Changes in level more than 1/2" are to be ramps.

y above the m beyond the s shall return to shall be t ramp run.	ADAS 505.10.1	Provide compliant handrail extensions. Coordinate with other ramp requirements.

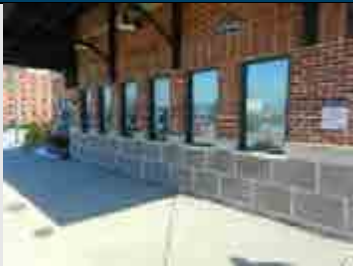
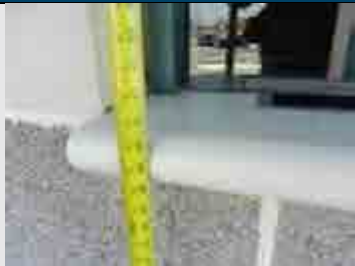
Location	Item #	Priority	Area	Element	Noncompliance Description	Requirement
Exterior	13.	2	Ticket Office	Service Counter	The service counter is too high at 40.5" aff.	Sales and service counters are to be no 36" aff.
Typical	14.	2	Signage	General	There is no tactile exit signage. This condition occurs at exit doors with illuminated exit signs.	Doors at exit passageways, exit discharge stairways shall be identified by tactile signs with 703.1, 703.2, and 703.5.
Typical	15.	2	Signage	Signage Height	Some tactile signage is mounted too high. This condition occurs at multiple tactile signs. Note: 1991 ADAAG permitted signage to mounted 60" aff measured to the centerline of the sign.	Tactile characters on signs shall be located (1220 mm) minimum above the finish floor surface, measured from the baseline of tactile character and 60 inches (1525 mm) above the finish floor or ground surface, from the baseline of the highest tactile character.

Code Reference	Possible Solution	Image #1	Image #2
higher than	ADAS 904.4.1	Modify and lower the counter.

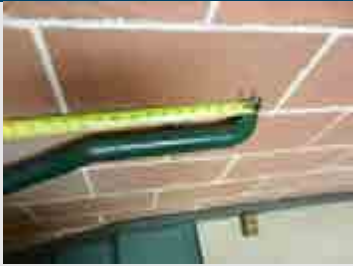
Location	Item #	Priority	Area	Element	Noncompliance Description	Requirement
Typical	20.	2	Stairs	Handrails	There is no handrail extension at the top landing. This condition was identified at the stair adjacent to the elevator.	At the top of a stair flight, handrails shall extend horizontally above the landing for 12 inches minimum beginning directly above the first step. Extensions shall return to a wall, guard, or handrail surface, or shall be continuous to the handrail of the adjacent stair flight.
Typical	21.	2	Assembly Seating	Aisle Seats	No designated aisle seats were identified. Though there are seats without armrests, they are not identified as accessible aisle seats.	At least 5 percent of the total number of seats provided are to comply with ADAS 802.4.1. Seats shall have folding or retractable armrests or no armrests located closest to accessible routes. Each designated aisle seat shall be identified by a sign or marking.

l extend ches (305 mm) rst riser nosing. or the landing ndrail of an	ADAS 505.10.2	Modify handrail.

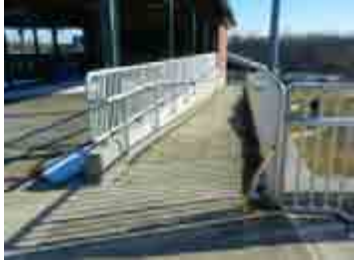
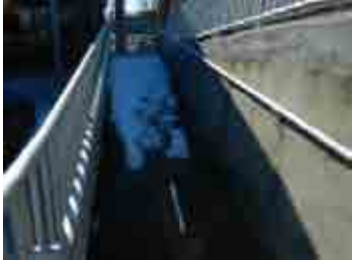
Location	Item #	Priority	Area	Element	Noncompliance Description	Requirement
Level 1	26.	2	Circulation	Drink shelf	The drink shelf protrudes more than 4" into the circulation path where the leading edge is below 80" aff. This condition occurs at both the North and South Concourse	Objects with leading edges more than 27 mm) and not more than 80 inches (2030 the finish floor or ground shall protrude 4 mm) maximum horizontally into the circul
Level 1	27.	2	Circulation	Picnic Table	No accessible picnic table identified. This condition occurs at the North and South Concourse and area near the home locker room.	Where dining surfaces are provided for the consumption of food or drink, at least 5 p seating spaces and standing spaces at the surfaces shall be accessible.
Level 1	28.	2	Circulation	South Concourse Ramp to Cross Aisle and Home Locker Room	There are multiple deficiencies along the ramp.	Ramps on accessible routes shall comply 405

y with ADAS	ADAS 405.1	Modify ramp.

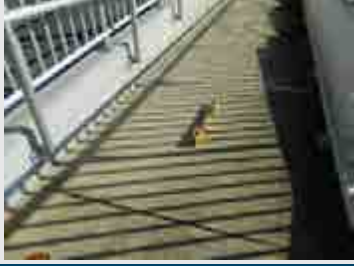
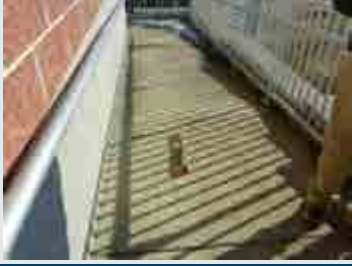
Level 1	29.	2	Circulation	South Concourse Ramp to Cross Aisle and Home Locker Room	The running slope is greater than 1:12 (8.3%) along the ramp run of up to 10.3% identified. This condition occurs at multiple points along the ramp.	Ramp runs shall have a running slope no 1:12.
Level 1	30.	2	Circulation	South Concourse Ramp to Cross Aisle and Home Locker Room	The cross slope is greater than 1:48 (2.08%) along the ramp run of up to 3.5% identified. This condition occurs at multiple points along the ramp.	Cross slope of ramp runs shall not be ste 1:48.
Level 1	31.	2	Circulation	South Concourse Ramp to Cross Aisle and Home Locker Room	The handrail is not continuous.	Handrails shall be continuous within the f each stair flight or ramp run

st steeper than	ADAS 405.2	Modify ramp.

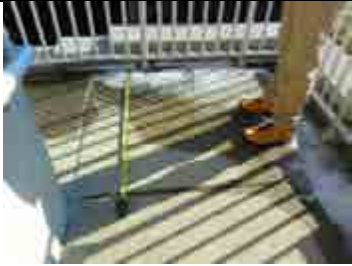
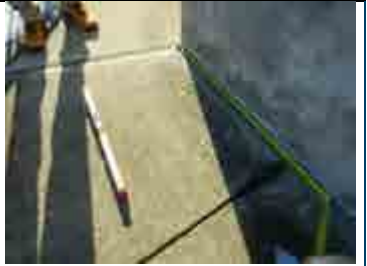
Location	Item #	Priority	Area	Element	Noncompliance Description	Requirement
Level 1	32.	2	Circulation	South Concourse Ramp to Cross Aisle and Home Locker Room	Top and bottom landings do not comply. Some landings do not have a length of 60" minimum.	Ramps shall have landings at the top and bottom of each ramp run. The landing clear length shall be 60 inches (1525 mm) long minimum.
Level 1	33.	2	Circulation	South Concourse Ramp to Cross Aisle and Home Locker Room	There are changes in level along the ramp and gaps greater than 1/2" wide.	Changes in level between 1/4 inch (6.4 mm) minimum and 1/2 inch (13 mm) high maximum shall be beveled with a slope not steeper than 1:2. Openings in floor or ground surfaces shall not allow the passage of a sphere more than 1/2 inch (13 mm) diameter.
Level 1	34.	2	Circulation	North Concourse Ramp to Cross Aisle	The running slope is greater than 1:12 (8.3%) along the ramp run of up to 8.8% identified	Ramp runs shall have a running slope not steeper than 1:12.

Code Reference	Possible Solution	Image #1	Image #2
and the bottom of shall be 60	ADAS 405.7	Modify ramp.

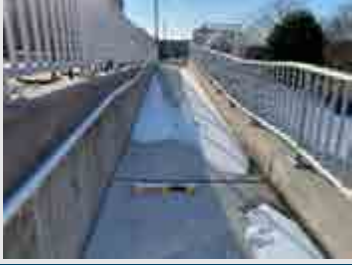
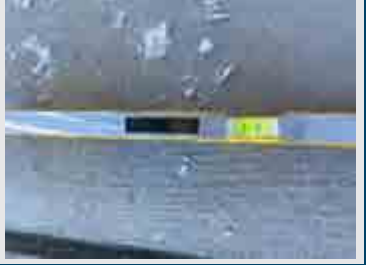
Level 1	35.	2	Circulation	North Concourse Ramp to Cross Aisle	The cross slope is greater than 1:48 (2.08%) along the ramp run of up to 3.0% identified.	Cross slope of ramp runs shall not be steeper than 1:48.
Level 1	36.	2	Circulation	North Concourse Ramp to Cross Aisle	Handrail is not provided on both sides of the ramp.	Handrails shall be provided on both sides of the ramp.
Level 1	37.	2	Circulation	Beverage Dispenser	Operable parts for the beverage dispenser are too high at approximately 52". This condition occurs at the picnic pavilion.	Elements are to be within accessible reach ranges. Where a clear floor or ground space allows for the approach to an element and the side reach is unobstructed, the high side reach shall be 48 inches (1220 mm) maximum and the low side reach shall be 15 inches (380 mm) minimum above the ground.

eeper than	ADAS 405.3	Modify ramp.

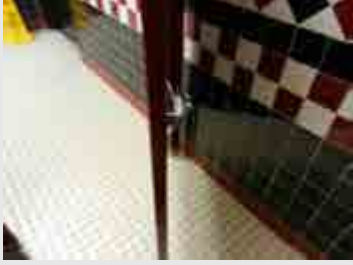
Level 1	49.	4	Ticket Office Men's Toilet Room	Accessible Compartment	The compartment door has a door pull on one side only.	A door pull complying with 404.2.7 shall be provided on both sides of the door near the latch.
Level 1	50.	4	Ticket Office Men's Toilet Room	Accessible Compartment	The clear floor space at the seat cover dispenser is obstructed and the seat cover dispenser is too high at 61" aff.	A clear floor space shall be provided at the seat cover dispenser. The seat cover dispenser shall be within the clear floor space and mounted no higher than 48" aff.

be placed on	ADAS 604.8.1.2	Install door pull

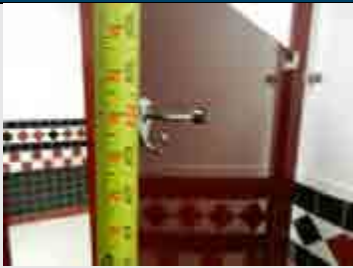
Location	Item #	Priority	Area	Element	Noncompliance Description	Requirement
Level 1	51.	4	Ticket Office Men's Toilet Room	Accessible Compartment	The coat hook is mounted too high at 64" aff.	Operable parts shall be mounted no higher than 48" aff.
Level 1	52.	4	Ticket Office Women's Toilet Room	Sink	The sink is mounted too high at 34.75" aff.	Lavatories and sinks shall be installed with the higher of the rim or counter surface 34" (863 mm) maximum above the finish floor or ground.
Level 1	53.	4	Ticket Office Women's Toilet Room	Mirror	The bottom of the reflecting surface is mounted higher than 40" aff at 42".	Mirrors located above lavatories or counters shall be installed with the bottom edge of the reflecting surface 40 inches (1015 mm) maximum above the finish floor or ground.
Level 1	54.	4	Ticket Office Women's Toilet Room	Accessible Compartment	The compartment door is not self-closing.	The door shall be self-closing.

Code Reference	Possible Solution	Image #1	Image #2
er than 48" aff.	ADAS 308	Relocate or install an additional coat hook.

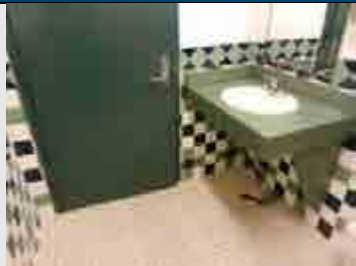
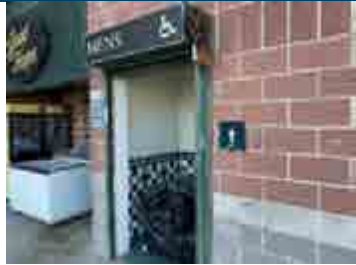
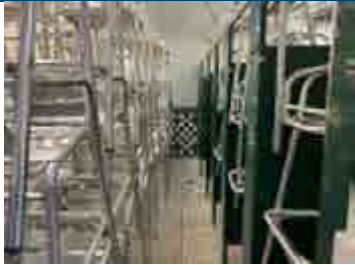
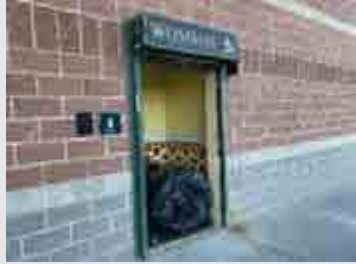
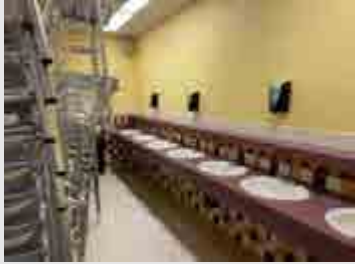
Code Reference	Possible Solution	Image #1	Image #2
Countertops shall be level with the finish floor	ADAS 603.3	Relocate mirror.

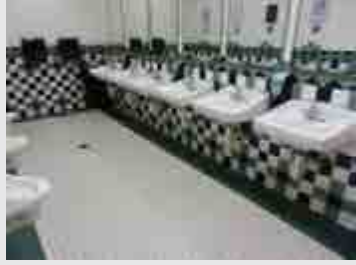
Level 1	61.	4	Team Shop Toilet Room	Sink	The sink is mounted too high at 34.5" aff.	Lavatories and sinks shall be installed with the higher of the rim or counter surface 36 inches (915 mm) maximum above the finish floor or ground.
Level 1	62.	4	Team Shop Toilet Room	Sink	The piping is not fully insulated.	Water supply and drain pipes under lavatories and sinks shall be insulated or otherwise covered to protect against contact. There shall be no exposed abrasive surfaces under lavatories and sinks.

Countertops shall be at least 34 inches (865 mm) high from the front of the counter to the ground.	ADAS 606.3	Alter sink.

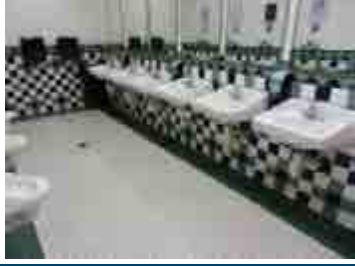
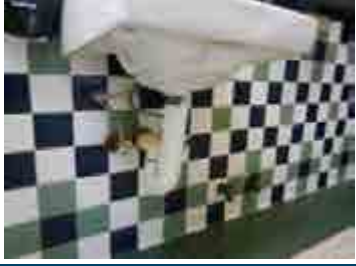
Level 1	68.	3	Men's Toilet Room (South)	Sink	The piping is not fully insulated.	Water supply and drain pipes under lavatories and sinks shall be insulated or otherwise covered to protect against contact. There shall be no exposed abrasive surfaces under lavatories and sinks.

Countertops shall be at least 34 inches (865 mm) high from the front of the counter to the ground.	ADAS 606.5	Install pipe protection.

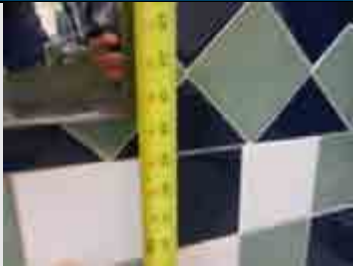
Location	Item #	Priority	Area	Element	Noncompliance Description	Requirement
Level 1	69.	3	Men's Toilet Room (South)	Mirror	The bottom of the reflecting surface is mounted higher than 40" aff at 40.75".	Mirrors located above lavatories or counters shall be installed with the bottom edge of the reflecting surface 40 inches (1015 mm) maximum above the finish floor or ground.
Level 1	70.	3	Men's Toilet Room (South)	Diaper Changing Station	The work surface of the changing station is too high at 40".	The tops of work surfaces shall be 28 inches (711 mm) minimum and 34 inches (865 mm) maximum above the finish floor or ground.
Level 1	71.	3	Men's Toilet Room (South)	Accessible Compartment	The compartment door is not self-closing.	The door shall be self-closing.
Level 1	72.	3	Men's Toilet Room (South)	Accessible Compartment	The compartment door has a door pull on one side only.	A door pull complying with 404.2.7 shall be provided on both sides of the door near the latch.

Code Reference	Possible Solution	Image #1	Image #2
Countertops shall be reflecting surface to the finish floor	ADAS 603.3	Relocate mirror.

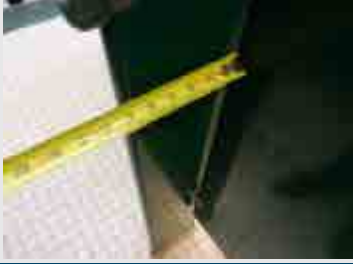
Level 1	73.	3	Men's Toilet Room (South)	Accessible Compartment	The door opening is greater than 4" from the corner at 6".	Where doors are located in the front part of the compartment, the opening shall be 4 inches (100 mm) maximum from the side wall or partition farthest from the wall.
Level 1	74.	3	Men's Toilet Room (South)	Side Grab Bar	The side grab bar is mounted greater than 12" from the rear wall at 13.75".	The side wall grab bar shall be 42 inches (1065 mm) long minimum, located 12 inches (305 mm) from the rear wall and extending 54 inches (1375 mm) minimum from the rear wall.

In addition, the door opening shall be a minimum from the water closet.	ADAS 604.8.1.2	Modify partition.

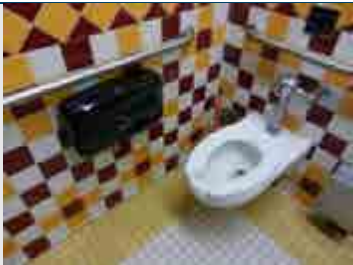
Level 1	85.	3	Women's Toilet Room (South)	Toilet	The flush valve of the toilet is on the wrong side.	Flush controls shall be hand operated or foot operated. Hand operated flush controls shall comply with 409.4. Flush controls shall be located on the opposite side of the water closet.
Level 1	86.	3	Women's Toilet Room (South)	Toilet Paper Dispenser	The centerline of the toilet paper dispenser is not 7-9" from the front edge of the toilet at 4.5".	Toilet paper dispensers shall comply with 409.5. The dispenser shall be 7 inches (180 mm) minimum and 9 inches (229 mm) maximum in front of the water closet. The centerline of the dispenser shall be 7-9 inches (178-229 mm) from the front edge of the toilet.

automatic. y with 309. en side of the	ADAS 604.6	Modify flush valve.

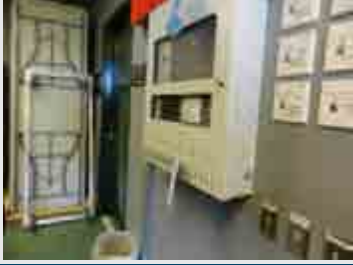
Level 1	91.	3	Family Toilet Room	Protruding Object	Fire alarm panel protrudes more than 4" into the circulation path where the leading edge is below 80" aff.	Objects with leading edges more than 27 mm) and not more than 80 inches (2030 the finish floor or ground shall protrude 4 mm) maximum horizontally into the circu
Level 1	92.	3	Family Toilet Room	Signage	Tactile characters are not sans serif.	Characters shall be sans serif.

7 inches (685 mm) above inches (100 lation path.	ADAS 307	Relocate fire alarm panel or provide cane detection.

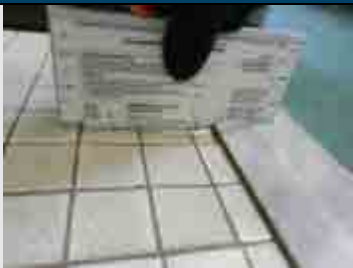
Location	Item #	Priority	Area	Element	Noncompliance Description	Requirement
Level 1	93.	3	Family Toilet Room	Door threshold	The door threshold is greater than ½" above the adjacent surface due to sloping tile.	Thresholds, if provided at doorways, shall be 13 mm (1/2") high maximum.
Level 1	94.	3	Family Toilet Room	Door Hardware	Thumb latch/door hardware requires grasping, pinching, or twisting of the wrist to operate.	Operable parts shall be operable with one hand. Operable parts shall not require tight grasping, pinching, or twisting of the wrist. The force required to activate controls shall be 5 pounds (22.2 N) maximum. Operable parts are to be within reach range.
Level 1	95.	2	Dining Terrace and Cafe	Dining Table	No accessible dining surfaces were identified. Pedestal tables do not comply with accessibility provisions as knee and toe clearance is obstructed. This condition occurs at tiered dining areas in left field and behind home plate.	Where dining surfaces are provided for the consumption of food or drink, at least 5 percent of the seating spaces and standing spaces at the dining surfaces shall be accessible. Dining surfaces are to provide knee and toe clearance in compliance with ADAS 902.2 including a minimum of 17" minimum.

Code Reference	Possible Solution	Image #1	Image #2
l be 1/2 inch	ADAS 404.2.5	Modify threshold and/or adjacent surface.

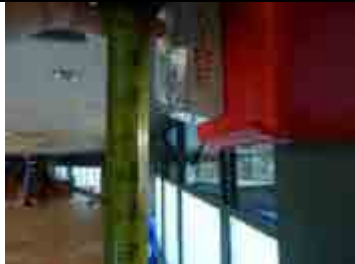
Location	Item #	Priority	Area	Element	Noncompliance Description	Requirement
Level 2	101.	2	Circulation	Protruding Object	The fire alarm protrudes more than 4" into the circulation path where the leading edge is below 80" aff. This condition occurs in both seating areas (North and South Club Box) on level two.	Objects with leading edges more than 27 mm) and not more than 80 inches (2030 mm) the finish floor or ground shall protrude 4 mm) maximum horizontally into the circ
Level 2	102.	2	Circulation	Fire Extinguisher	The fire extinguisher is mounted greater than 48" aff measured to the top of the extinguisher.	Elements are to be within accessible rea Where a clear floor or ground space allow approach to an element and the side rea unobstructed, the high side reach shall b (1220 mm) maximum and the low side re 15 inches (380 mm) minimum above the ground.
Level 2	103.	2	Circulation	Protruding Object	Television protrudes more than 4" into the circulation path where the leading edge is below 80" aff. This condition occurs in both seating areas (North and South Club Box) on level two.	Objects with leading edges more than 27 mm) and not more than 80 inches (2030 mm) the finish floor or ground shall protrude 4 mm) maximum horizontally into the circ

Code Reference	Possible Solution	Image #1	Image #2
7 inches (685 mm) above inches (100 lation path.	ADAS 307	Relocate fire alarm or provide cane detection.

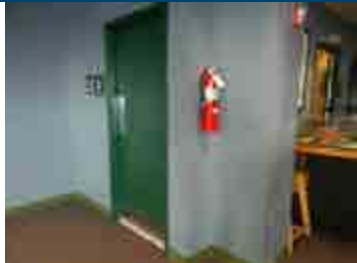
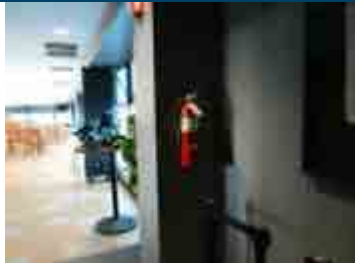
ch range. ws a parallel ch is e 48 inches each shall be finish floor or	ADAS 308.3	Relocate fire extinguisher.

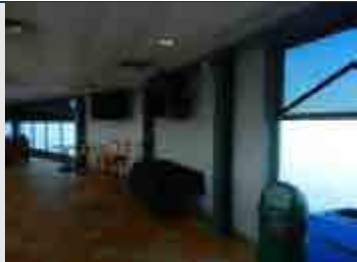
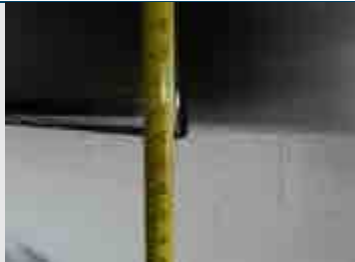
7 inches (685 mm) above inches (100 lation path.	ADAS 307	Relocate television or provide cane detection.

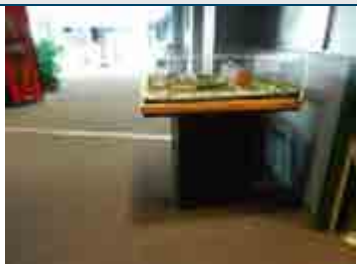
7 inches (685 mm) above inches (100 lation path.	ADAS 307	Relocate or provide cane detection.

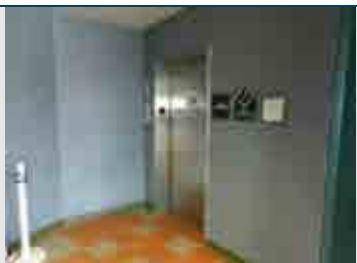
ADAS 703.2.3	Tactile characters are not sans serif.

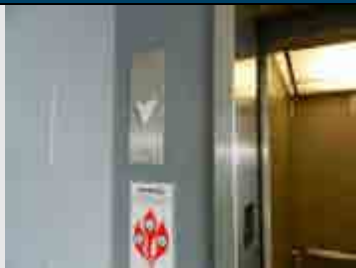
Location	Item #	Priority	Area	Element	Noncompliance Description	Requirement
Level 2	107.	4	Circulation	Service Elevator	There is no audible signal.	Audible signals shall sound once for the up direction and twice for the down direction, or shall have visual annunciators that indicate the direction of travel.
Level 2	108.	4	Drinking Fountain	Drinking Fountain	No high drinking fountain for standing persons was identified.	Where drinking fountains are provided, not less than two drinking fountains shall be provided. One drinking fountain shall comply with 602.6 and one drinking fountain shall comply with 602.7 for standing persons.
Level 2	109.	2	Buffet	Protruding Object	Signage hardware protrudes more than 4" into the circulation path where the leading edge is below 80" aff. This condition occurs at the bar service area across from the elevator.	Objects with leading edges more than 27 mm) and not more than 80 inches (2030 mm) above the finish floor or ground shall protrude 4 mm) maximum horizontally into the circulation path.

Code Reference	Possible Solution	Image #1	Image #2
up direction have verbal of elevator car	ADAS 407.2.2.3	Repair.

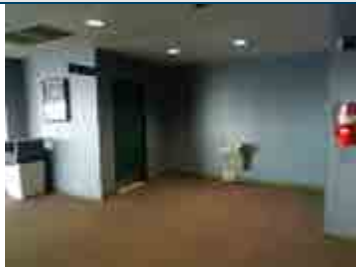
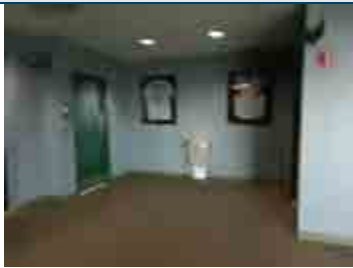
no fewer than on the floor. 602.1 through ply with	ADAS 211.2	Install high drinking fountain.

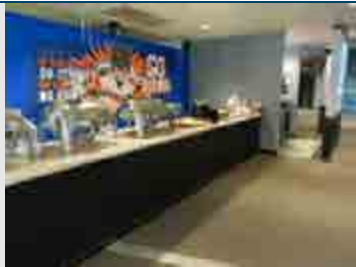
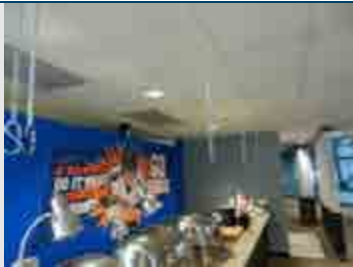
7 inches (685 mm) above inches (100 lation path.	ADAS 307	Relocate hardware.

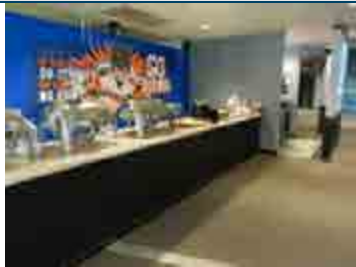
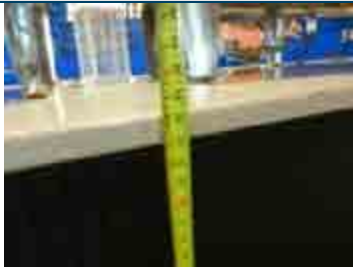
Level 2	110.	2	Buffet	Service Counter	The service counter is too high at 36.25" aff.	Sales and service counters are to be no more than 36" aff.
Level 2	111.	2	Buffet	Beverage Dispenser	Operable parts for the beverage dispenser are too high at approximately 54".	Elements are to be within accessible reach. Where a clear floor or ground space allows for a side approach to an element and the side reach is unobstructed, the high side reach shall be no more than 48 inches (1220 mm) maximum and the low side reach shall be no less than 15 inches (380 mm) minimum above the ground.
Level 2	112.	2	Concierge	Service Counter	The service counter is too high at 41" aff.	Sales and service counters are to be no more than 36" aff.

higher than	ADAS 904.4.1	Modfiy and/or lower the counter.

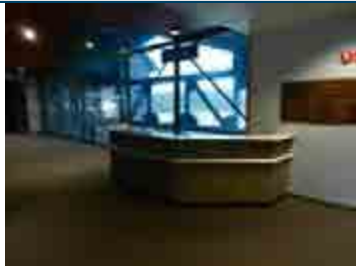
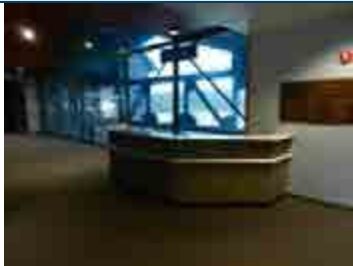
higher than	ADAS 904.4.1	Modify and/or lower the counter

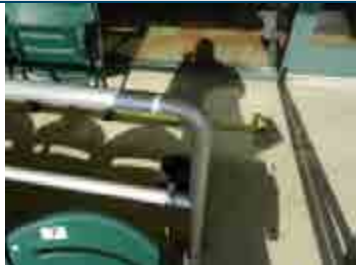
Location	Item #	Priority	Area	Element	Noncompliance Description	Requirement
Level 2	113.	2	Club Box	Wheelchair Space	The wheelchair space obstructs the door maneuvering clearance at some club box locations. This condition occurs at Club Box 12.	The wheelchair space should not obstruct the door maneuvering clearance.
Level 2	114.	2	Club Box	Wheelchair Space	The wheelchair space is less than 60" long due to the handrail where the approach is only from the side. This condition was identified at Club Box 5 and 11.	Where a wheelchair space can be entered from the front or rear, the wheelchair space shall be 60 inches (1525 mm) deep minimum. Where a wheelchair space can be entered only from the side, the wheelchair space shall be 60 inches (1525 mm) deep minimum.
Level 2	115.	2	Club Box	Door threshold	The door threshold is greater than ½" at 7/8".	Thresholds, if provided at doorways, shall be ½" (13 mm) high maximum.

Code Reference	Possible Solution	Image #1	Image #2
ct access.	ADAS 802.1.5	Modify adjacent seating and relocate wheelchair space.	 	
ed from the be 48 inches wheelchair space wheelchair ep minimum.	ADAS 802.1.3	Modfiy adjacent seating and relocate wheelchair space.

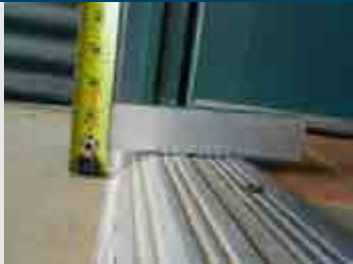
ll be 1/2 inch	ADAS 404.2.5	Modify threshold and/or adjacent surface.

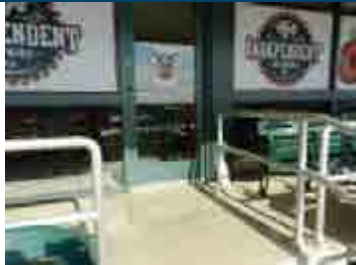
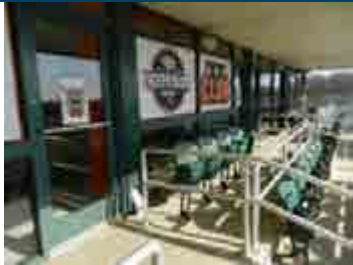
Level 2	116.	2	Club Box	Door	Door maneuvering clearance is obstructed on the push side of the door by a stair handrail. This condition was identified at Club Box 14.	Door maneuvering clearance is to be free of obstructions.
Level 2	117.	2	Box 1 Suite	Sink	The sink is too high at approximately 36" aff. (Furniture was in the room at the time of the survey. Unable to fully survey)	Lavatories and sinks shall be installed with the higher of the rim or counter surface 36" (915 mm) maximum above the finish floor or ground.
Level 2	118.	2	Box 1 Suite	Ceiling Fan	Operable parts for the ceiling fan were not identified. (Furniture was in the room at the time of the survey. Unable to fully survey)	Operable parts shall be operable with one hand, shall not require tight grasping, pinching, or the wrist. The force required to activate controls shall be 5 pounds (22.2 N) maximum. Operable parts are to be within reach range.

e of	ADAS 404.2.4	Modify handrail.

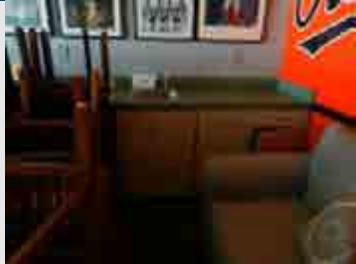
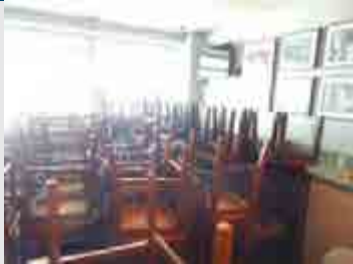
with the front of 34 inches (865 ground.	ADAS 606.3	Alter sink.

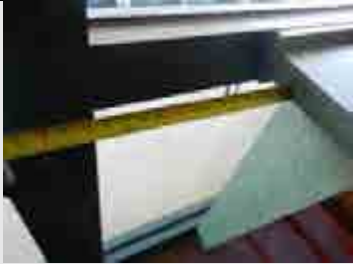
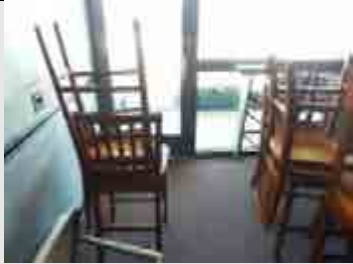
Location	Item #	Priority	Area	Element	Noncompliance Description	Requirement
Level 2	119.	2	Box 1 Suite	Door	Door maneuvering clearance is not provided on the pull side of the door due to a shelf. (Furniture was in the room at the time of the survey. Unable to fully survey)	18" min. clearance beyond the latch mechanism to the doorway is required on the pull side.
Level 2	120.	2	Box 1 Suite	Door	Door maneuvering clearance is obstructed on the push side of the door by a stair handrail.	Door maneuvering clearance is to be free of obstructions.
Level 2	121.	2	Box 1 Suite	Door	The door surface is not smooth due to a door stop.	Swinging door and gate surfaces within 18" (457 mm) of the finish floor or ground measurement shall have a smooth surface on the push side extending the full width of the door or gate.
Level 2	122.	3	Box 1 Toilet Room	Door Hardware	Thumb latch/door hardware requires grasping, pinching, or twisting of the wrist to operate.	Operable parts shall be operable with one hand, shall not require tight grasping, pinching, or twisting of the wrist. The force required to activate controls shall be 5 pounds (22.2 N) maximum. Operable parts are to be within reach range.

Code Reference	Possible Solution	Image #1	Image #2
Insured parallel e of the door.	ADAS 404.2.4	Alter the shelf.

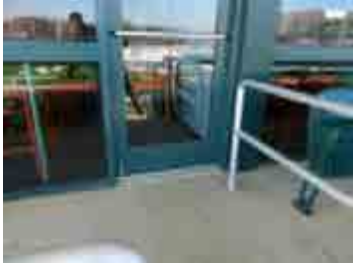
e of	ADAS 404.2.4	Modify handrail or relocate door.

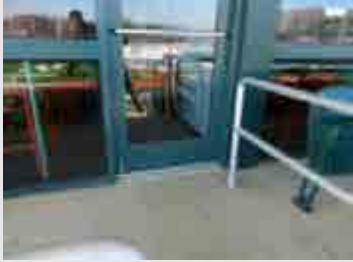
10 inches (255 ed vertically side te.	ADAS 404.2.10	Remove door stop.

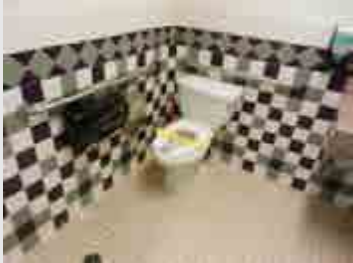
Level 2	123.	3	Box 1 Toilet Room	Toilet Clearance	The clearance at the toilet is less than 60" wide at 52.75".	Clearance around a water closet shall be 60 inches (1525 mm) minimum measured perpendicular to the side wall and 56 inches (1420 mm) minimum perpendicular from the rear wall.
Level 2	124.	3	Box 1 Toilet Room	Sink	The sink is mounted too high at 34.5" aff.	Lavatories and sinks shall be installed with the higher of the rim or counter surface 34 inches (863 mm) maximum above the finish floor or ground.

e hand and or twisting of operable parts operable parts	ADAS 309	Modify thumb latch.	No photo	
e 60 inches ircular from the num measured	ADAS 604.3.1	Modify lavatory.

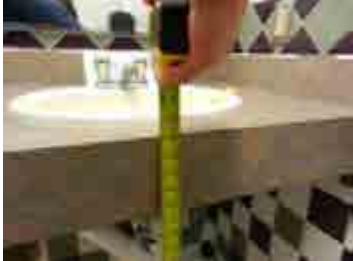
th the front of 4 inches (865 ground.	ADAS 606.3	Alter sink.

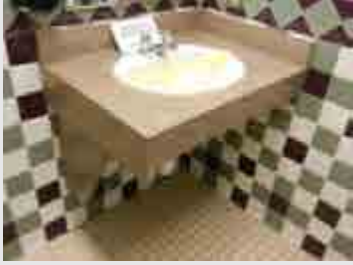
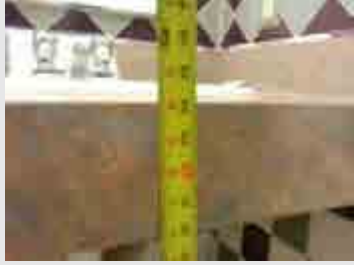
Level 2	141.	3	Box 3 Toilet Room	Sink	The sink is mounted too high at 34.5" aff.	Lavatories and sinks shall be installed with the top of the higher of the rim or counter surface 34 inches (863 mm) maximum above the finish floor or ground.
Level 2	142.	3	Box 3 Toilet Room	Mirror	The bottom of the reflecting surface is mounted higher than 40" aff at 41.5".	Mirrors located above lavatories or counters shall be installed with the bottom edge of the reflecting surface 40 inches (1015 mm) maximum above the finish floor or ground.
Level 2	143.	3	Box 3 Toilet Room	Control	Operable part requires grasping, pinching, or twisting of the wrist.	Operable parts shall be operable with one hand, shall not require tight grasping, pinching, or twisting of the wrist. The force required to activate controls shall be 5 pounds (22.2 N) maximum. Operable parts are to be within reach range.

Code Reference	Possible Solution	Image #1	Image #2
be 36 inches	ADAS 403.5.1	Relocate furniture.	 	
the hand and or twisting of operable parts operable parts	ADAS 309	Modify thumb latch.	 	
60 inches icular from the num measured	ADAS 604.3.1	Modify lavatory.	 	
th the front of 4 inches (865 ground.	ADAS 606.3	Alter sink.

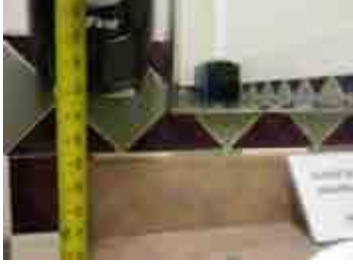
ertops shall be ecting surface e finish floor	ADAS 603.3	Relocate mirror.

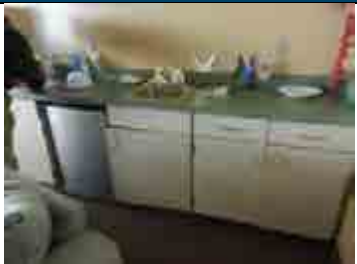
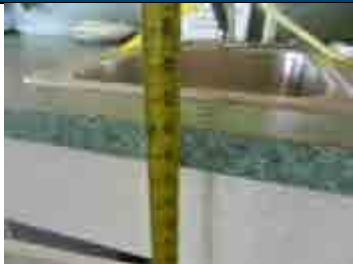
Location	Item #	Priority	Area	Element	Noncompliance Description	Requirement
Level 2	144.	2	Box 5 Suite	Sink	The sink is too high at approximately 36" aff.	Lavatories and sinks shall be installed with the higher of the rim or counter surface 36" (914 mm) maximum above the finish floor or ground.
Level 2	145.	2	Box 5 Suite	Ceiling Fan	Operable parts for the ceiling fan were not identified.	Operable parts shall be operable with one hand. They shall not require tight grasping, pinching, or twisting of the wrist. The force required to activate controls shall be 5 pounds (22.2 N) maximum. Operable parts are to be within reach range.
Level 2	146.	2	Box 5 Suite	Door	Door maneuvering clearance is not provided on the pull side of the door due to a shelf.	18" min. clearance beyond the latch mechanism to the doorway is required on the pull side.
Level 2	147.	3	Box 5 Toilet Room	Door Hardware	Thumb latch/door hardware requires grasping, pinching, or twisting of the wrist to operate.	Operable parts shall be operable with one hand. They shall not require tight grasping, pinching, or twisting of the wrist. The force required to activate controls shall be 5 pounds (22.2 N) maximum. Operable parts are to be within reach range.

Code Reference	Possible Solution	Image #1	Image #2
with the front of 34 inches (865 ground.	ADAS 606.3	Alter sink.

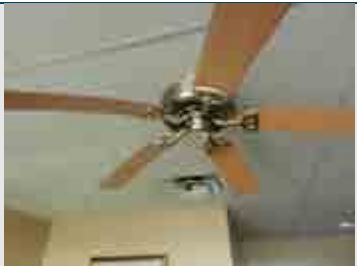
the hand and or twisting of operable parts operable parts	ADAS 309 and 308	Confirm operable part for ceiling fan is accessible.

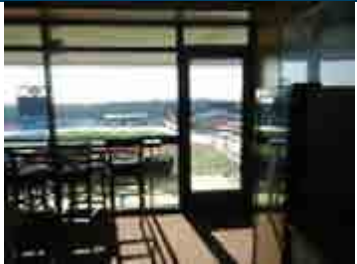
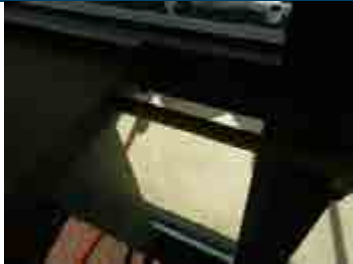
insured parallel e of the door.	ADAS 404.2.4	Alter the shelf.

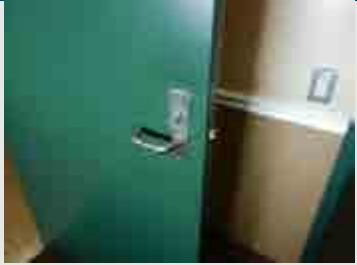
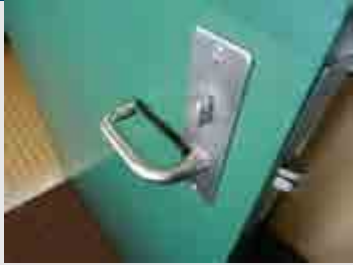
the hand and or twisting of operable parts operable parts	ADAS 309	Modify thumb latch.

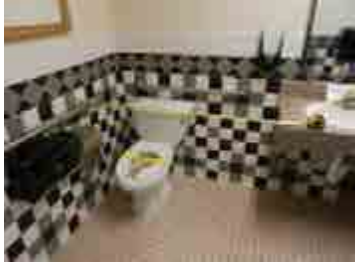
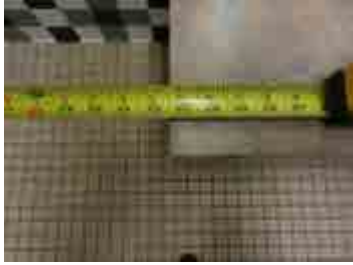
Level 2	148.	3	Box 5 Toilet Room	Toilet Clearance	The clearance at the toilet is less than 60" wide at 52.5".	Clearance around a water closet shall be 60 inches (1525 mm) minimum measured perpendicular to the side wall and 56 inches (1420 mm) minimum perpendicular from the rear wall.
Level 2	149.	3	Box 5 Toilet Room	Side Grab Bar	The side grab bar is mounted greater than 12" from the rear wall at 13.5".	The side wall grab bar shall be 42 inches long minimum, located 12 inches (305 mm) from the rear wall and extending 54 inches minimum from the rear wall.

e 60 inches icular from the mum measured	ADAS 604.3.1	Modify lavatory.

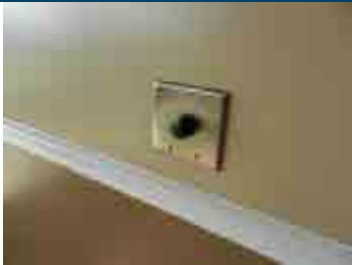
Level 2	154.	2	Box 6 Suite	Audio Control	Audio control requires grasping, pinching, or twisting of the wrist to operate.	Operable parts shall be operable with one hand, shall not require tight grasping, pinching, or the wrist. The force required to activate controls shall be 5 pounds (22.2 N) maximum. Operable parts are to be within reach range.
Level 2	155.	2	Box 6 Suite	Door	Door maneuvering clearance is not provided on the pull side of the door due to a shelf.	18" min. clearance beyond the latch mechanism to the doorway is required on the pull side of the door.

e hand and or twisting of operable parts operable parts	ADAS 309 and 308	Confirm operable part for ceiling fan is accessible.	No photo	
e hand and or twisting of operable parts operable parts	ADAS 309	Modify control.

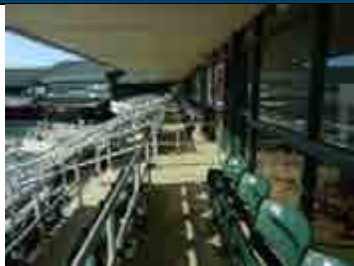
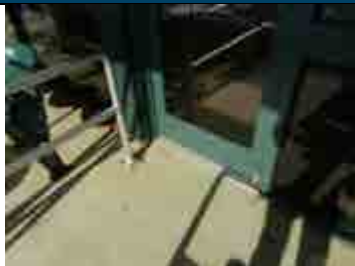
Location	Item #	Priority	Area	Element	Noncompliance Description	Requirement
Level 2	156.	2	Box 6 Suite	Door	Door maneuvering clearance is obstructed on the push side of the door by a stair handrail.	Door maneuvering clearance is to be free of obstructions.
Level 2	157.	2	Box 6 Suite	Door	The door surface is not smooth due to a door stop.	Swinging door and gate surfaces within 18 inches (457 mm) of the finish floor or ground measure shall have a smooth surface on the push side extending the full width of the door or gate.
Level 2	158.	3	Box 6 Toilet Room	Door Hardware	Thumb latch/door hardware requires grasping, pinching, or twisting of the wrist to operate.	Operable parts shall be operable with one hand. They shall not require tight grasping, pinching, or twisting of the wrist. The force required to activate controls shall be 5 pounds (22.2 N) maximum. Operable parts are to be within reach range.

Code Reference	Possible Solution	Image #1	Image #2
of	ADAS 404.2.4	Modify handrail or relocate door.
