LEIDOS FIELD AT RIPKEN STADIUM

Assessment Report | July 8, 2022

EXECUTIVE SUMMARY

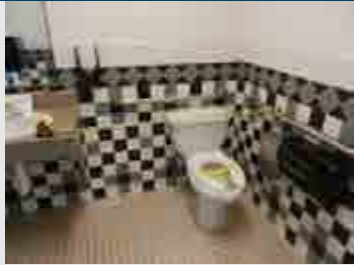
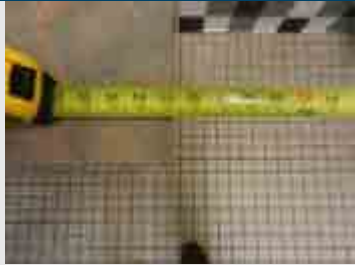
Level 2	159.	3	Box 6 Toilet Room	Toilet Clearance	The clearance at the toilet is less than 60" wide at 52.75".	Clearance around a water closet shall be 60 inches (1525 mm) minimum measured perpendicular to the side wall and 56 inches (1420 mm) minimum perpendicular from the rear wall.
Level 2	160.	3	Box 6 Toilet Room	Sink	The sink is mounted too high at 34.5" aff.	Lavatories and sinks shall be installed with the higher of the rim or counter surface 34 inches (863 mm) maximum above the finish floor or ground.
Level 2	161.	2	Club Bar	Service Counter	The service counter is too high at 36.5" aff.	Sales and service counters are to be no higher than 36 inches (914 mm) aff.

60 inches ircular from the um measured	ADAS 604.3.1	Modify lavatory.

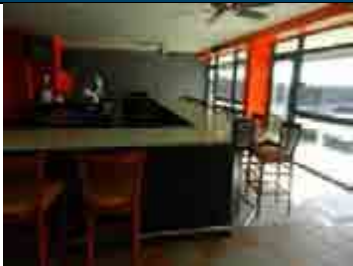
Location	Item #	Priority	Area	Element	Noncompliance Description	Requirement
Level 2	162.	2	Club Bar	Bar Seating	There is no accessible seating at the bar.	Where dining surfaces are provided for the consumption of food or drink, at least 5 p seating spaces and standing spaces at the surfaces shall comply with 902.
Level 2	163.	2	Club Bar	Seating	There are no accessible tables provided as no tables have compliant knee and toe clearance.	Where dining surfaces are provided for the consumption of food or drink, at least 5 p seating spaces and standing spaces at the surfaces shall comply with 902.
Level 2	164.	4	Press Box	Door Maneuvering Clearance	Door maneuvering clearance is not provided on the push side and pull side of the door. Door maneuvering clearance is less than 12" beyond the latch for a forward approach on the push side of the door and less than 54" measured perpendicular from the doorway for a latch approach at 52.5" on the pull side of the door.	12" min. clearance beyond the latch mea to the doorway is required on the push side for a forward approach to a door with a c latch. 54" min. clearance beyond the latch mea perpendicular to the doorway is required side of the door for a door with a closer.

Code Reference	Possible Solution	Image #1	Image #2
the percent of the the dining	ADAS 226.1	Modify and provide a lower portion of the bar.

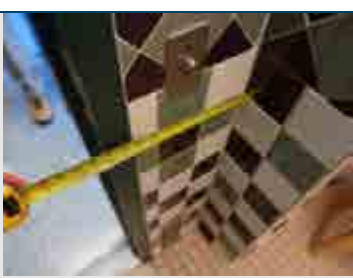
Level 2	165.	4	Press Box Toilet Room	Door Maneuvering Clearance	Door maneuvering clearance is not provided on the pull side of the door.	Maneuvering clearances for forward app provided when any obstruction within 18 mm) of the latch side of a doorway proje 8 inches (205 mm) beyond the face of the measured perpendicular to the face of the
Level 2	166.	4	Press Box Toilet Room	Toilet	The flush valve of the toilet is on the wrong side.	Flush controls shall be hand operated or Hand operated flush controls shall compl Flush controls shall be located on the op water closet
Level 2	167.	4	Press Box Toilet Room	Sink	The sink is mounted too high at 34.25" aff.	Lavatories and sinks shall be installed wi the higher of the rim or counter surface 3 mm) maximum above the finish floor or g

roach shall be inches (455 acts more than e door, e door or gate.	ADAS 404.2.4.3	Install auto door opener.

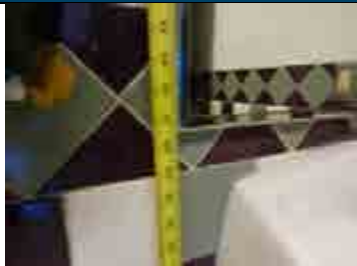
Location	Item #	Priority	Area	Element	Noncompliance Description	Requirement
Level 2	168.	4	Press Box Toilet Room	Mirror	The bottom of the reflecting surface is mounted higher than 40" aff at 41".	Mirrors located above lavatories or counters shall be installed with the bottom edge of the reflecting surface 40 inches (1015 mm) maximum above the finish floor or ground.
Level 2	169.	4	Press Box Toilet Room	Faucet	The hot water faucet does not remain open for 10 seconds minimum.	Controls for faucets shall comply with 301.10. Operated metering faucets shall remain open for 10 seconds minimum.
Level 2	170.	4	Press Box Toilet Room	Feminine Napkin Dispenser	Feminine napkin dispenser requires grasping, pinching, or twisting of the wrist to operate.	Operable parts shall be operable with one hand, open fist, without tight grasping, pinching, or twisting of the wrist. The force required to activate controls shall be 5 pounds (22.2 N) maximum. Operable parts are to be within reach range.

Code Reference	Possible Solution	Image #1	Image #2
tertops shall be ecting surface ne finish floor	ADAS 603.3	Relocate mirror.

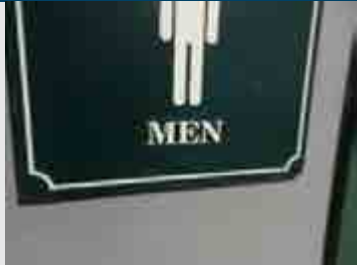
Level 2	171.	3	Men's Toilet Room near elevator (North)	Signage	Tactile characters are not sans serif.	Characters shall be sans serif.
Level 2	172.	3	Men's Toilet Room near elevator (North)	Door threshold	The door threshold is greater than 1/2" above the adjacent surface due to sloping tile.	Thresholds, if provided at doorways, shall be 1/2" (13 mm) high maximum.
Level 2	173.	3	Men's Toilet Room near elevator (North)	Sink	The sink is mounted too high at 34.5" aff.	Lavatories and sinks shall be installed with the rim or counter surface 34" (863 mm) maximum above the finish floor or ground.

ADAS 703.2.3	Replace signage with compliant type.

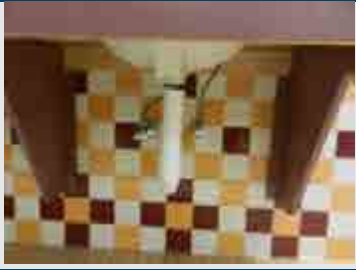
Level 2	184.	3	Women's Toilet Room near elevator (North)	Sink	The sink is mounted too high at 34.5" aff.	Lavatories and sinks shall be installed wi the higher of the rim or counter surface 3 (mm) maximum above the finish floor or g
Level 2	185.	3	Women's Toilet Room near elevator (North)	Sink	The piping is not fully insulated.	Water supply and drain pipes under lavat sinks shall be insulated or otherwise conf protect against contact. There shall be no abrasive surfaces under lavatories and si

ories and figured to o sharp or inks.	ADAS 606.5	Install pipe protection.

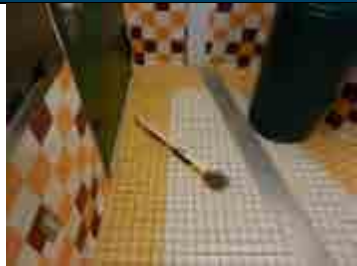
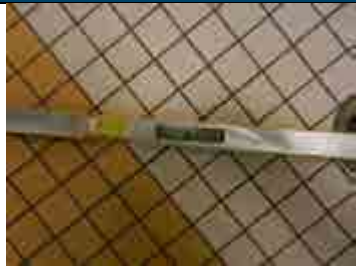
Level 2	190.	3	Women's Toilet Room near elevator (North)	Accessible Compartment	The door opening is greater than 4" from the corner at 5.5".	Where doors are located in the front partition, the door opening shall be 4 inches (100 mm) maximum from the side wall or partition farthest from the wall.
Level 2	191.	3	Women's Toilet Room near elevator (North)	Accessible Compartment	The clear floor space at the seat cover dispenser is obstructed and the seat cover dispenser is too high at 61" aff.	A clear floor space shall be provided at the seat cover dispenser. The seat cover dispenser shall be within the clear floor space and mounted no higher than 48" aff.

Code Reference	Possible Solution	Image #1	Image #2
Will not be	ADAS 403.3	Alter floor to reduce slope to no greater than 1:48.

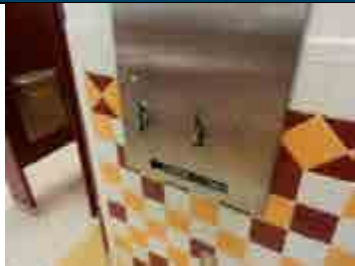
Location	Item #	Priority	Area	Element	Noncompliance Description	Requirement
Level 2	192.	3	Women's Toilet Room near elevator (North)	Feminine Napkin Dispenser	Feminine napkin dispenser requires grasping, pinching, or twisting of the wrist to operate.	Operable parts shall be operable with o shall not require tight grasping, pinching the wrist. The force required to activate shall be 5 pounds (22.2 N) maximum. C are to be within reach range.
Level 2	193.	3	Men's Toilet Room (South)	Signage	Tactile characters are not sans serif.	Characters shall be sans serif.
Level 2	194.	3	Men's Toilet Room (South)	Door	Door maneuvering clearance is not level due to a drain. The adjacent slope is 3.1%	The slope of the door maneuvering clear be steeper than 1:48 (2.08%) in any dire
Level 2	195.	3	Men's Toilet Room (South)	Sink	The sink is mounted too high at 34.75" aff.	Lavatories and sinks shall be installed v the higher of the rim or counter surface mm) maximum above the finish floor or

Code Reference	Possible Solution	Image #1	Image #2
the hand and g, or twisting of operable parts operable parts	ADAS 309	Modify control.

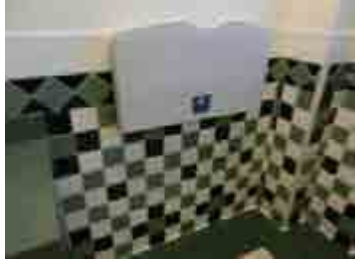
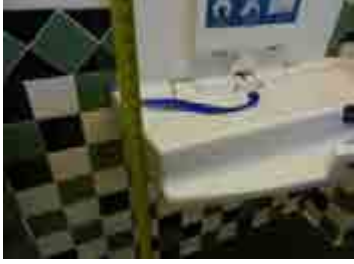
Level 2	196.	3	Men's Toilet Room (South)	Diaper Changing Station	The work surface of the changing station is too high at 38".	The tops of work surfaces shall be 28 in minimum and 34 inches (865 mm) maxi finish floor or ground.
Level 2	197.	3	Men's Toilet Room (South)	Accessible Compartment	The compartment door is not self-closing.	The door shall be self-closing.

ches (710 mm) mum above the	ADAS 902.3	Relocate the changing station.

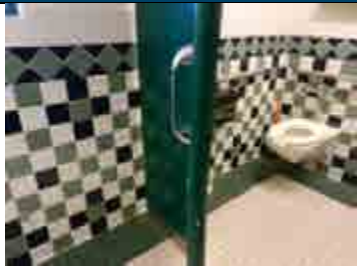
Location	Item #	Priority	Area	Element	Noncompliance Description	Requirement
Level 2	198.	3	Men's Toilet Room (South)	Accessible Compartment	The compartment door has a door pull on one side only.	A door pull complying with 404.2.7 shall be provided on both sides of the door near the latch.
Level 2	199.	3	Men's Toilet Room (South)	Accessible Compartment	The door opening is greater than 4" from the corner at 5".	Where doors are located in the front partition, the door opening shall be 4 inches (100 mm) maximum from the side wall or partition farthest from the wall.
Level 2	200.	3	Men's Toilet Room (South)	Accessible Compartment	The clear floor space at the seat cover dispenser is obstructed and the seat cover dispenser is too high at 61" aff.	A clear floor space shall be provided at the seat cover dispenser. The seat cover dispenser shall be within 48" of the floor and mounted no higher than 48" aff.

Code Reference	Possible Solution	Image #1	Image #2
be placed on	ADAS 604.8.1.2	Install door pull

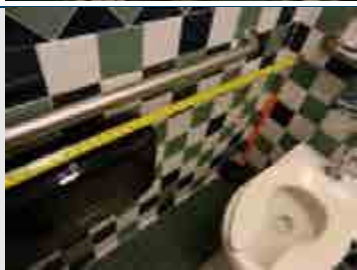
Level 2	201.	3	Men's Toilet Room (South)	Toilet Paper Dispenser	The centerline of the toilet paper dispenser is not 7-9" from the front edge of the toilet at 12".	Toilet paper dispensers shall comply with 405.2.1. The dispenser shall be 7 inches (180 mm) minimum and 9 inches (225 mm) maximum in front of the water closet. The centerline of the dispenser shall be 7-9 inches (180-225 mm) from the front edge of the toilet.
Level 2	202.	3	Women's Toilet Room (South)	Signage	Tactile characters are not sans serif.	Characters shall be sans serif.
Level 2	203.	3	Women's Toilet Room (South)	Door threshold	The door threshold is greater than 1/2" above the adjacent surface due to sloping tile.	Thresholds, if provided at doorways, shall not be more than 1/2 inch (13 mm) high maximum.

n 309.4 and d 9 inches (230 et measured to	ADAS 604.7	Relocate toilet paper dispenser.

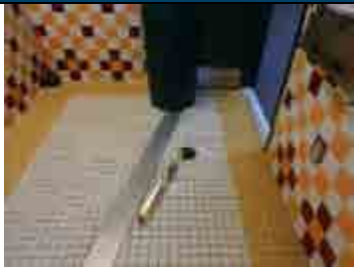
Location	Item #	Priority	Area	Element	Noncompliance Description	Requirement
Level 2	204.	3	Women's Toilet Room (South)	Door	Door maneuvering clearance is not level due to a drain. The adjacent slope is 4.1%	The slope of the door maneuvering clearance shall not be steeper than 1:48 (2.08%) in any direction.
Level 2	205.	3	Women's Toilet Room (South)	Door	There is a level change within the door maneuvering clearance.	Changes in level between 1/4 inch (6.4 mm) maximum and 1/2 inch (13 mm) high maximum shall be beveled with a slope not steeper than 1:2.
Level 2	206.	3	Women's Toilet Room (South)	Sink	The sink is mounted too high at 34.75" aff.	Lavatories and sinks shall be installed with the top of the rim or counter surface 34 inches (865 mm) maximum above the finish floor or ground.
Level 2	207.	3	Women's Toilet Room (South)	Diaper Changing Station	The work surface of the changing station is too high at 38".	The tops of work surfaces shall be 28 inches (711 mm) minimum and 34 inches (865 mm) maximum above the finish floor or ground.

Code Reference	Possible Solution	Image #1	Image #2
ance shall not ction.	ADAS 404.2.4.4	Modfiy floor surface.

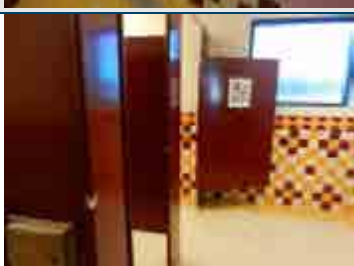
Level 2	208.	3	Women's Toilet Room (South)	Accessible Compartment	The compartment door is not self-closing.	The door shall be self-closing.
Level 2	209.	3	Women's Toilet Room (South)	Accessible Compartment	The compartment door has a door pull on one side only.	A door pull complying with 404.2.7 shall be provided on both sides of the door near the latch.

ADAS 604.8.1.2	Modfiy door hardware as needed.

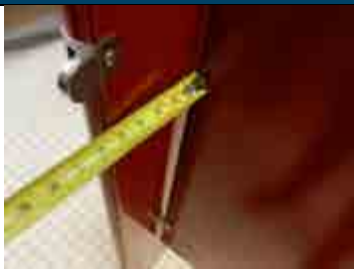
Location	Item #	Priority	Area	Element	Noncompliance Description	Requirement
Level 2	210.	3	Women's Toilet Room (South)	Accessible Compartment	The door opening is greater than 4" from the corner at 5".	Where doors are located in the front part opening shall be 4 inches (100 mm) maximum side wall or partition farthest from the wall.
Level 2	211.	3	Women's Toilet Room (South)	Accessible Compartment	The clear floor space at the seat cover dispenser is obstructed and the seat cover dispenser is too high at 61" aff.	A clear floor space shall be provided at the seat cover dispenser. The seat cover dispenser shall be within reach range and mounted no higher than 48" aff.
Level 2	212.	3	Women's Toilet Room (South)	Feminine Napkin Dispenser	Feminine napkin dispenser requires grasping, pinching, or twisting of the wrist to operate.	Operable parts shall be operable with one hand. The force required to activate or operate shall not require tight grasping, pinching, or twisting of the wrist. The force required to activate or operate shall be 5 pounds (22.2 N) maximum. Operable parts shall be within reach range.

Code Reference	Possible Solution	Image #1	Image #2
ition, the door imum from the ter closet.	ADAS 604.8.1.2	Modfiy partition.

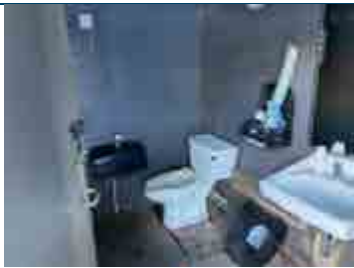
Dugout	213.	3	Dugout	Toilet Room	There are no accessible features in the dugout toilet room. One toilet room was locked at the time of the survey.	Where toilet rooms are provided, they shall be accessible.
Dugout	214.	2	Dugout	Player Seating	Player seating is not located on an accessible route and there is no accessible player seating provided.	At least one accessible route shall connect building or facility entrances with all accessible routes and elements within the building or facility, and otherwise connected by a circulation path. At least one wheelchair space shall be provided in team or player seating areas serving areas of activity.
Locker Room – Home Clubhouse	215.	2	Locker Room	Lockers	No accessible lockers were identified. This condition occurs in the Coaches Locker Room and Players Locker Room.	Lockers are to be accessible. Where lockers are provided, at least 5 percent, but no fewer than 3 lockers of each type, shall be accessible. Storage elements shall comply with accessibility provisions including reach range and operable parts.

e hand and or twisting of perable parts perable parts	ADAS 309	Modify control.	No photo	
all be	ADAS 213.1	Modify toilet room.

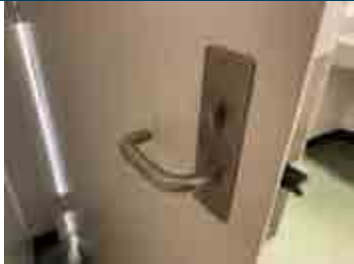
Locker Room – Home Clubhouse	216.	3	Manager Bathroom	Door Hardware	Thumb latch/door hardware requires grasping, pinching, or twisting of the wrist to operate.	Operable parts shall be operable with one hand. The force required to activate or operate shall not require tight grasping, pinching, or twisting of the wrist. The force required to activate or operate shall be 5 pounds (22.2 N) maximum. Operable parts shall be within reach range.

e hand and or twisting of perable parts perable parts	ADAS 309	Modify thumb latch.

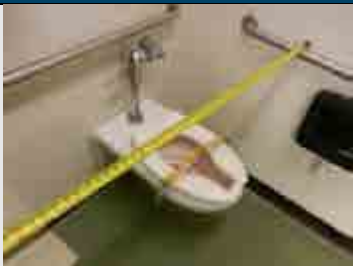
Location	Item #	Priority	Area	Element	Noncompliance Description	Requirement
Locker Room – Home Clubhouse	217.	3	Manager Bathroom	Toilet Clearance	The clearance at the toilet is less than 60" wide at 46".	Clearance around a water closet shall be (1525 mm) minimum measured perpendicular to the side wall and 56 inches (1420 mm) minimum perpendicular from the rear wall.
Locker Room – Home Clubhouse	218.	3	Manager Bathroom	Sink	The sink is mounted too high at 34.5" aff.	Lavatories and sinks shall be installed with the higher of the rim or counter surface 36 inches (915 mm) maximum above the finish floor or ground.
Locker Room – Home Clubhouse	219.	3	Manager Bathroom	Sink	The piping is not fully insulated.	Water supply and drain pipes under lavatories and sinks shall be insulated or otherwise covered to protect against contact. There shall be no exposed abrasive surfaces under lavatories and sinks.

Code Reference	Possible Solution	Image #1	Image #2
60 inches angular from the num measured	ADAS 604.3.1	Modify lavatory.

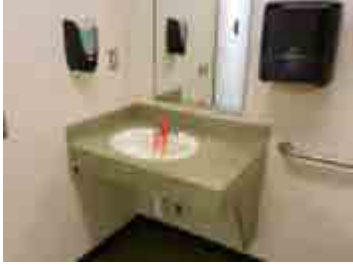
Locker Room – Home Clubhouse	220.	3	Manager Bathroom	Mirror	The bottom of the reflecting surface is mounted higher than 40" aff at 41.25".	Mirrors located above lavatories or counters shall be installed with the bottom edge of the reflecting surface 40 inches (1015 mm) maximum above the finish floor or ground.
Locker Room – Home Clubhouse	221.	3	Manager Bathroom	Soap Dispenser	The soap dispenser is mounted greater than 48" aff at 57".	Elements are to be within accessible reach ranges. Where a clear floor or ground space allows for approach to an element and the side reach is unobstructed, the high side reach shall be 48 inches (1220 mm) maximum and the low side reach shall be 15 inches (380 mm) minimum above the finish floor or ground.
Locker Room – Home Clubhouse	222.	3	Manager Bathroom	Shower	The shower compartment dimensions do not conform with transfer type shower dimensions. The shower measures 38.5" x 40". Transfer shower dimensions are required to be an absolute 36"x36".	Transfer type shower compartments shall be 36 inches (915 mm) by 36 inches (915 mm) clear interior dimensions measured at the center point of the front sides and shall have a 36 inch (915 mm) minimum entry on the face of the shower compartment.

ertops shall be ecting surface e finish floor	ADAS 603.3	Relocate mirror.

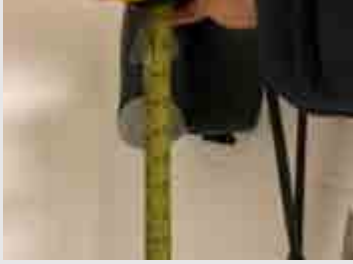
Location	Item #	Priority	Area	Element	Noncompliance Description	Requirement
Locker Room – Home Clubhouse	223.	3	Manager Bathroom	Shower	The shower clear floor space is not adjacent to the shower opening.	Clearance of 36 inches (915 mm) wide minimum and 48 inches (1220 mm) long minimum measurement. A control wall shall be provided.
Locker Room – Home Clubhouse	224.	3	Manager Bathroom	Shower	The grab bar does not extend the full width of the control wall.	In transfer type compartments, grab bars shall be provided across the control wall and back to the control wall point 18 inches (455 mm) from the control wall.
Locker Room – Home Clubhouse	225.	2	Coaches Shower Area	Signage	Tactile characters are not sans serif.	Characters shall be sans serif.
Locker Room – Home Clubhouse	226.	3	Coaches Shower Area	Sink	The sink is mounted too high at 35" aff.	Lavatories and sinks shall be installed with the higher of the rim or counter surface 36 inches (915 mm) maximum above the finish floor or ground.

ch range. ws a parallel ch is e 48 inches each shall be finish floor or	ADAS 308	Relocate dispenser.

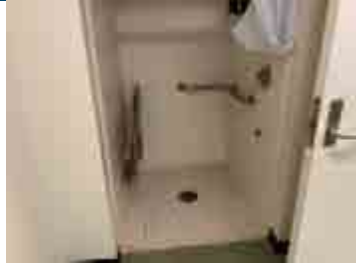
Locker Room – Home Clubhouse	227.	3	Coaches Shower Area	Mirror	The bottom of the reflecting surface is mounted higher than 40" aff at 41".	Mirrors located above lavatories or counters shall be installed with the bottom edge of the reflecting surface 40 inches (1015 mm) maximum above the finish floor or ground.
Locker Room – Home Clubhouse	228.	3	Coaches Shower Area	Walking Surface	The slope of the walking surface is greater than 1:48 (2.08%) at the drain. There is a drain in the toilet room where the adjacent slope is greater than 2.08%.	The cross slope of walking surfaces shall be steeper than 1:48.

shall be k wall to a ol wall.	ADAS 608.3.1	Replace grab bar with compliant type.

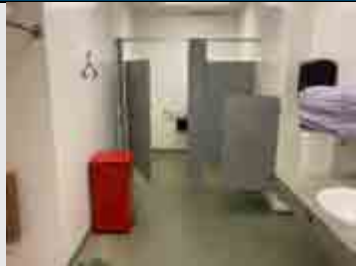
Location	Item #	Priority	Area	Element	Noncompliance Description	Requirement
Locker Room – Home Clubhouse	229.	3	Coaches Shower Area	Accessible Compartment	The compartment door is not self-closing.	The door shall be self-closing.
Locker Room – Home Clubhouse	230.	3	Coaches Shower Area	Accessible Compartment	The compartment door has a door pull on one side only.	A door pull complying with 404.2.7 shall be provided on both sides of the door near the latch.
Locker Room – Home Clubhouse	231.	3	Coaches Shower Area	Toilet Paper Dispenser	The centerline of the toilet paper dispenser is not 7-9" from the front edge of the toilet at 4.5".	Toilet paper dispensers shall comply with 405.2.2. The dispenser shall be 7 inches (180 mm) minimum and 9 inches (225 mm) maximum in front of the water closet or toilet. The centerline of the dispenser.
Locker Room – Home Clubhouse	232.	3	Coaches Shower Area	Paper Towel Dispenser	The dispenser is mounted greater than 48" aff at 54".	Elements are to be within accessible reach. Where a clear floor or ground space allows for a side approach to an element and the side reach is unobstructed, the high side reach shall be 48 inches (1220 mm) maximum and the low side reach shall be 15 inches (380 mm) minimum above the ground.

Code Reference	Possible Solution	Image #1	Image #2
	ADAS 604.8.1.2	Modfiy door hardware as needed.

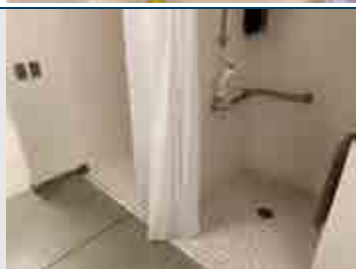
Locker Room – Home Clubhouse	233.	3	Coaches Shower Area	Shower	The shower compartment dimensions do not conform with transfer type shower dimensions. The shower measures 38.5" x 45". Transfer shower dimensions are required to be an absolute 36"x36".	Transfer type shower compartments shall be 36 inches (915 mm) by 36 inches (915 mm) clear interior dimensions measured at the center point of the shower sides and shall have a 36 inch (915 mm) minimum entry on the face of the shower.
Locker Room – Home Clubhouse	234.	3	Coaches Shower Area	Shower	The grab bar does not extend the full width of the control wall.	In transfer type compartments, grab bars shall be provided across the control wall and back wall at a point 18 inches (455 mm) from the control wall.

l be 36 inches inside s of opposing wide compartment.	ADAS 608.2.1	Modify shower.

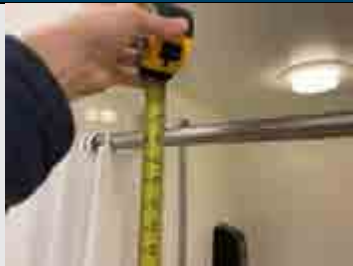
Location	Item #	Priority	Area	Element	Noncompliance Description	Requirement
Locker Room – Home Clubhouse	235.	3	Coaches Shower Area	Shower	The shower curtain reduces headroom to less than 80" aff at 78".	Vertical clearance shall be 80 inches (2030 mm) minimum. Guardrails or other barriers shall be provided where the vertical clearance is less than 80 inches (2030 mm) high
Locker Room – Home Clubhouse	236.	3	Coaches Shower Area	Shower	The L-shaped shower seat is not configured correctly.	The rear edge of an L-shaped seat shall be 16 inches (405 mm) maximum and the front edge shall be 16 inches (405 mm) minimum and 16 inches (405 mm) from the seat wall. The rear edge of the seat shall be 1 1/2 inches (38 mm) minimum and the front edge shall be 14 inches (355 mm) minimum and 15 inches (380 mm) maximum from the wall. The end of the "L" shall be 22 inches (559 mm) minimum and 23 inches maximum from the main seat wall.

Code Reference	Possible Solution	Image #1	Image #2
(30 mm) high shall be provided 80 inches	ADAS 307.4	Relocate shower curtain.

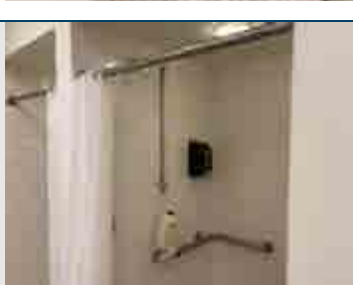
Locker Room – Home Clubhouse	237.	3	Coaches Shower Area	Shower	No shower spray unit with a hose is provided.	A shower spray unit with a hose 59 inches (1500 mm) long minimum that can be used both as a shower head and as a hand-held shower head is provided.
Locker Room – Home Clubhouse	238.	3	Players Shower Area	Sink	The sink is mounted too high at 34.5" aff.	Lavatories and sinks shall be installed with the higher of the rim or counter surface 34 inches (863 mm) maximum above the finish floor or ground.
Locker Room – Home Clubhouse	239.	3	Players Shower Area	Mirror	The bottom of the reflecting surface is mounted higher than 40" aff at 40.5".	Mirrors located above lavatories or counters shall be installed with the bottom edge of the reflecting surface 40 inches (1015 mm) maximum above the finish floor or ground.
Locker Room – Home Clubhouse	240.	3	Players Shower Area	Accessible Compartment	The compartment door has a door pull on one side only.	A door pull complying with 404.2.7 shall be provided on both sides of the door near the latch.

es (1500 mm) a fixed-position r shall be	ADAS 607.6	Install a compliant shower spray.

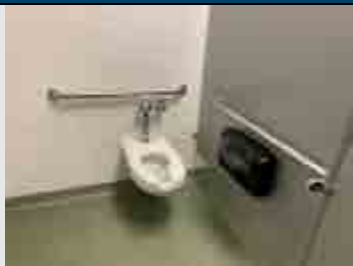
Location	Item #	Priority	Area	Element	Noncompliance Description	Requirement
Locker Room – Home Clubhouse	241.	3	Players Shower Area	Accessible Compartment	The centerline of the toilet is not between 16-18" from the side wall. Centerline is 18.5".	The centerline of the water closet shall be (405 mm) minimum to 18 inches (455 mm) from the side wall or partition
Locker Room – Home Clubhouse	242.	3	Players Shower Area	Accessible Compartment	The door opening is greater than 4" from the corner at 9".	Where doors are located in the front part opening shall be 4 inches (100 mm) maximum side wall or partition farthest from the wall
Locker Room – Home Clubhouse	243.	3	Players Shower Area	Protruding Object	Paper towel dispenser protrudes more than 4" into the circulation path where the leading edge is below 80" aff.	Objects with leading edges more than 27 inches (685 mm) and not more than 80 inches (2030 mm) the finish floor or ground shall protrude 4 inches (100 mm) maximum horizontally into the circulation path

Code Reference	Possible Solution	Image #1	Image #2
6 inches (152 mm) maximum	ADAS 604.2	Relocate toilet or partition.

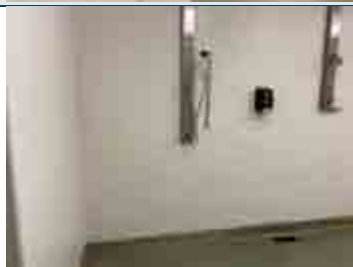
Locker Room – Home Clubhouse	244.	3	Players Shower Area	Shower	There is no accessible shower provided in the gang shower.	Where gang showers are provided, a full shower is required. Either a transfer compartment or a roll-in compartment can be integrated with the shower.
Locker Room – Home Clubhouse	245.	3	Players Shower Area	Shower	The shower threshold is greater than 1/2" above the adjacent surface.	Thresholds shall be 1/2 inch (13 mm) high and beveled 1:2.
Locker Room – Visitor Clubhouse	246.	2	Locker Room	Entrance	An accessible route does not connect the locker room to other spaces and elements on the site.	At least one accessible route shall connect the locker room to building or facility entrances with all accessible spaces and elements within the building or facility otherwise connected by a circulation path. At least one wheelchair space shall be provided in team or player seating areas serving the locker room activity.

Fully compliant compartment or a compartment with a gang	ADAS 608	Provide an accessible shower compartment.

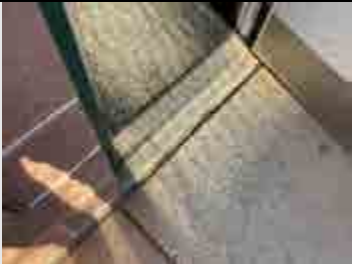
Location	Item #	Priority	Area	Element	Noncompliance Description	Requirement
Locker Room – Visitor Clubhouse	247.	2	Entrance	Door	There are gaps greater than ½” wide and ¼” deep along the accessible route. This condition occurs at the Visitor Clubhouse entrance door.	Openings in floor or ground surfaces shall allow the passage of a sphere more than 1/2 inch diameter.
Locker Room – Visitor Clubhouse	248.	2	Locker Room	Lockers	No accessible lockers were identified. This condition occurs in the Coaches Locker Room, Players Locker Room, and Umpires Locker Room.	Lockers are to be accessible. Where lockers are provided, at least 5 percent, but no fewer than 3 lockers of each type, shall be accessible. Storage elements shall comply with accessibility provisions including clearances, reach range and operable parts.
Locker Room – Visitor Clubhouse	249.	3	Umpire Bathroom	Sink	The sink is mounted too high at 34.5” aff.	Lavatories and sinks shall be installed with the top of the higher of the rim or counter surface 34 inches (863 mm) maximum above the finish floor or ground.

Code Reference	Possible Solution	Image #1	Image #2
all not allow (13 mm)	ADAS 302.3	Modfiy gap.

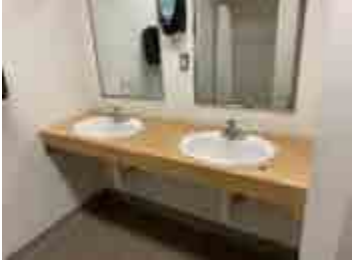
Locker Room – Visitor Clubhouse	250.	3	Umpire Bathroom	Mirror	The bottom of the reflecting surface is mounted higher than 40” aff at 41.25”.	Mirrors located above lavatories or counters shall be installed with the bottom edge of the reflecting surface 40 inches (1015 mm) maximum above the finish floor or ground.
Locker Room – Visitor Clubhouse	251.	3	Umpire Bathroom	Soap Dispenser	The soap dispenser is mounted greater than 48” aff at 56”.	Elements are to be within accessible reach ranges. Where a clear floor or ground space allows for side approach to an element and the side reach is unobstructed, the high side reach shall be 48 inches (1220 mm) maximum and the low side reach shall be 15 inches (380 mm) minimum above the finish floor or ground.
Locker Room – Visitor Clubhouse	252.	3	Umpire Bathroom	Shower	The shower compartment dimensions do not conform with transfer type shower dimensions. The shower measures 38.5” x 42”. Transfer shower dimensions are required to be an absolute 36”x36”.	Transfer type shower compartments shall be 36 inches (915 mm) by 36 inches (915 mm) clear interior dimensions measured at the center point of the shower sides and shall have a 36 inch (915 mm) minimum entry on the face of the shower compartment.

ertops shall be ecting surface e finish floor	ADAS 603.3	Relocate mirror.

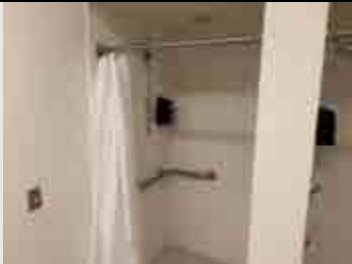
Location	Item #	Priority	Area	Element	Noncompliance Description	Requirement
Locker Room – Visitor Clubhouse	253.	3	Umpire Bathroom	Shower	The grab bar does not extend the full width of the control wall.	In transfer type compartments, grab bars provided across the control wall and back point 18 inches (455 mm) from the control
Locker Room – Visitor Clubhouse	254.	3	Umpire Bathroom	Shower	The shower curtain reduces headroom to less than 80" aff at 78".	Vertical clearance shall be 80 inches (2030 mm) minimum. Guardrails or other barriers shall be provided where the vertical clearance is less than 80 inches (2030 mm) high
Locker Room – Visitor Clubhouse	255.	3	Umpire Bathroom	Shower	There is no shower seat provided.	A folding or non-folding seat shall be provided in transfer type shower compartments.
Locker Room – Visitor Clubhouse	256.	3	Umpire Bathroom	Accessible Compartment	The compartment door is not self-closing.	The door shall be self-closing.

Code Reference	Possible Solution	Image #1	Image #2
s shall be k wall to a ol wall.	ADAS 608.3.1	Replace grab bar with compliant type.

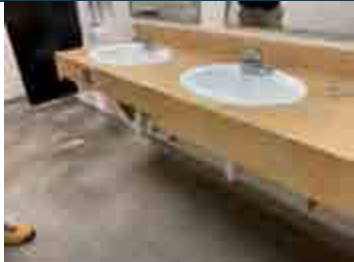
tertops shall be ecting surface he finish floor	ADAS 603.3	Relocate mirror.

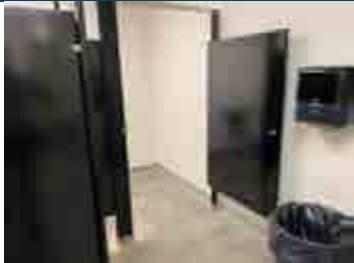
asured parallel le of the door.	ADAS 404.2.4	Relocate partition.

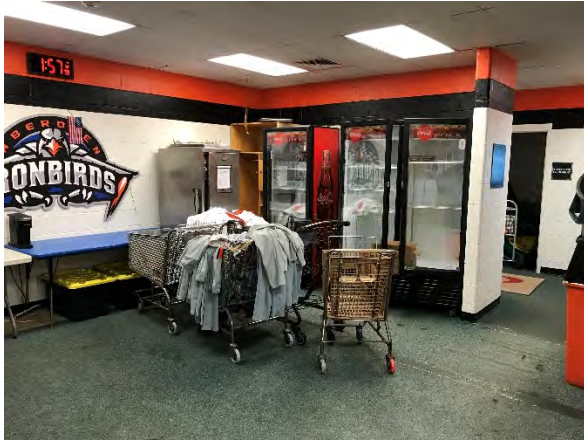
SECTION 3.2: HOME COMMISSARY AND DINING DID NOT HAVE A DESIGNATED SEATING AREA FOR 8. ALSO THE SPACE DID NOT HAVE A FREEZER, SINK OR DISHWASHER.

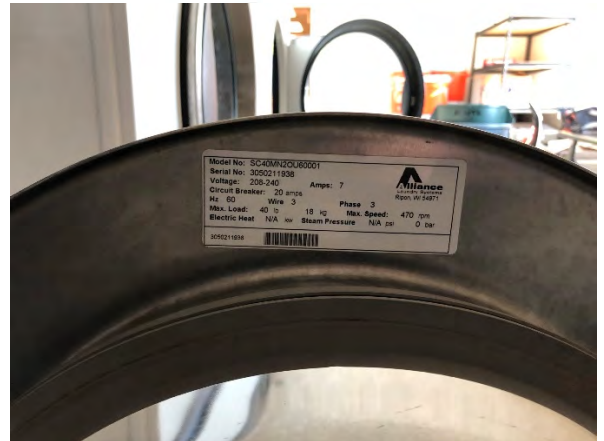
SECTION 3.5: BOTH COMMERCIAL WASHERS IN THE LAUNDRY ROOM ARE CURRENTLY UNDERSIZED AT 40 LB CAPACITY.

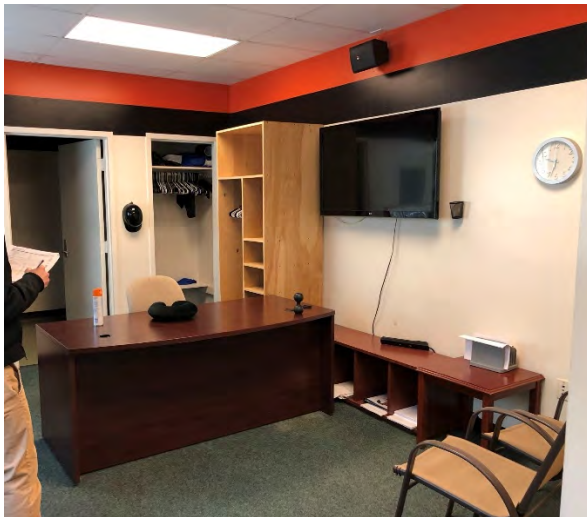
SECTION 3.8: THE HOME MANAGERS OFFICE'S FURNITURE LAYOUT DOES NOT ACCOUNT FOR A MEETING OF 6 PEOPLE – PLENTY OF SPACE TO ACCOMMODATE THIS REQUIREMENT.

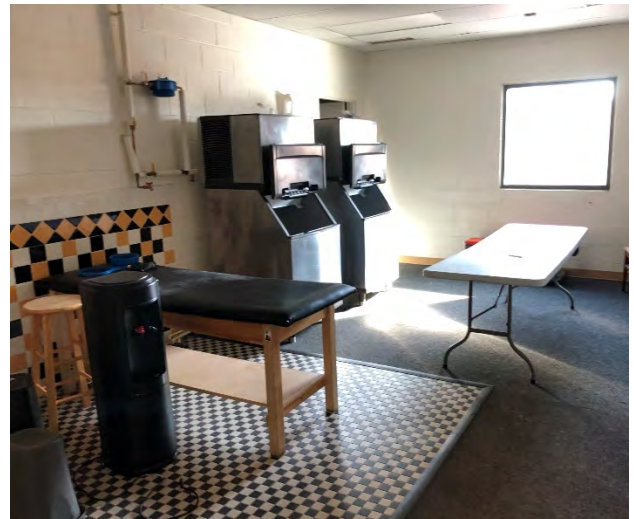
SECTION 4.4: VISITORS TRAINING ROOM DOES NOT HAVE A SINK OR DEDICATED WHIRPOOLS FOR VISITING TEAM.

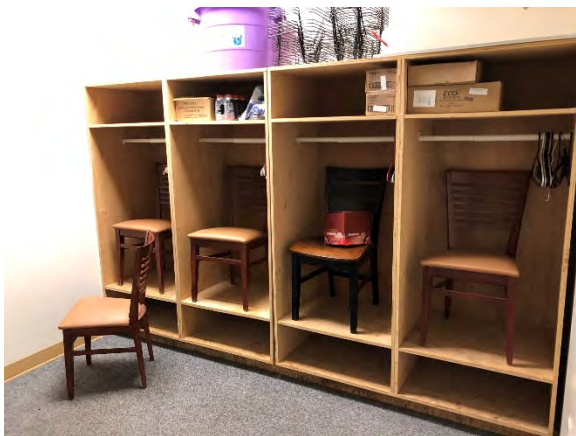
SECTION 4.5: VISITING STAFF LOCKER ROOM ONLY HAS 4 REGULATION SIZE LOCKERS AND DOES NOT HAVE SPACE TO INCLUDE MORE LOCKERS

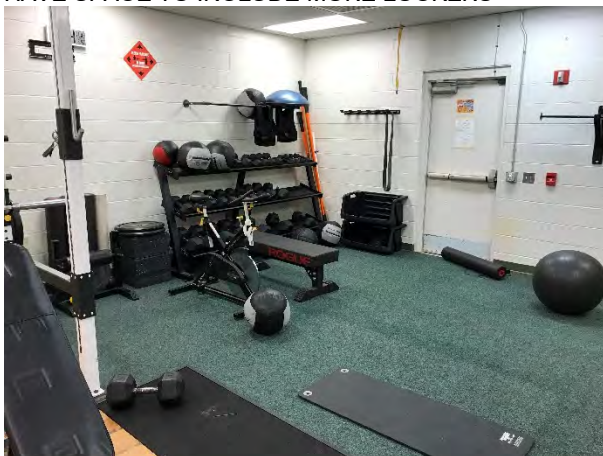
SECTION 4.5: THE WEIGHT ROOM IS NOT LARGE ENOUGH AND IS GENERALLY COVERED WITH CARPETTING – NOT A RUBBER/ MLB APPROVED FLOORING

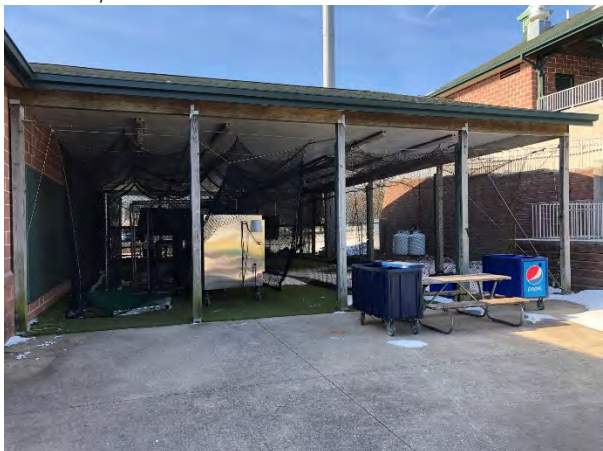
SECTION 5.6: BATTING TUNNELS ARE OPEN AIR AND NOT LONG ENOUGH – 55 FEET

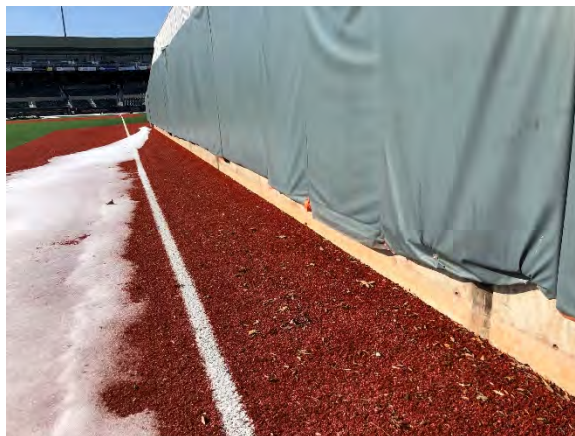
SECTION 7.3: PROTECTIVE PADDING GENERALLY IS INSTALLED ABOVE THE 4 INCH THRESHOLD AT BASE. COMMON THROUGHOUT PLAYING FIELD.

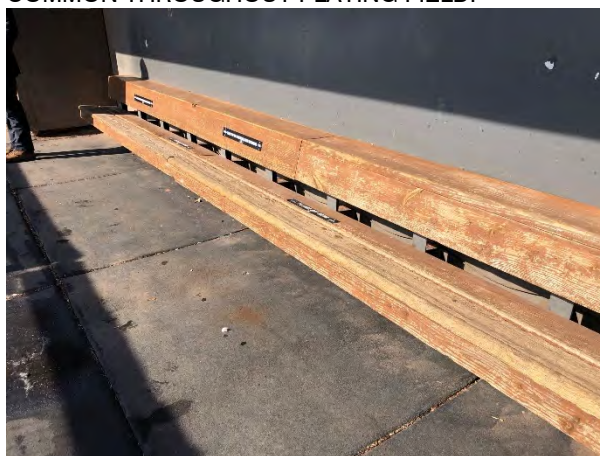
SECTION 7.5: BOTH HOME AND AWAY DUGOUT BENCHES ARE LESS THAN 45 FEET IN LENGTH

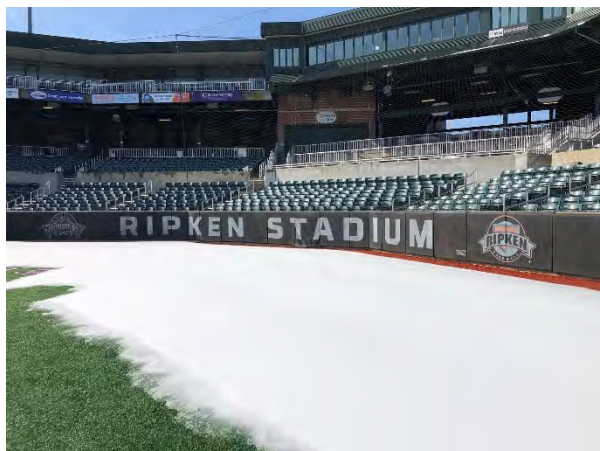
SECTION 7.9: WHITE SIGNAGE AT BACKSTOP. TO BE PAINTED ORANGE THIS OFF SEASON.

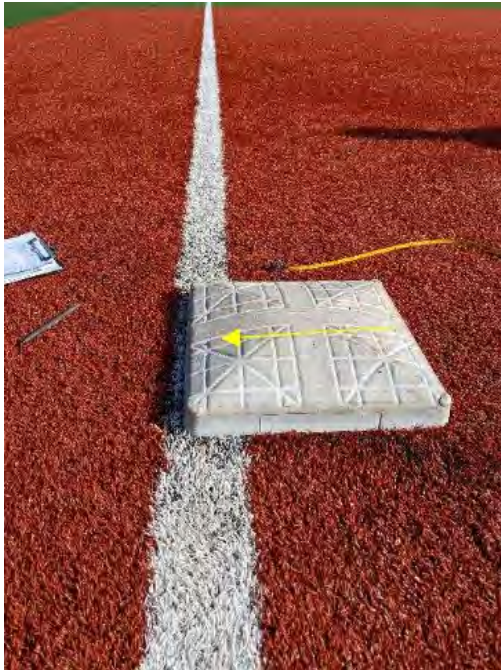
3RD BASE IS NOT PROPERLY ALIGNED WITH THE TURF FOUL LINE.

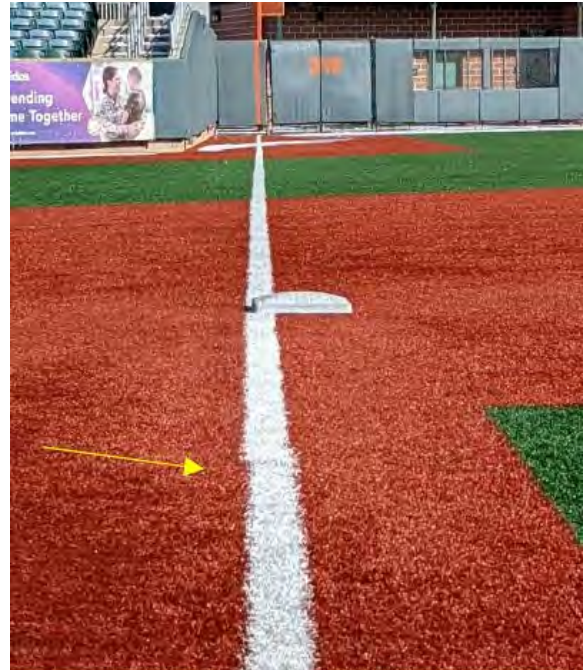
3RD BASE FOUL LINE JOINT IS OFFSET, RESULTING IN A CROOKED FOUL LINE.

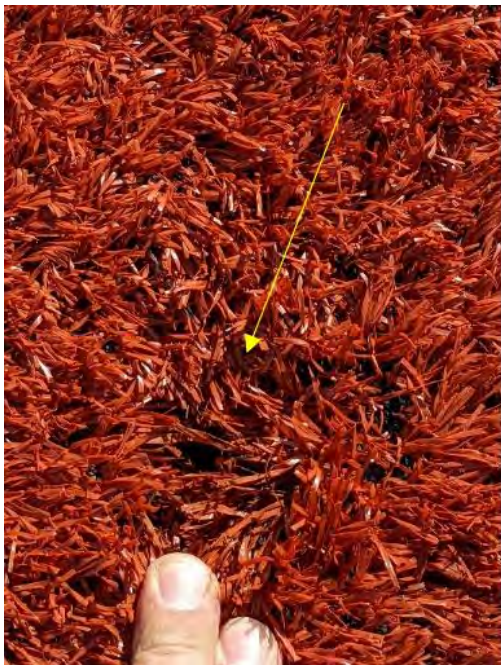
BASE ANCHOR HOLE FOR 60' BASES (YOUTH GAMES). TODD SAID PLUGS WITH TURF INFILL ON TOP ARE FABRICATED AND ARE INSTALLED FOR MiLB GAMES.

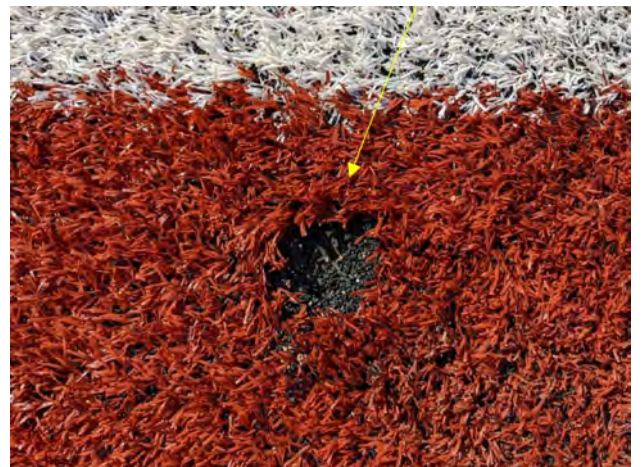
RUBBER BASE PLUG FOR 60' BASES. TODD WILL INSTALL TURF & INFILL ON TOP OF THE PLUGS PRIOR TO THE MiLB SEASON.

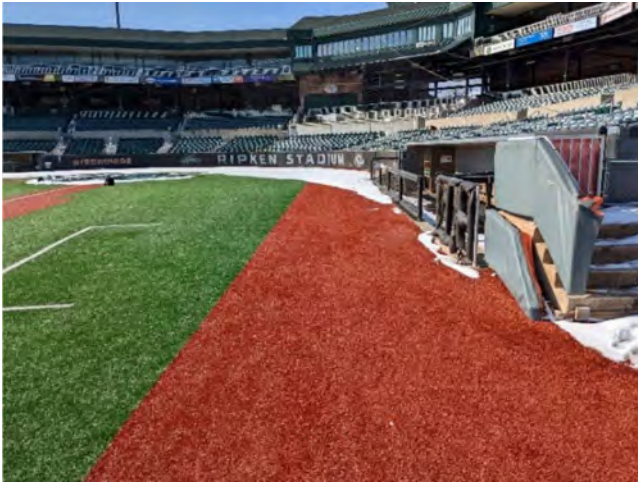
WARNING TRACK IN FRONT OF DUGOUTS DOES NOT MEET 15' MINIMUM WIDTH REQUIREMENT. WARNING TRACK DOES NOT PROVIDE TACTILE DIFFERENCE.

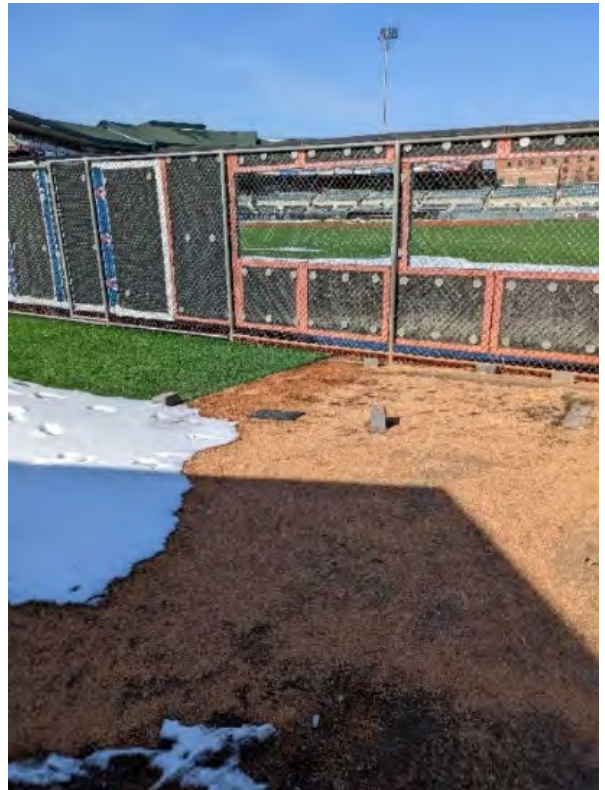
RIGHT FIELD BULLPEN – 1ST BASE DUGOUT NOT VISIBLE FROM THE PITCHING RUBBER LOCATED FARTEST FROM THE FIELD.

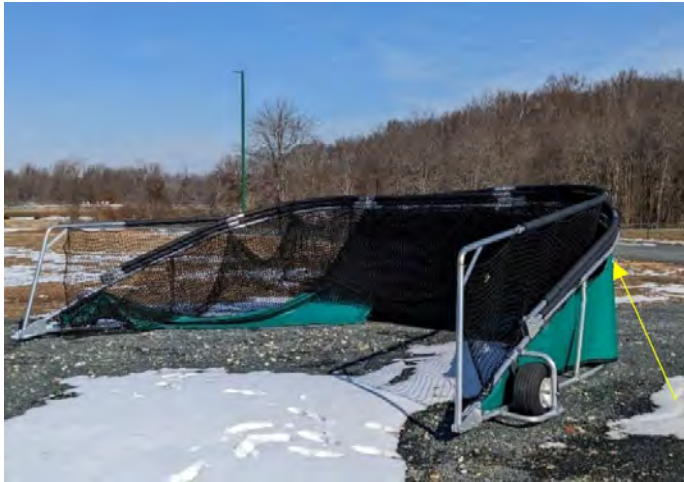
PROVIDE ADDITIONAL PADDING ON BATTING CAGE FRAME – THE BACK ALUMINUM RAIL NEEDS PADDING.
