**RIPKEN STADIUM STRUCTURAL REPAIR
CITY OF ABERDEEN, MARYLAND**

STRUCTURAL CONDITION REPORT

RIPKEN STADIUM LEFT FIELD RAMP RETAINING WALL

HCEA JOB NO.18317A

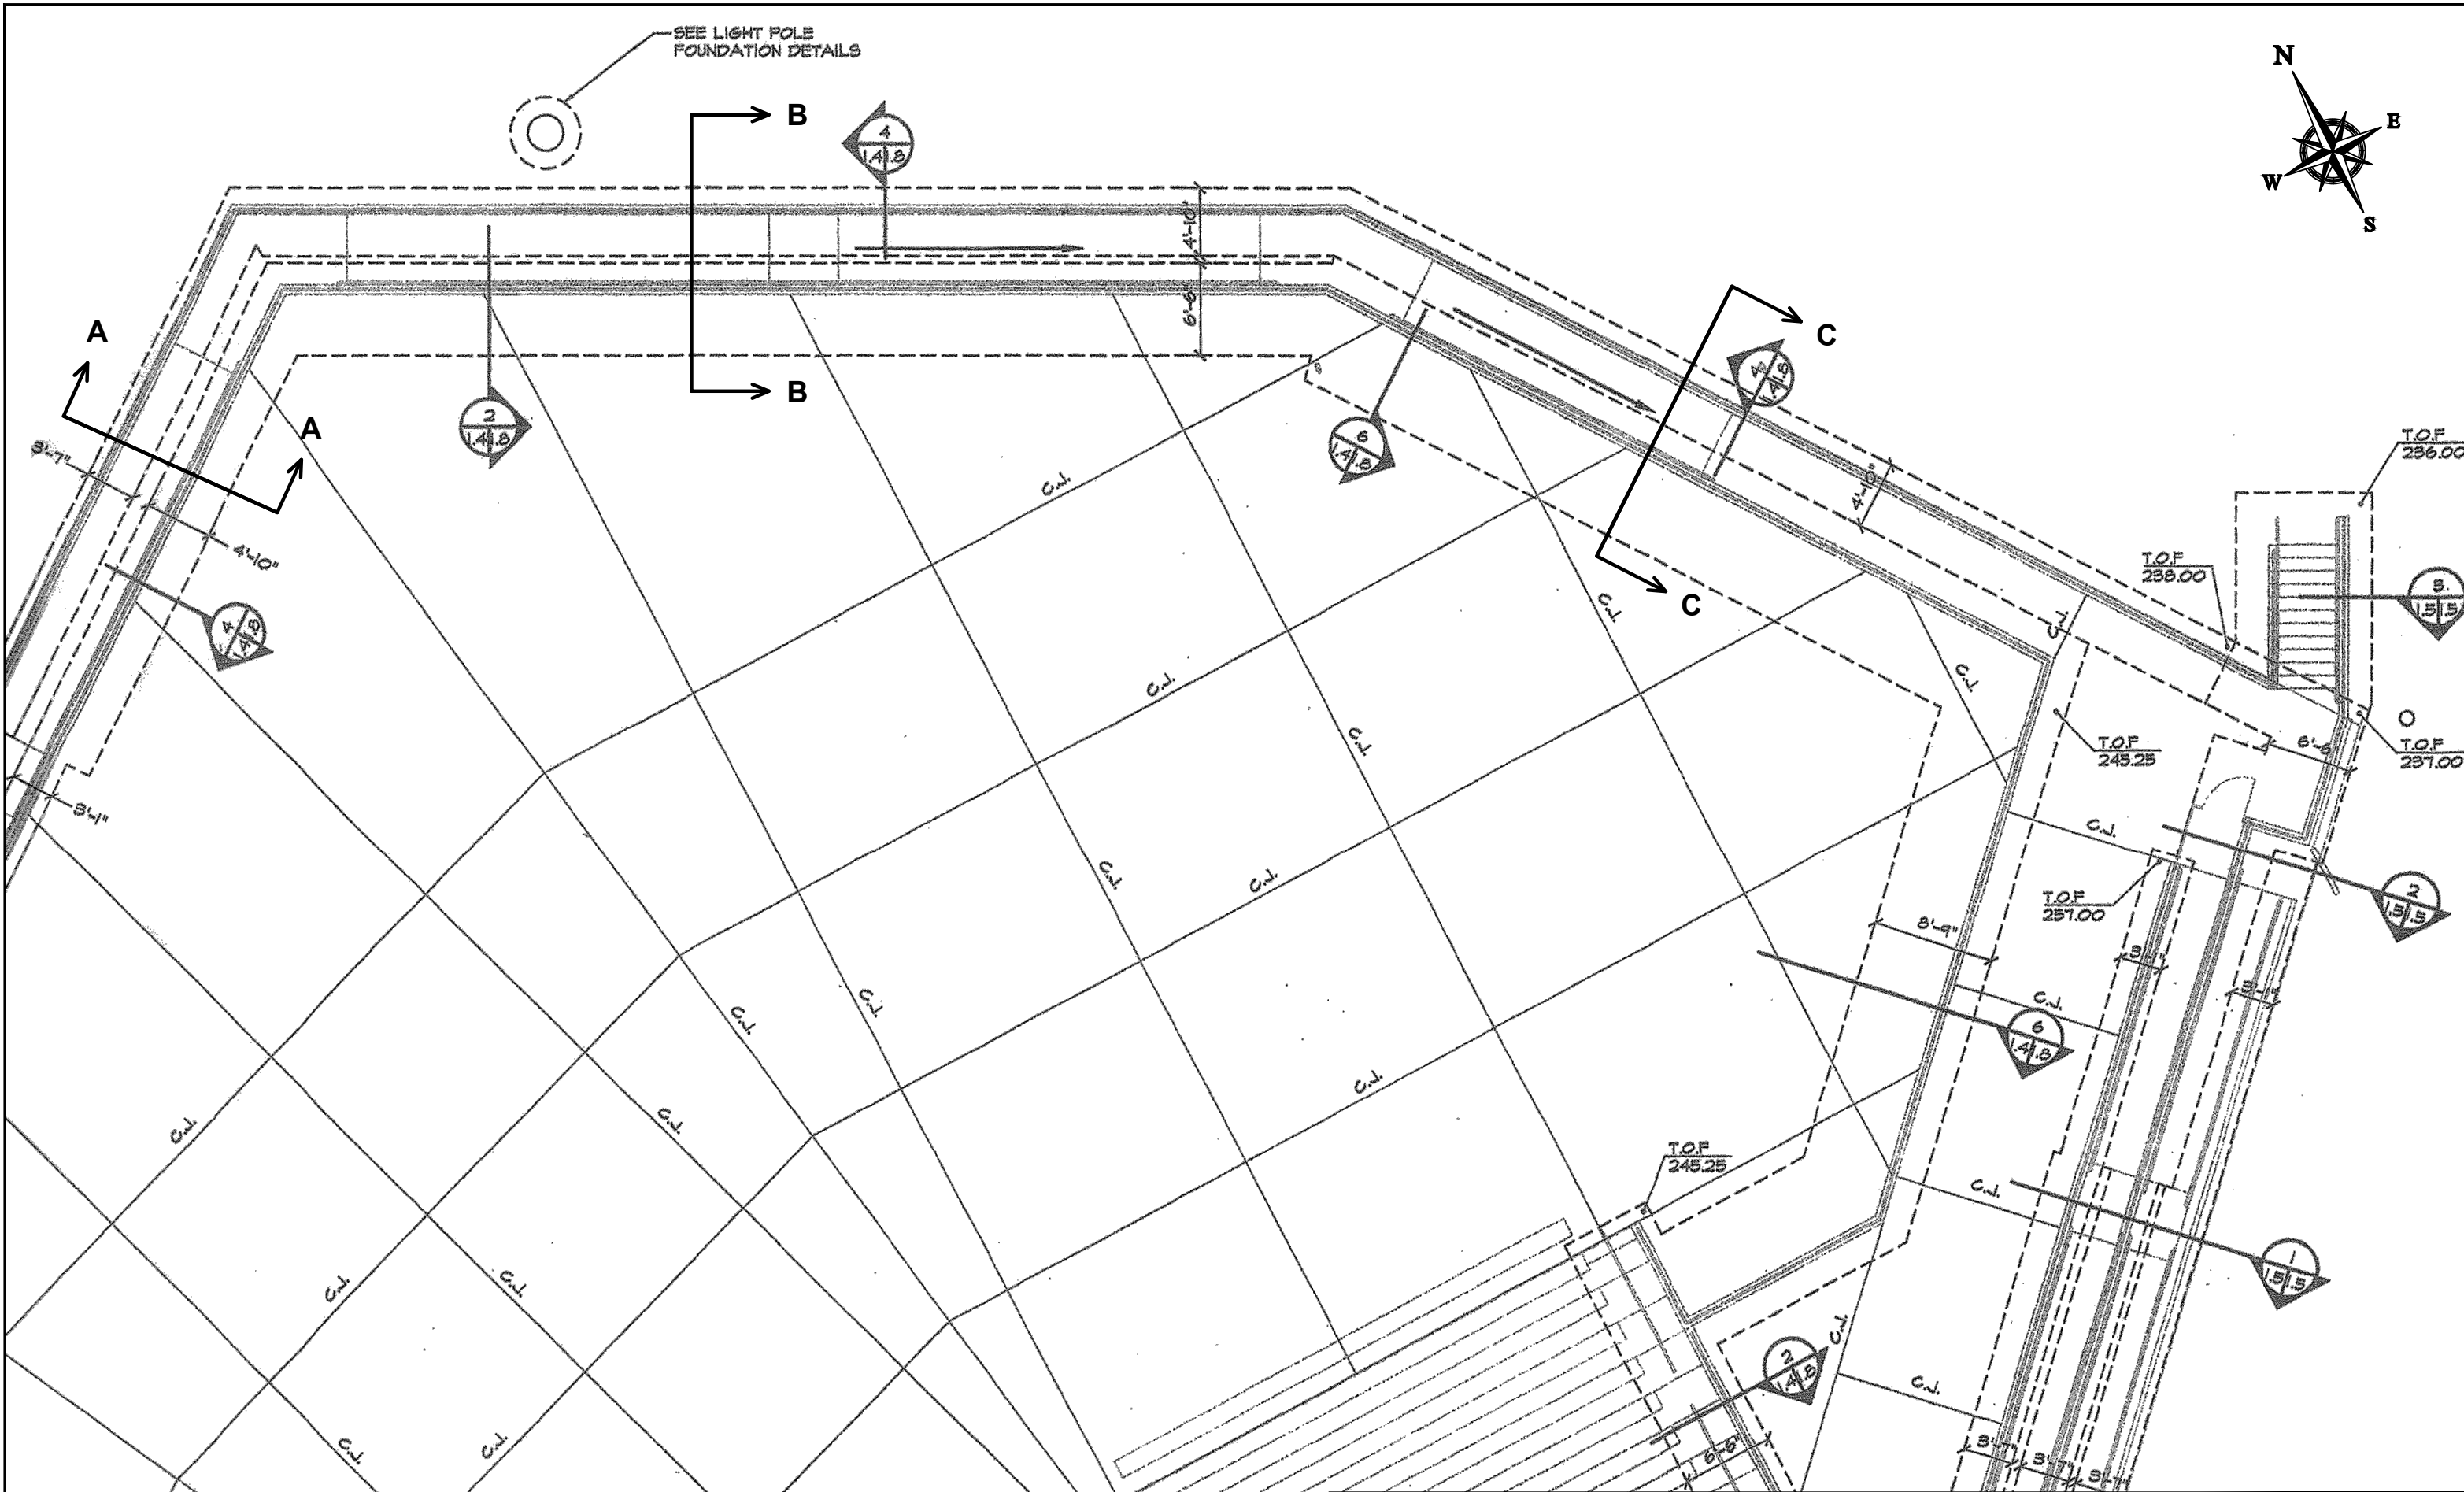
PROJECT NO.	18317A	DESIGN BY:	
DATE	8/9/18	DRAWN BY:	AM
SCALE	3/32"=1'-0"	CHECKED BY:	TJC
SHEET	S-1

SEE LIGHT POLE FOUNDATION DETAILS

Provide a new concrete wall in front of the existing lower wall along the ramp. This wall will be placed directly against the existing wall. In order to construct this wall, tiebacks will be installed at approximately 9 feet on center through the existing low wall and extend through the new wall. This will stabilize the existing wall while excavating for the new wall foundation and provide additional lateral support for the new wall. We recommend that this new wall extend from the existing stairs at the bottom of the ramp to approximately 35 feet from the beginning of the ramp at the high end. Refer to Options 1 and 2 sections attached.
