**ABERDEEN COMMUNITY SERVICES BUILDING
FABRIC STUDY/FACILITIES ASSESSMENT REPORT**

**34 North Philadelphia Blvd.
Aberdeen, Maryland 21001**

Prepared For:
City of Aberdeen
Department of Planning and Community Development

Submitted:
October 21, 2015

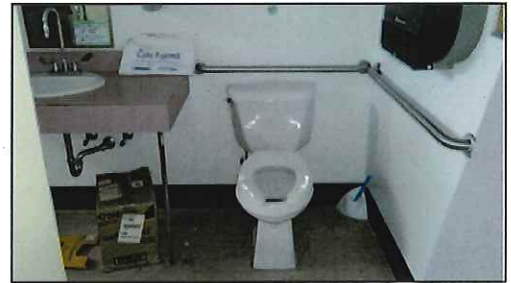
Non-Compliant Hardware vs.
Required Hardware

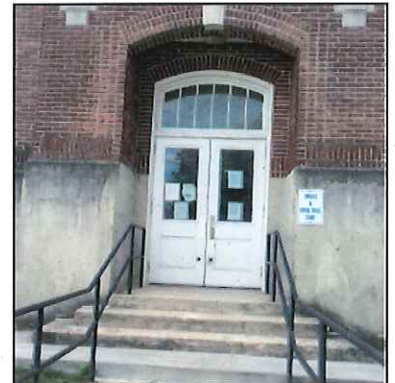
Exterior Stair at North Wing

The north exterior entrance stair is concrete with steel pipe handrails, and is in solid, but weathered condition. The nosings are worn and spalling in many places, but there are no major visible structural concerns. Tread and riser dimensions appear to be within the allowable code requirements. The steel pipe handrails are structurally sound, but are in violation of height and extension requirements.

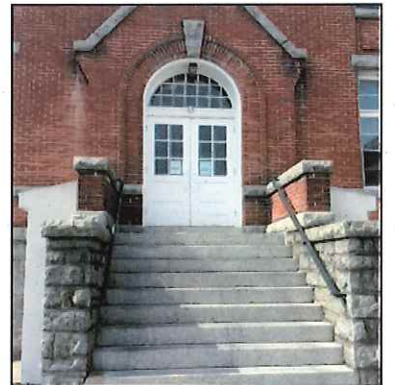
Exterior Stair at South Wing

The exterior stair on the eastern side of the south wing is comprised of stone treads and risers with stone wall guards and steel pipe handrails. The masonry appears to be structurally sound and the treads and riser dimensions appear to be within allowable code requirements. The steel pipe handrails are structurally sound, but are in violation of height and handrail extension requirements. The width of the stair may require the addition of an additional handrail down the centerline of the stair. The height of the masonry wall acting as a guard may need to be modified or supplemented to provide adequate fall protection. Under this stair, there are two flanking stairs that provide access to the lower level via a shared landing located directly below the landing of the entrance stair. These stairs are concrete and also appear to be dimensionally acceptable, but are in violation of handrail requirements.

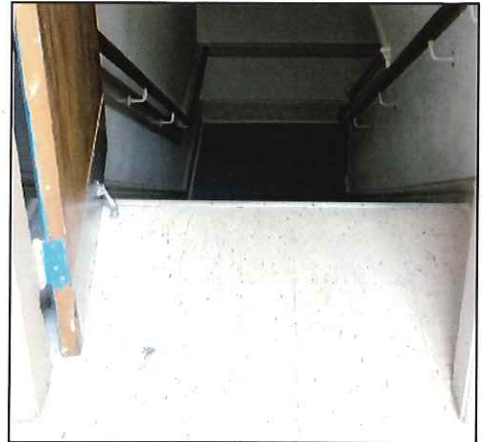
Non-Code Compliant Landing Size

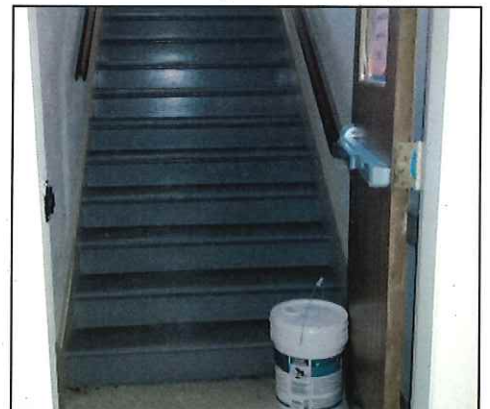
Non-Code Compliant Handrail,
Landing, & Tread Material

The interior stairs appear to be in good condition, but will require modifications to comply with current code standards. The stair structure should be evaluated by a licensed structural engineer, and reinforced or modified as needed. The exterior stairs also appear to be in good condition, but will require replacement of handrails and possible modifications for fall protection. The elevator is in good working order, but should be inspected and serviced.

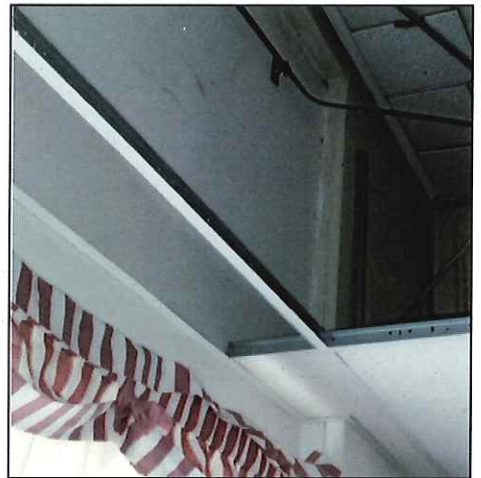
- There were then one or more major interior renovations that most likely occurred between the 1960's and 1990's. One such renovation was a large scale systemic upgrade in which the window heads were lowered to accommodate drop ceilings and the new HVAC systems installed above those ceilings. Shorter windows were installed and the space above was infilled with aluminum siding.

Lowered Original Window Openings from Inside

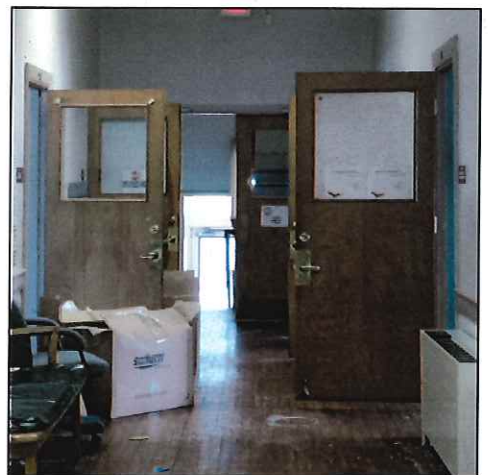
In general, most interior doors are wood veneer set in a hollow metal frame. There are some hollow metal doors, but they are largely limited to the first floor mechanical areas and kitchen area. Across the entire building, door sizes and types vary widely. Most of the wood doors have several layers of paint, and it is likely (because of the findings of the attached hazardous materials report) that this paint contains lead. Many of the doors exhibit wear and damage beyond what would be considered fair condition. Some of the wired glazing in the doors is cracked and the putty is falling apart.

Door hardware is similarly a mix of components throughout the building. Some of the door hardware sets are matched in certain areas, like the Catholic Charities Offices. Other areas, like the first floor day care area, which require several keys to open all of the inclusive doors. Some of the hardware is very old, and no longer functions correctly. Some of the newer hardware has been corroded or damaged to the point where the operation is affected.

Interior Doors

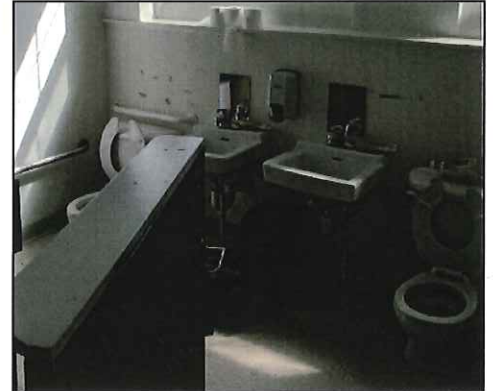
Most of the toilet rooms are undersized and their dimensions, clearances, and accessories are not ADA-compliant. The fixture and accessories are in poor condition, and inconsistent throughout the building. We recommend the full removal of all fixtures, finishes, and accessories in the existing toilet rooms, and code compliant toilet rooms be integrated into the new building program.

Children's Toilet Room

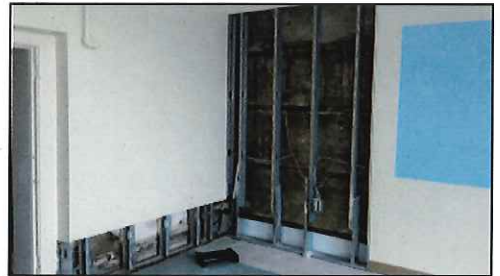
Children's Toilet Room

In general, the finishes are widely varied throughout the building, in appearance, as well as condition. Because of the diverse nature of the finishes, their varying degrees of wear, and the presence of hazardous materials, we recommend the full removal of all finishes down to the rough framing. This will allow a clean, consistent, responsible renovation of the interior that will ultimately yield more value in the restored building than a piecemeal treatment of the interiors.

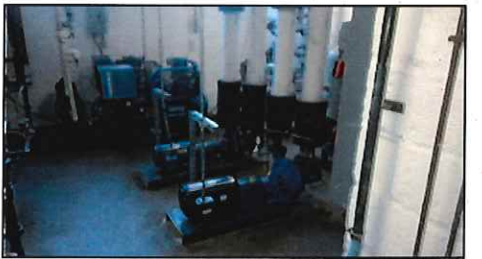
Two-Pipe System - Pumps

The pumps are base-mounted, end-suction configuration. In general, the pumps are of high quality, however, they are approximately 20 years old and are near the end of their lifespan. Given that refurbishing the pumps will be only slightly less expensive than replacing them, new pumps should be installed and sized for the building's new function.

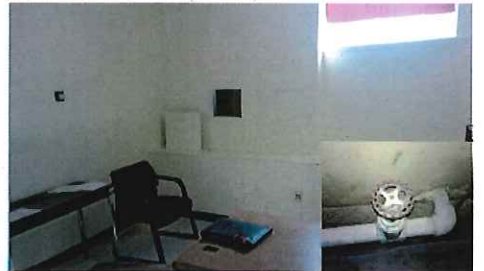
Water Service Entrance - Office 105

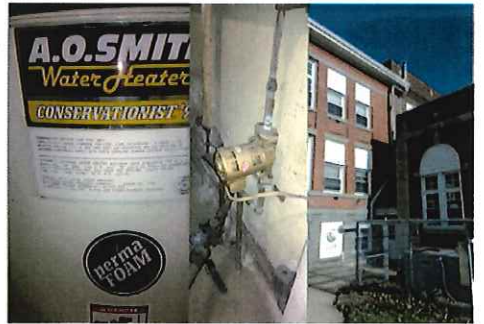
Water Heater, Circulating Pump and Exhaust Duct

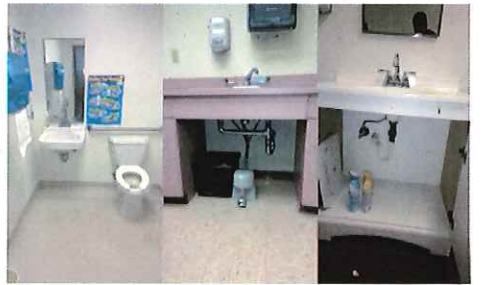
Plumbing fixtures are in good condition.

Plumbing Fixtures

The plumbing fixtures are in good condition and could be reused if desired. Plumbing piping and sanitary mains can be reused, but should be closely inspected during any renovation due to their age. Piping sizes should be re-evaluated based on the final architectural design.

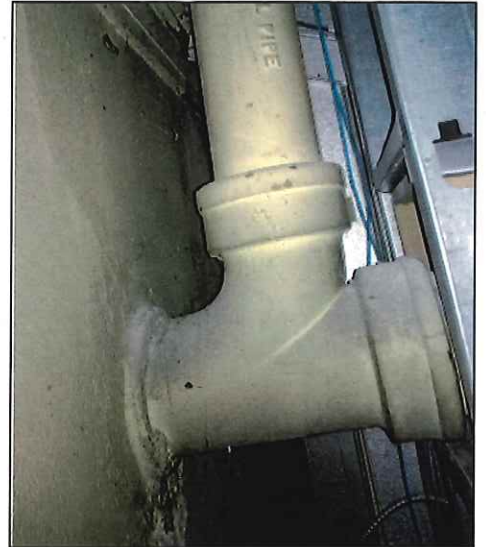
Sanitary Sewer Pipe

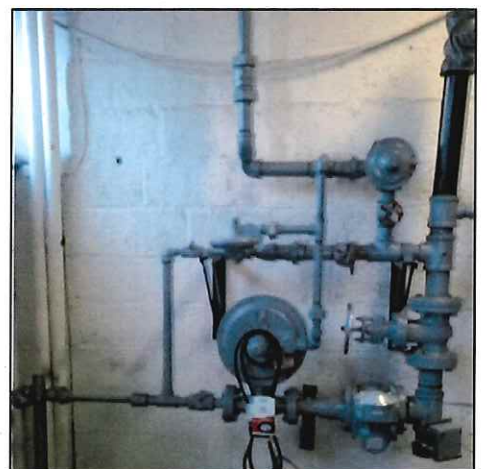
The 1" high pressure natural gas service is brought into the facility from Howard Street. From there, distribution piping runs to the mechanical room boilers and building domestic water heater. The gas regulator, meter and piping are all in good condition.

Natural Gas Regulator, Meter,
and Piping

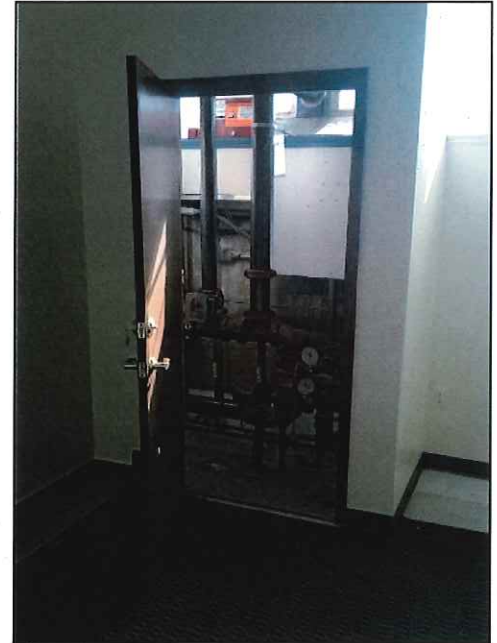
The building's 4" fire main enters the building from Pulaski Highway into a first floor Office Closet. The building is fully-sprinklered with multiple fire zones with zone valves.

Fire Main - Entrance Point

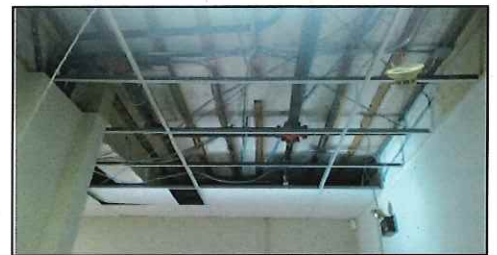
The sprinkler system was installed sometime after the building was constructed. The sprinkler piping is concealed by false ceilings that are installed beneath the building's original ones.

The sprinkler system is in good condition. The system, however, should be re-evaluated and modified based on the final architectural design and use of the building. Also, a hydrant flow test should be completed to confirm flows and pressures available to the system.

Sprinkler System Beyond Drop Ceiling

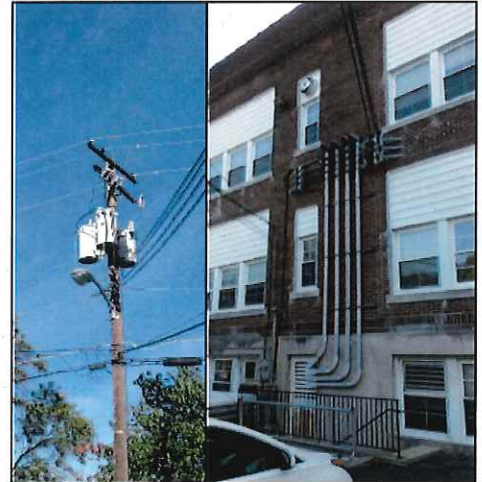
At the back of the building, on Howard Street, there are three pole-mounted transformers configured in a 208 Volt, 3 phase, WYE service that is run overhead to four weatherheads and conduits running down the building. The service then penetrates the exterior wall into an existing wiring trough located in the existing mechanical room in the basement. The electrical conduits and weatherheads appear to be in good condition.

Pole Mounted Transformers and Conduit Running into Building

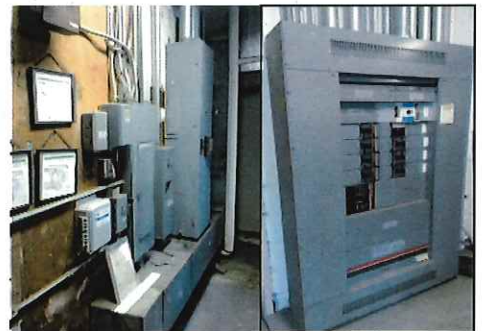
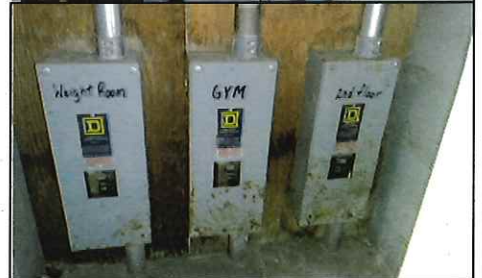
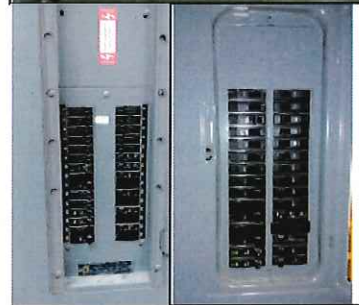
A majority of the panel boards are dated 1989 as installation date. The electric service is provided by Baltimore Gas & Electric Company. The existing service entrance rated enclosed circuit breaker enclosures have accumulated rust.

Panel Boards and Circuit Breakers

The existing electrical service appears to be of adequate size for the use of the building. Existing panel boards and service entrance rated enclosed circuit breakers are recommended to be replaced due to age. All electrical wiring devices throughout the building should be replaced due to wear and tear.

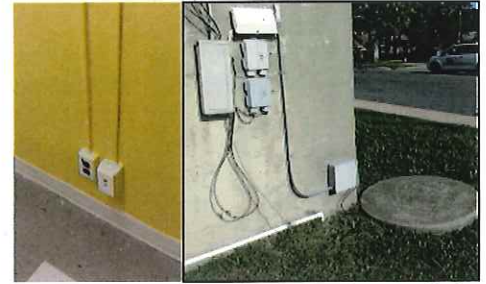
Existing receptacles and tele/data outlets are located throughout the building in walls and utilize Wiremold in areas. The existing receptacles and tele/data outlets located throughout the building are old and worn. The existing tele/data utility service enters the north side of the building, fed overhead from an existing utility pole and then terminates on demarcation board located in basement mechanical room. Existing telephone service is marked Bell Atlantic.

Receptacles and Tele/Data Outlets

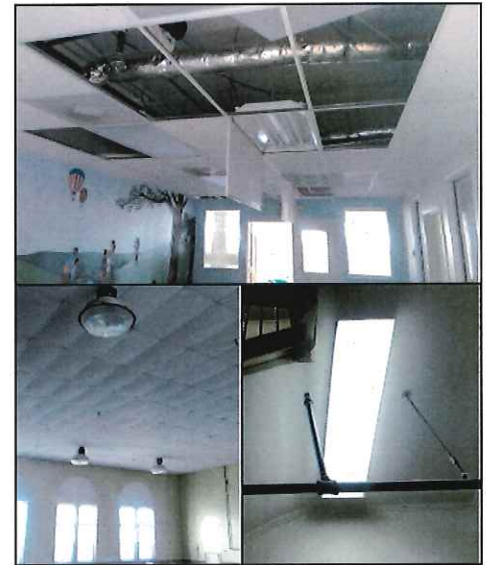
A majority of the existing lighting throughout the building consists of 2'x4' fluorescent troffers, 4' wraparounds and downlights utilizing fluorescent T8 lamps and compact fluorescent lamps respectively. In the existing gym, metal halide high-bay fixtures are utilized. All lighting has manual light switches for control. The lighting should be replaced.

Interior Lighting Fixtures

We recommend replacing all inefficient interior and exterior fluorescent and incandescent lighting fixtures with new LED type fixtures and new lighting controls. The controls should include occupancy sensors, photocells, time clocks and dimming controls to meet Code requirements. All battery backup emergency fixtures should be replaced with emergency backup integral to fixtures. All exit signage should be replaced with new LED type exit signs with battery back-up.

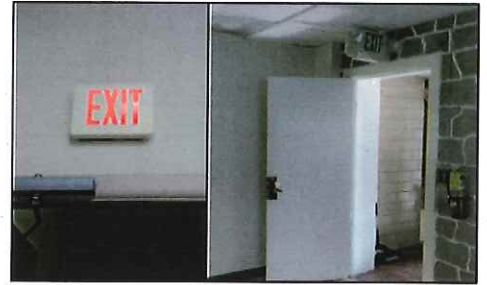
Existing exit signs are ceiling and wall mounted throughout the building. Exit signs typically are LED with white thermoplastic housings, red lettering and battery backup for emergency operation. There are a few locations where the exit sign is a combination exit/emergency light fixture with green lettering. In other locations, the exit sign has an aluminum housing with red letters and an incandescent lamp source. The exit signs are old and should be replaced.

Ceiling and Wall-Mounted Exit Signs

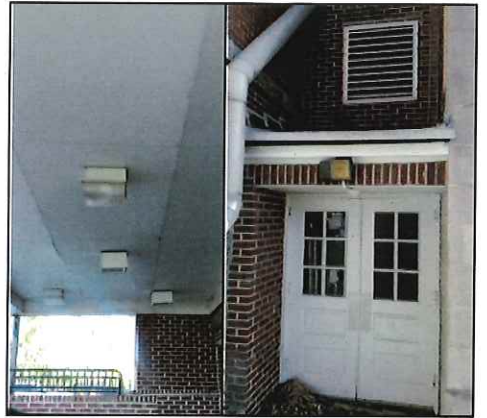
Existing exterior fixtures consist of ceiling and wall mounted metal halide fixtures. Existing exterior fixtures located overtop of exit doors are worn and their lenses are yellowed. Existing ceiling mounted fixtures at daycare canopy are different fixtures which do not match. These fixtures should be replaced.

Exterior Lighting Fixtures

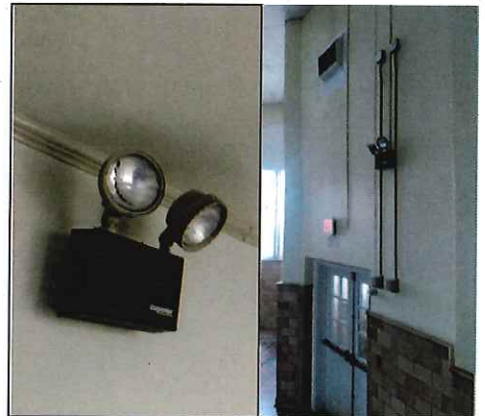
Emergency lighting fixtures with battery back-up are scattered throughout the building for emergency egress lighting. Existing emergency fixtures are old and using incandescent lamp sources. The emergency lights should be replaced.

Emergency Lighting Fixtures

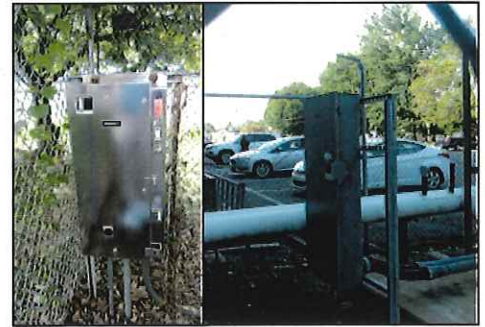
The existing disconnecting means to the HVAC equipment looks to be in excellent condition.

HVAC Equipment Disconnects

Existing disconnect switches feeding mechanical HVAC equipment look to be in excellent condition and we recommend keeping switches for reuse.

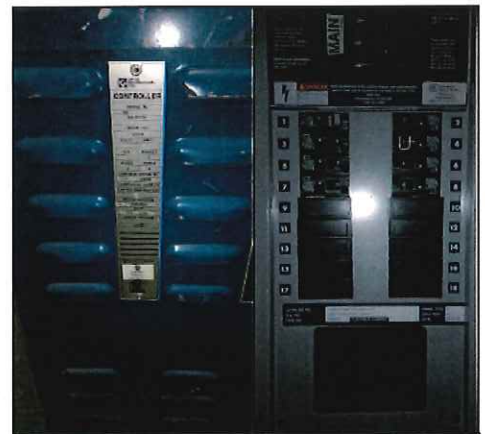
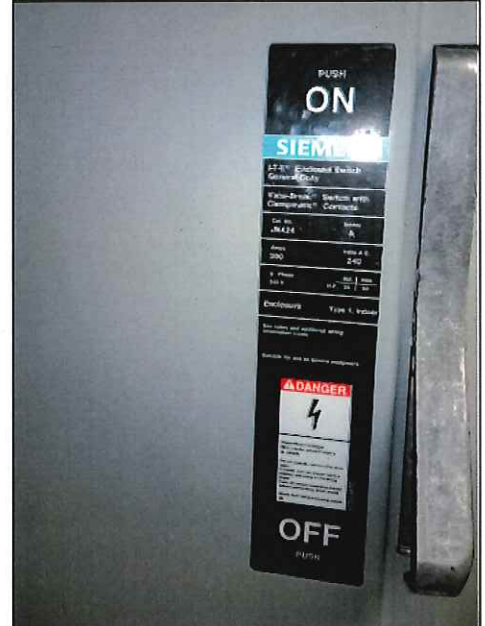
The elevator is a 30 HP hydraulic type elevator and has a 200 amp, 3 pole disconnect feeding it. The elevator controller was installed in 1995 based on nameplate data. The elevator machine room is fed from its own panelboard located in closet 3 #304 adjacent to the elevator machine room and is in good condition. The elevator machine room meets code, as it has devices required by the elevator code including the elevator disconnect with shunt trip breaker, heat detector, smoke detector, sprinkler head and a fan coil unit for conditioning of the space.

Elevator Controller, Panelboard and Disconnect

There are no recommendations for the existing elevator installation as it meets code requirements and is in good working order.

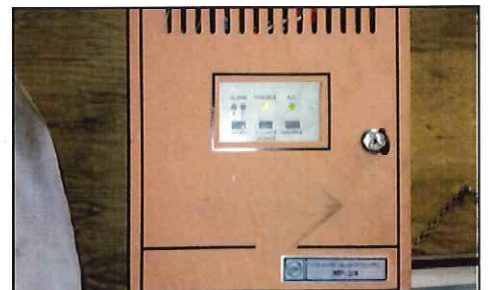
The existing fire alarm control panel is a Fire Lite Alarms Inc. panel which is old and dated. The existing panel had a trouble message during the survey. The fire alarm control panel should be replaced.

Fire Alarm Control Panel

Existing fire alarm system is old and dated and we recommend updating entire fire alarm system with new fully addressable building fire alarm system.

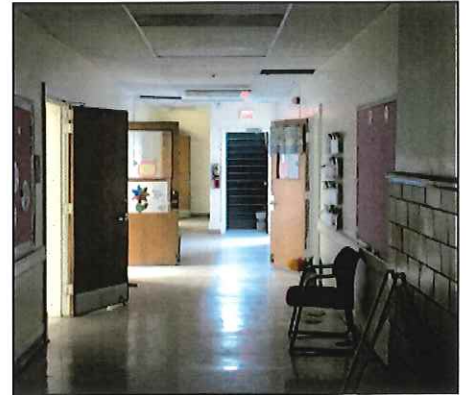
From a holistic view, the building's general organization and number of available exits seems to support the proposed use as a community services building. However, the construction type of the existing floors, corridors, and exit stairs may require modifications to the structure to maintain code-required fire separation.

Common Corridor (1st floor)

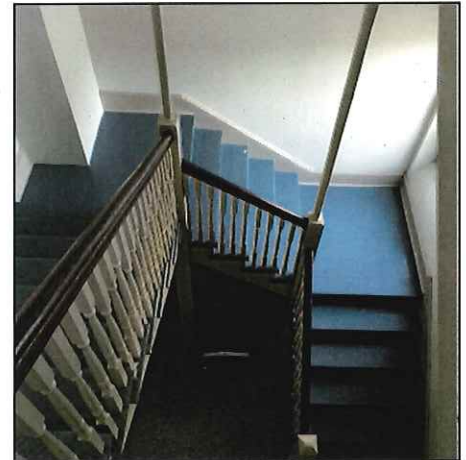
South Exit Stair

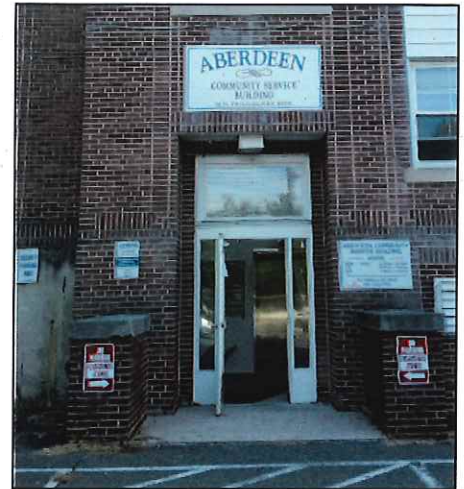
While the gymnasium is accessible from the exterior, there is no internal access to either the gymnasium or the stage areas from the central core. Installing a ramp would take a significant amount of space and would be technically infeasible to contain within the existing structure without compromising the configuration of the gymnasium and stage. An hydraulic lift or a limited-use, limited-application elevator would need to be installed to grant access to the gymnasium and stair from the main building.

Entrance with Elevator at West Side of Central Core
