**REHABILITATION OF THE 250,000 GALLON, RIVETED STEEL, KROUSE
ELEVATED WATER TANK, ABERDEEN, MARYLAND**

INSPECTION REPORT

**250,000 GALLON RIVETED ELEVATED
KROUSE WATER TANK
ABERDEEN, MARYLAND**

Inspection Date: November 30, 2017

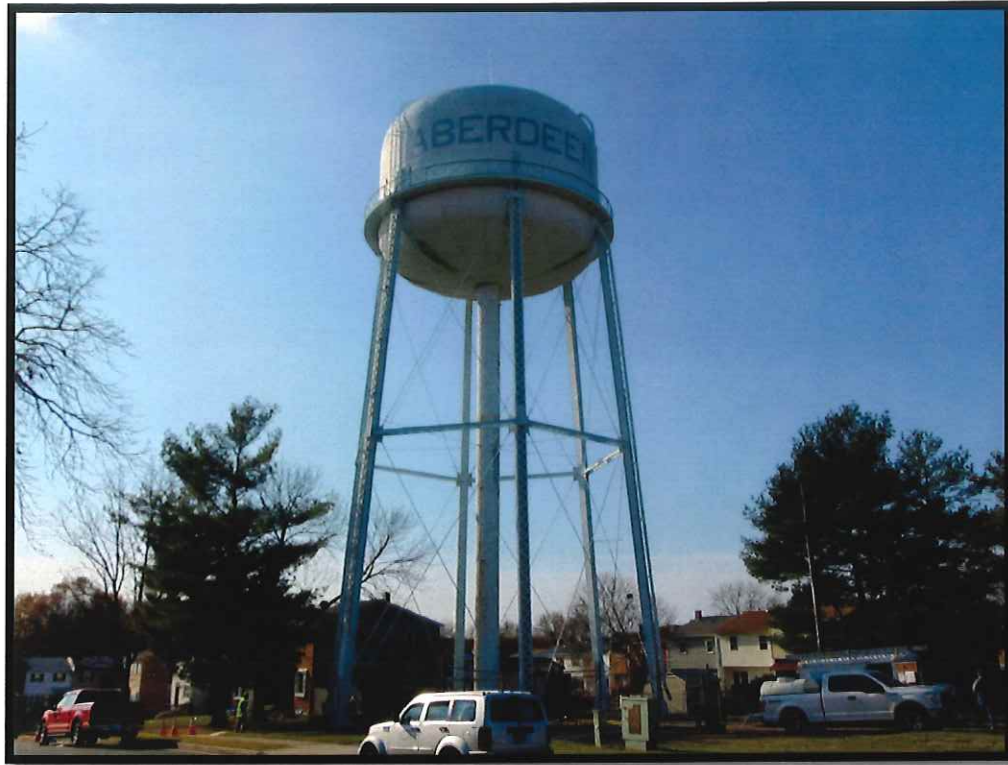
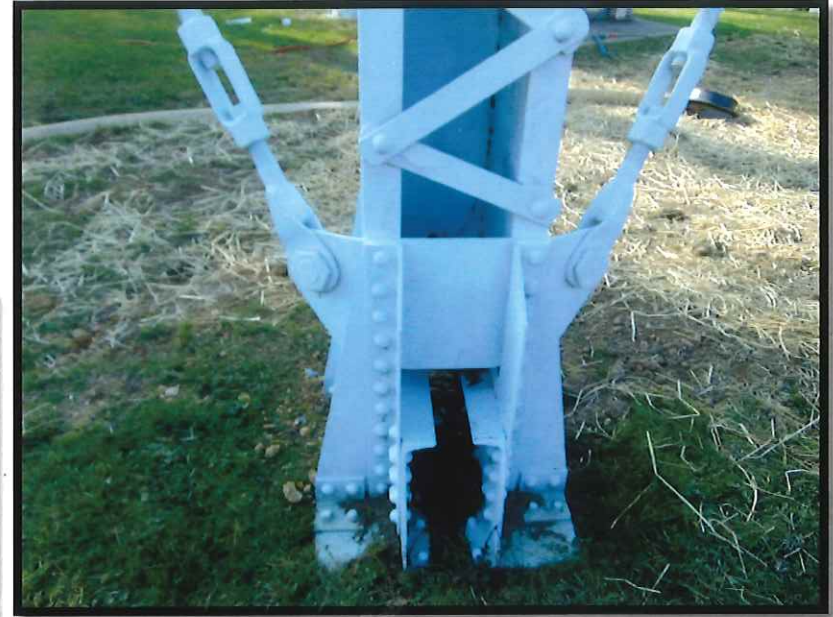
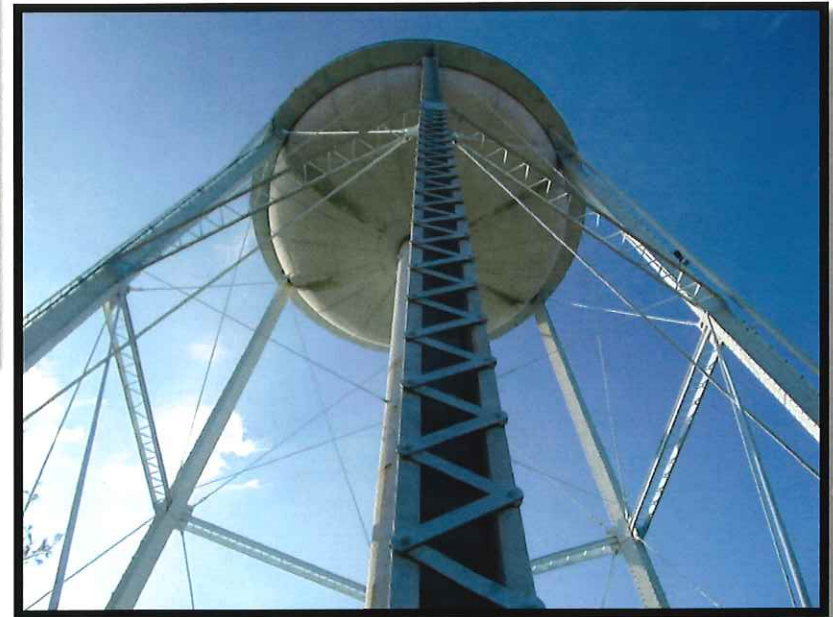
The tank is equipped with six single-laced 15 inch column legs. Observed corrosion was present on less than 5% of surfaces, although staining is present where back to back steel exists (leg laces). The overflow pipe is attached to a column leg via a series of welded stand off support brackets. Heavy localized corrosion is present on the welded areas.

View of the tank and column legs.

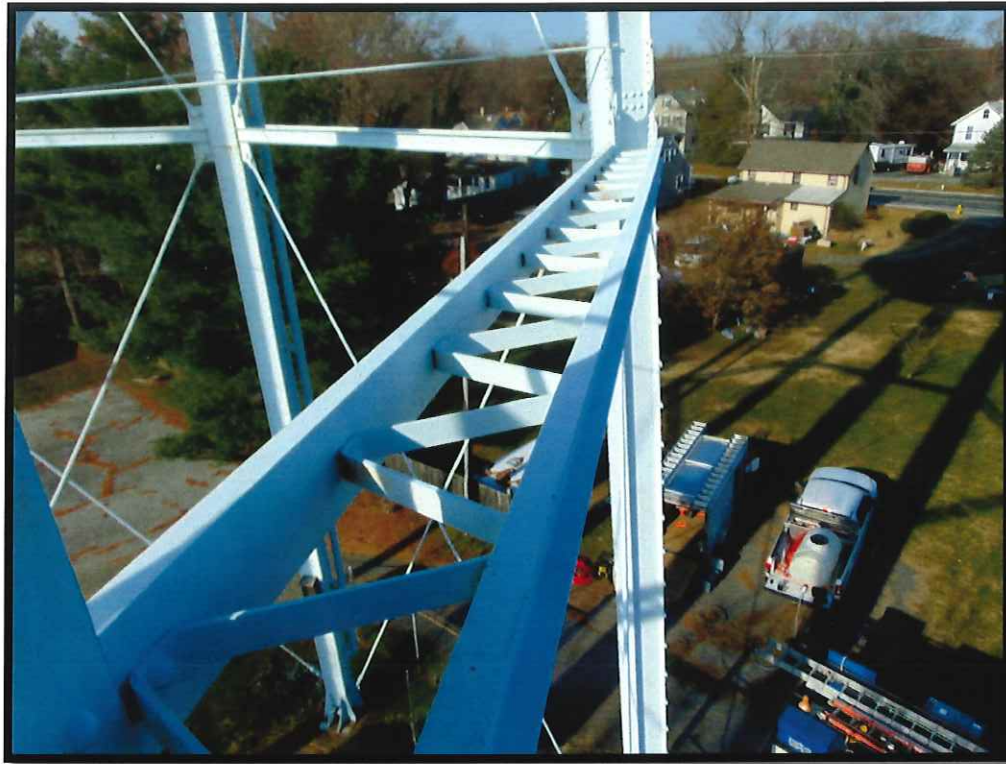
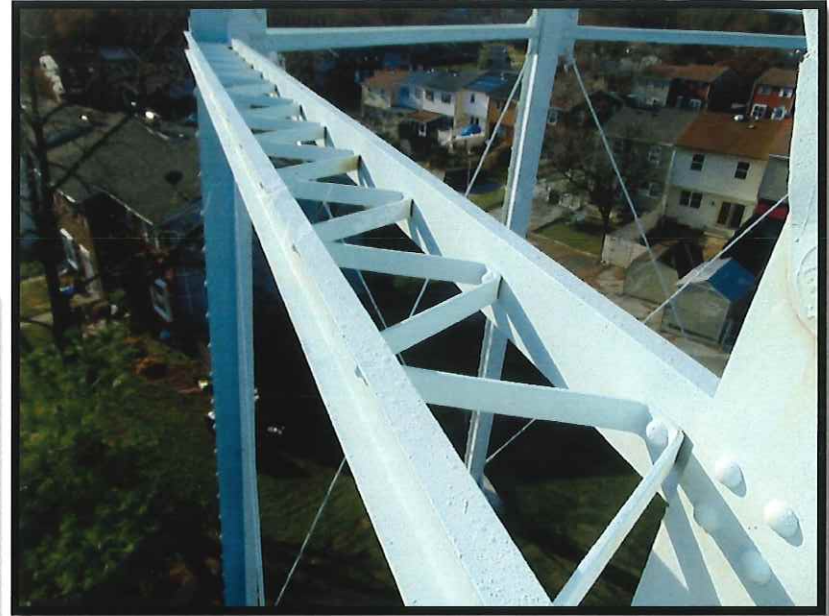
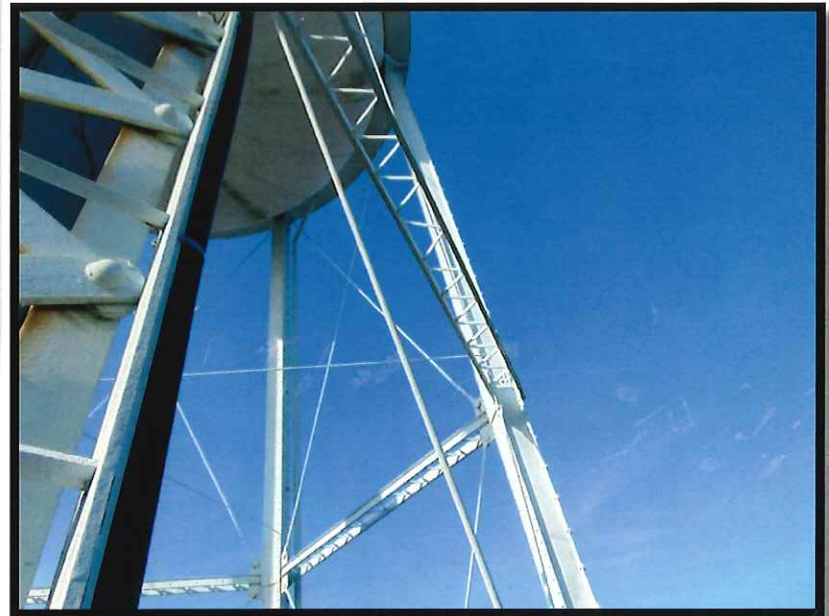
The tank is not missing any rods. The rods measure 1 3/4-inch in diameter and are securely attached to the column legs. Light surface rust was observed on the irregular surfaces of the rods (threads) not exceeding 5% of total rod surfaces. The laced struts are in good condition with no corrosion observed.

View of the struts.

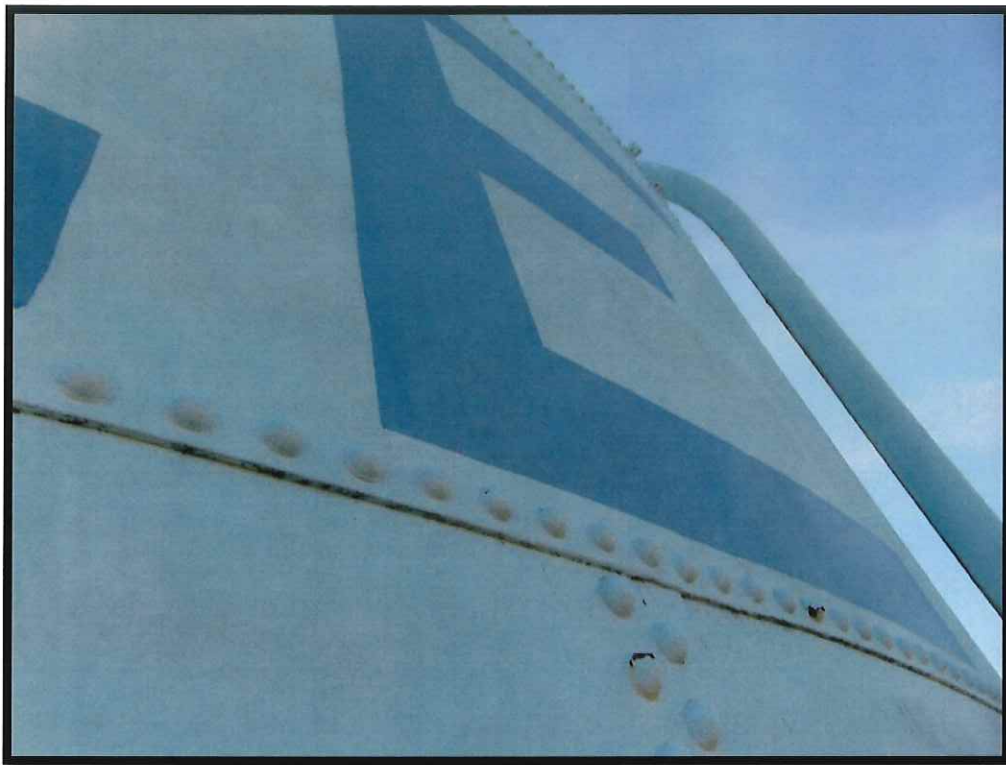
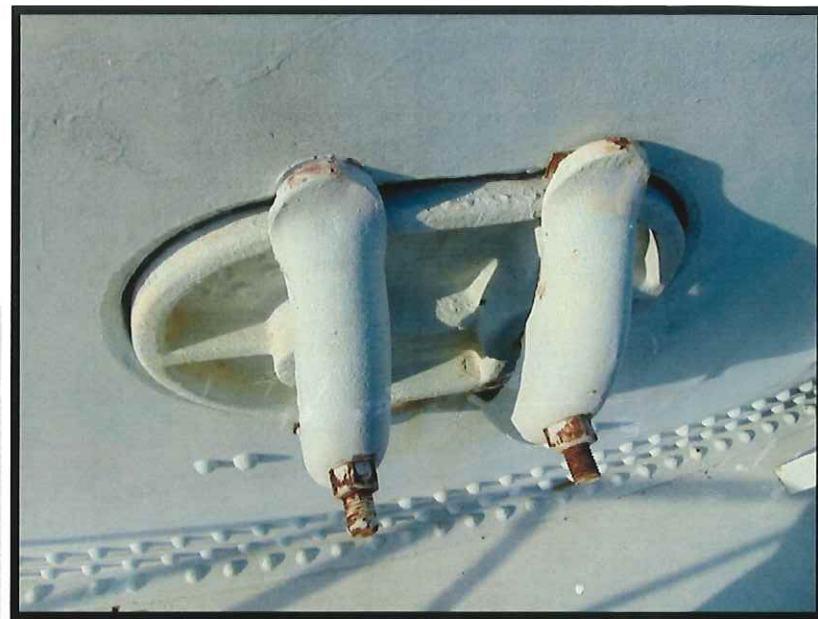
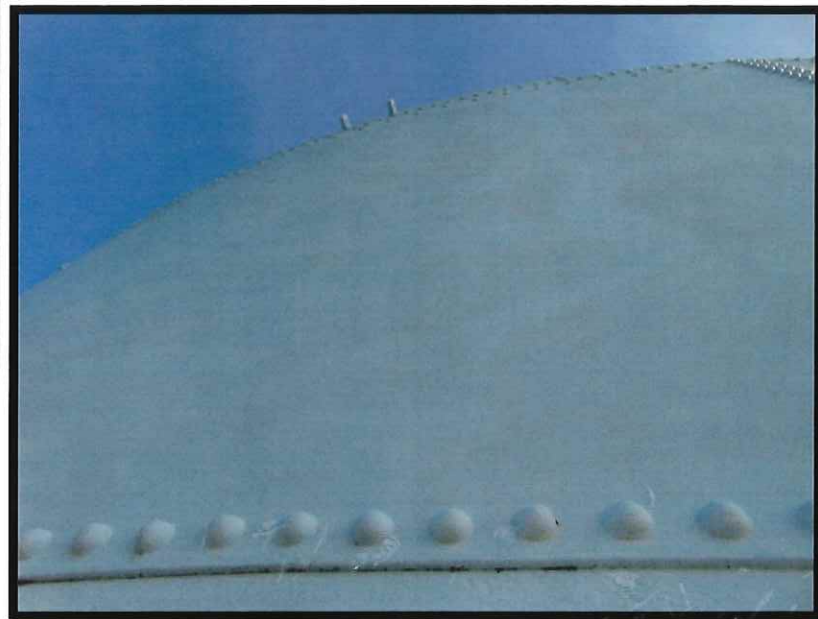
View of the shell wall and shell wall manway.

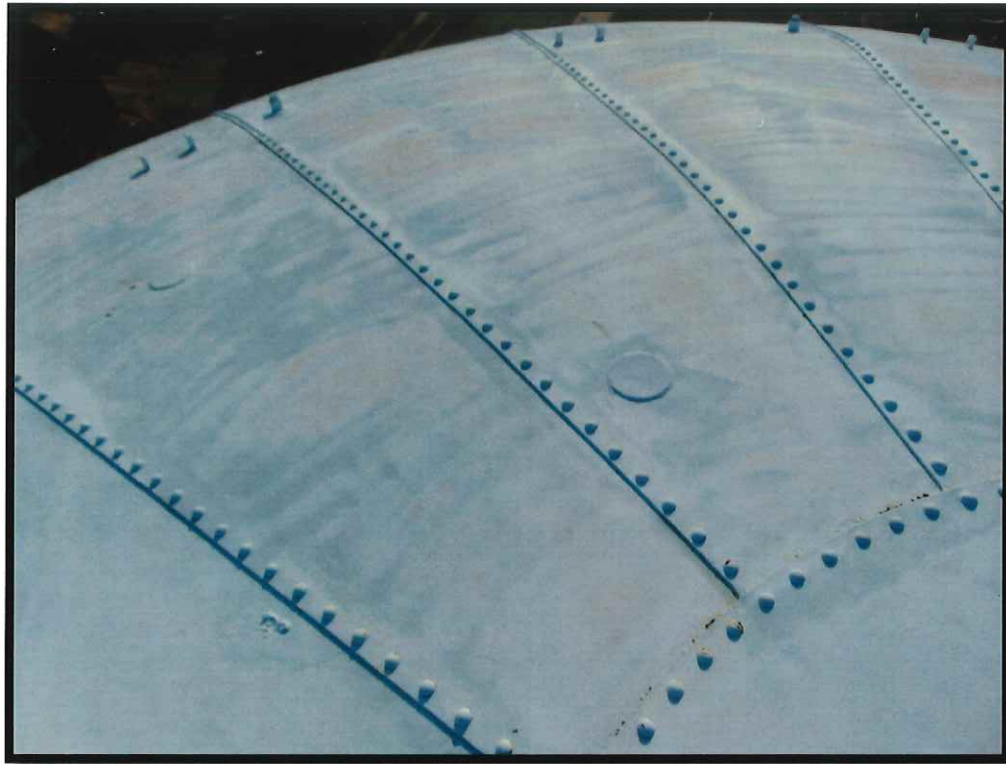
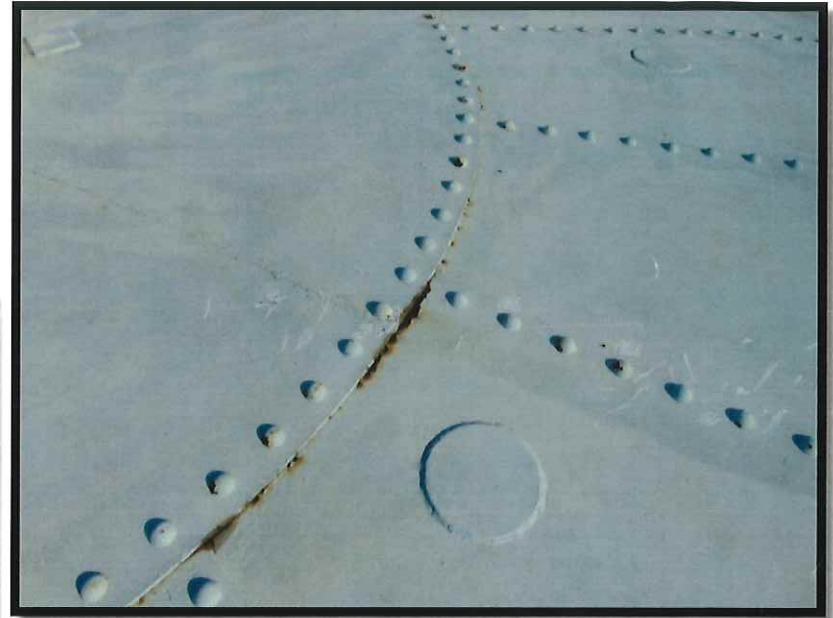
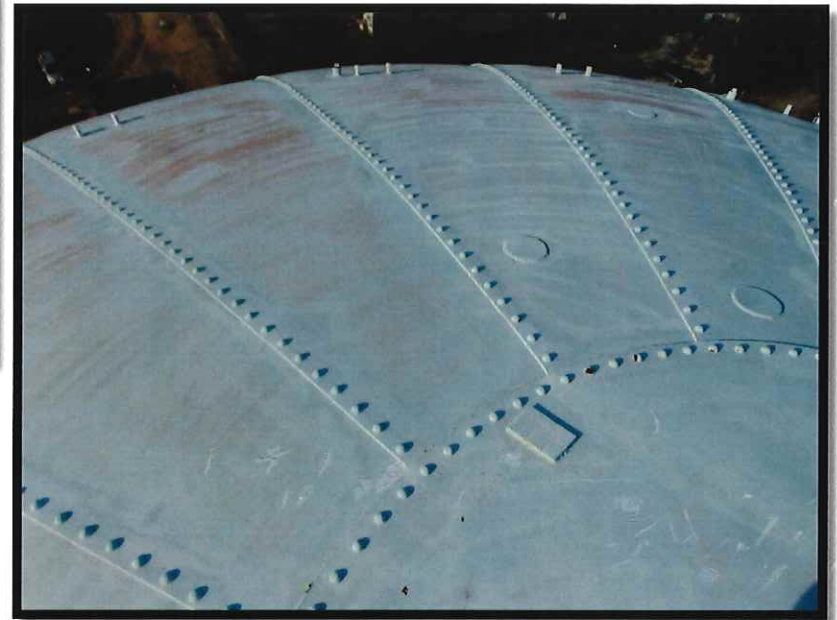
The tank roof is in fair condition with observed corrosion observed on less than 5% of surfaces.

View of the roof.
